BIA Rt 15: Battaglia Dr to SR 86 Road Safety Assessment

Prepared for:
The Tohono O'odham Nation

May 2023

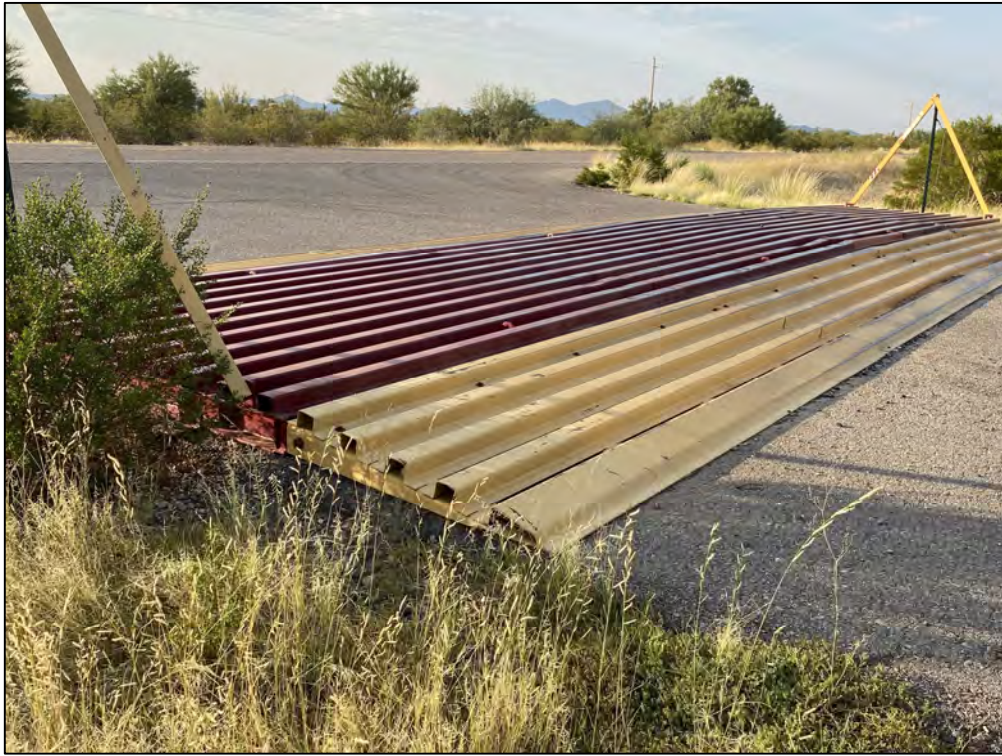
Cattle guard at mile marker 8

A cattle guard was observed to be set too high for the grade at the driveway for the Hanam Kek development near mile marker 8. This cattle guard was also noted as missing an object marker sign on either side.

- Continuous fencing
- Conduct a systematic inspection on the right-of-way fence, gates, and cattle guards and develop a repair plan
- Replace non-standard cattle guards with standard cattle guards

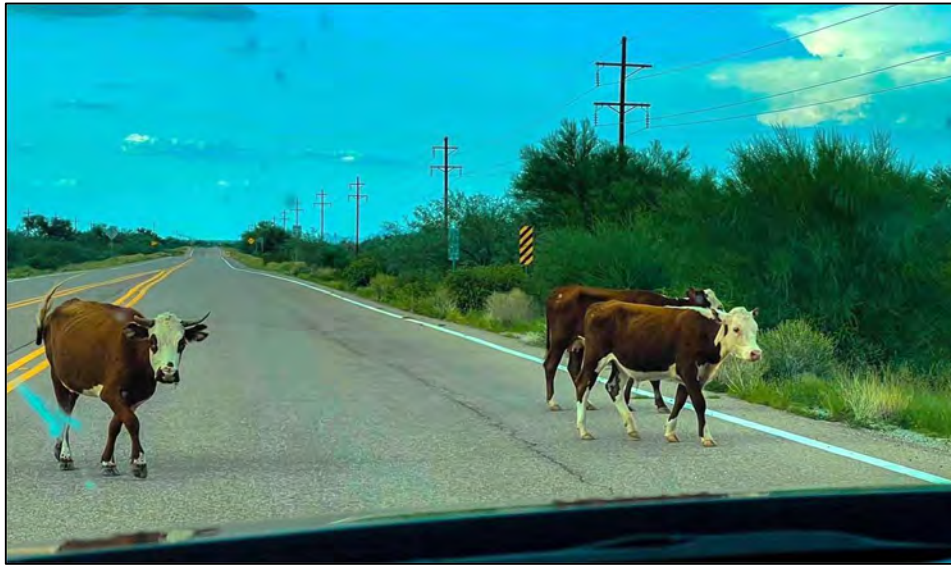
It was observed that cattle were periodically walking in and along the roadway. The RSA team observed other cattle congregating on the side of the roadway where vegetation could potentially obstruct their view.

Cattle in the roadway and warning sign of an open range

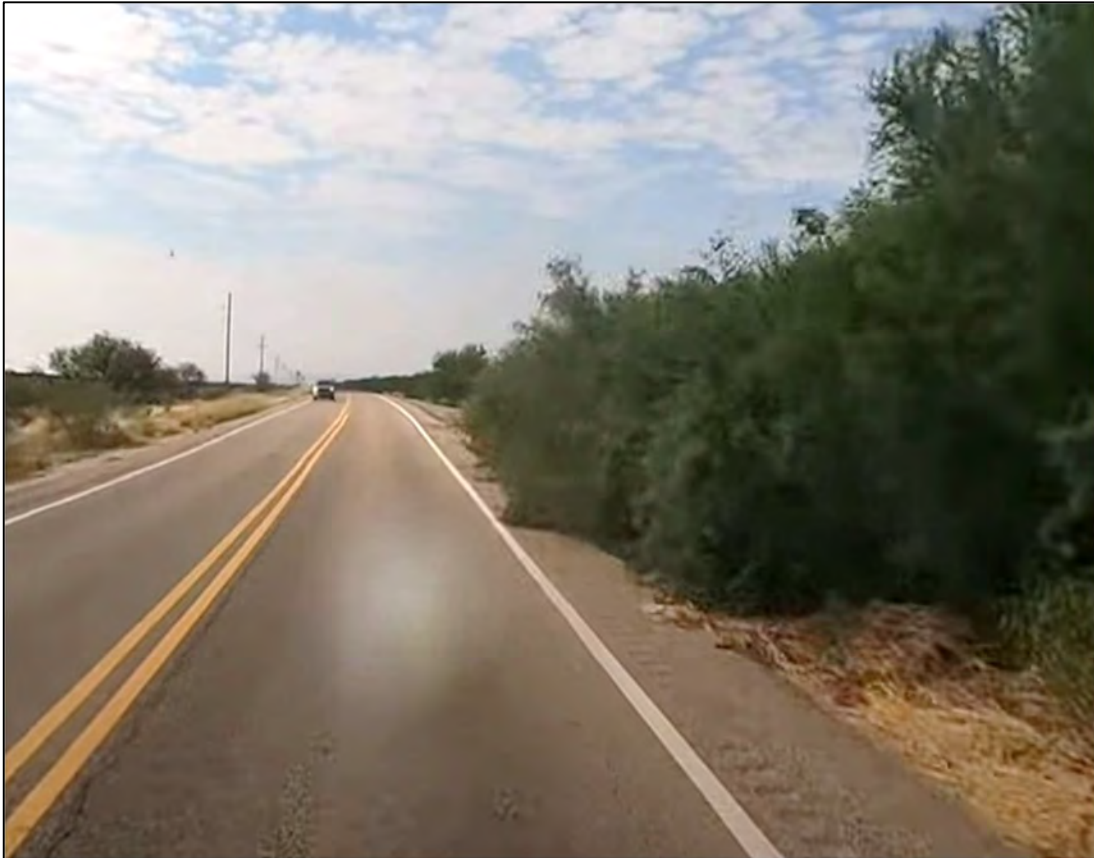
Vegetation was observed obstructing the view of the shoulder and some signs. The locations at mile markers 26 and 48 were noted to be in the worst condition.

Vegetation on the shoulder of Route 15

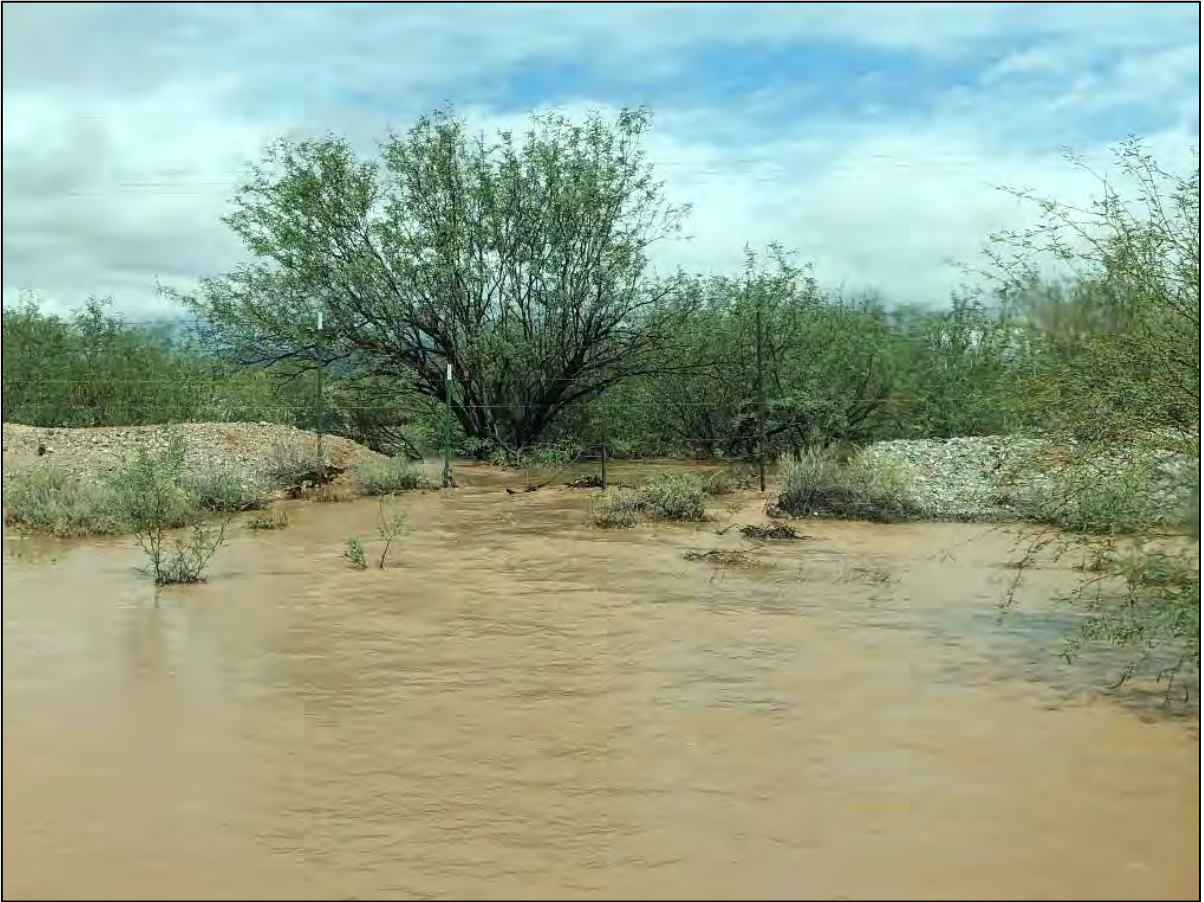
Areas along the route show degradation of protective dykes. Some dyke areas are observed to have been breached and have been allowing flooding in the right-of-way during storm events.

It was flooding between mileposts 22 and 26, as reported by a district chair person.

- Culverts at sag curves that experience flooding
- Clean and maintain clogged culverts and under bridges
- Inspect and repair damaged dikes in the right-of-way

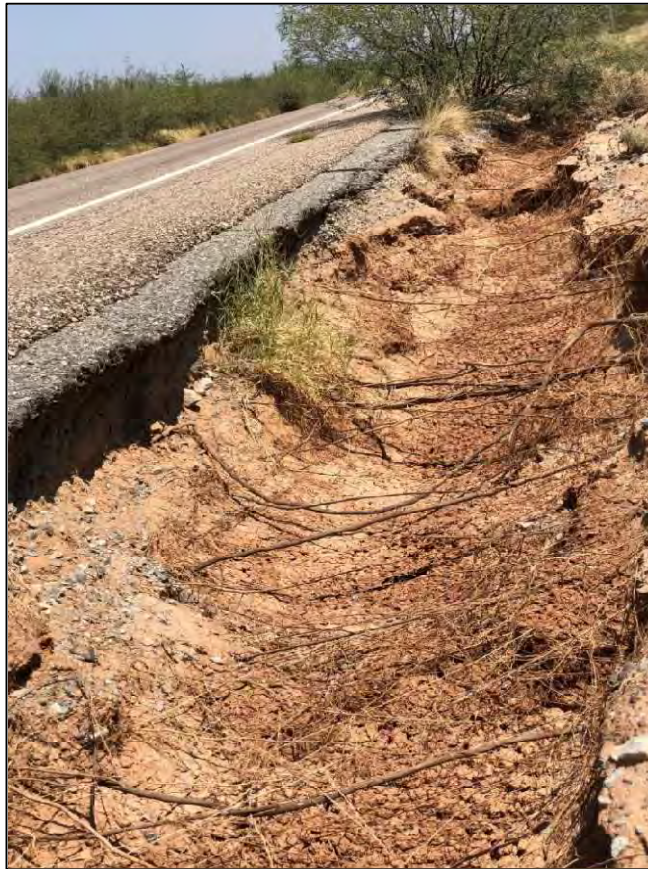
Extensive shoulder and sub-roadway erosion, as reported by Rita Wilson.

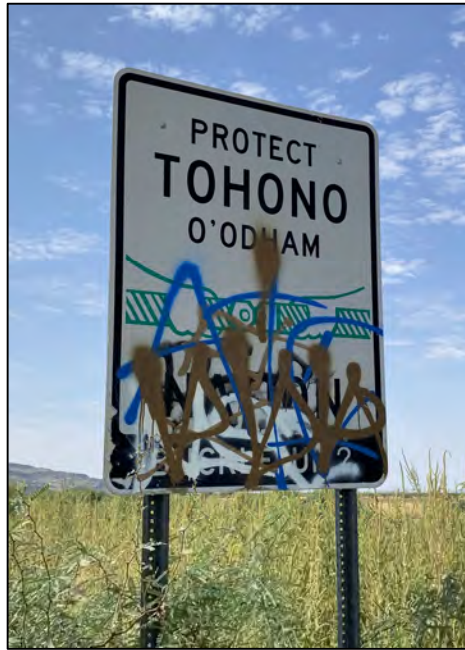
Most signs were visible during the daytime and appeared to have adequate retroreflectivity at night. Signs near mile markers 1, 40, and 48 had graffiti damage. Signs near mile markers 26 and 48 were obstructed with vegetation.

Roadway signage is obscured with paint.

- Install intersection warning signs.
- Install cattle guard warning signs
- Removal of sign graffiti or replace damaged signs
- Removal of vegetation obstructing signs
- Review passing zones in curves for adequate sight distance
- Install standard community signs
- Install flash flood warning sign

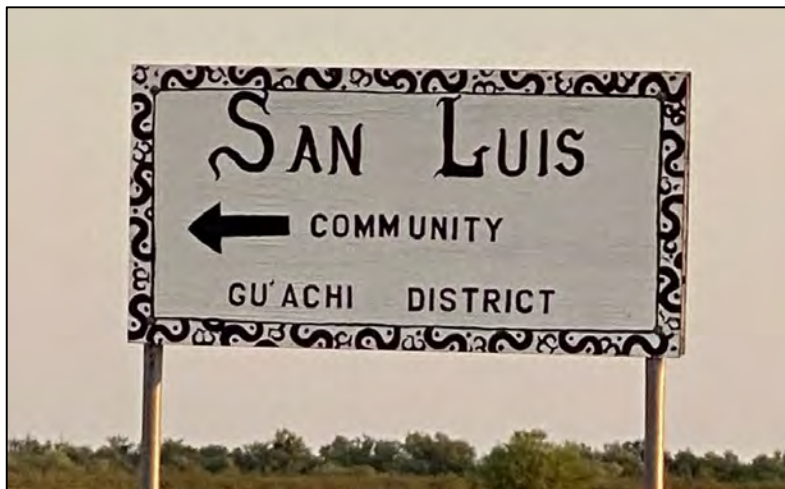
Nonstandard community sign on Route 15
