BIA Rt 19: SR 86 to End of Road Road Safety Assessment

Prepared for:
The Tohono O'odham Nation

May 2023

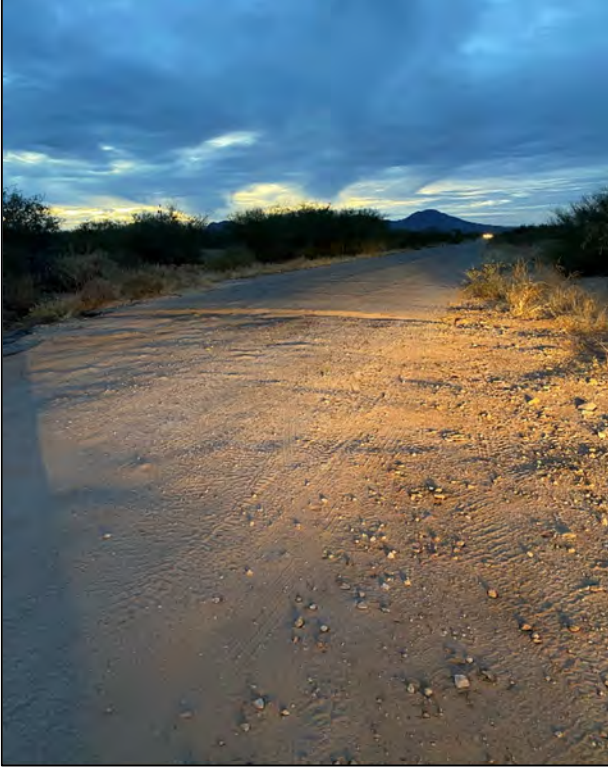
The lighting in the corridor was observed to be absent throughout the team's nighttime review. The observed low lighting conditions appear to allow for the potential of cattle to congregate on the roadway unseen by vehicles until they approach. No driveways or unsignalized intersections were observed to have lighting.

End of the road of Route 19 in low-level lighting conditions and sample solar-powered streetlight

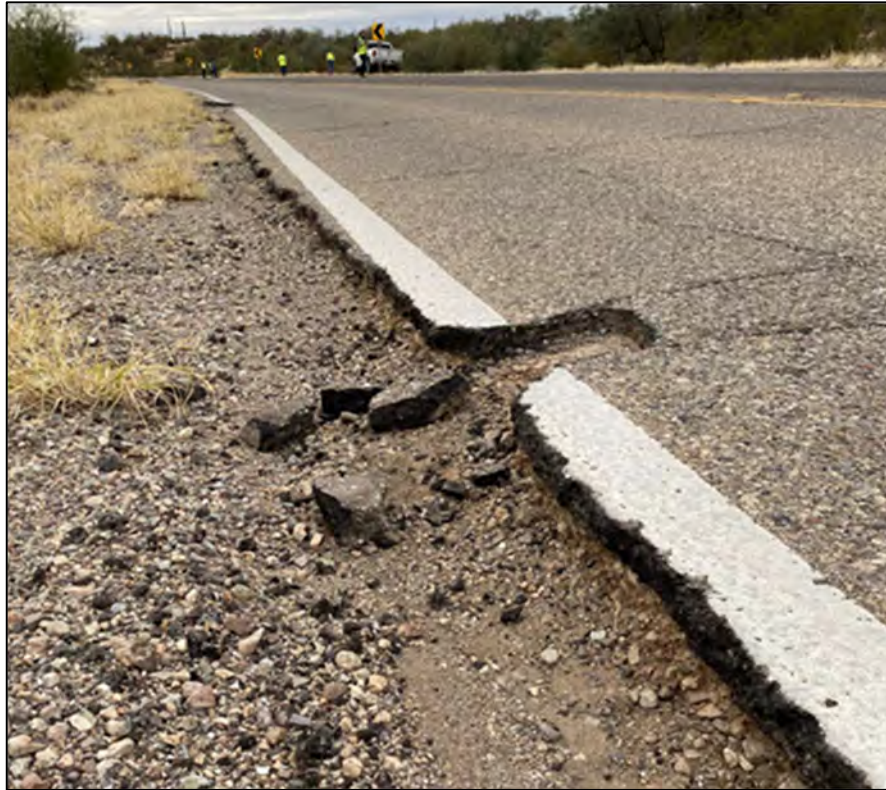
The pavement on most of the route appears to have dropped to a “poor” level of repair.

Pavement potholes and cracking on the shoulder of Route 19

- Conduct pavement maintenance (i.e., Chip Seal)
- Ensure a 4 ft paved shoulder minimum
- Improve all shoulder recovery zones to AASHTO standards
- Repair eroded soil and shoulder pavement
- Restore shoulder and side slope where the soil has eroded
- Rumble strips
- Safety EdgesSM
- Relocate driveways located in curves

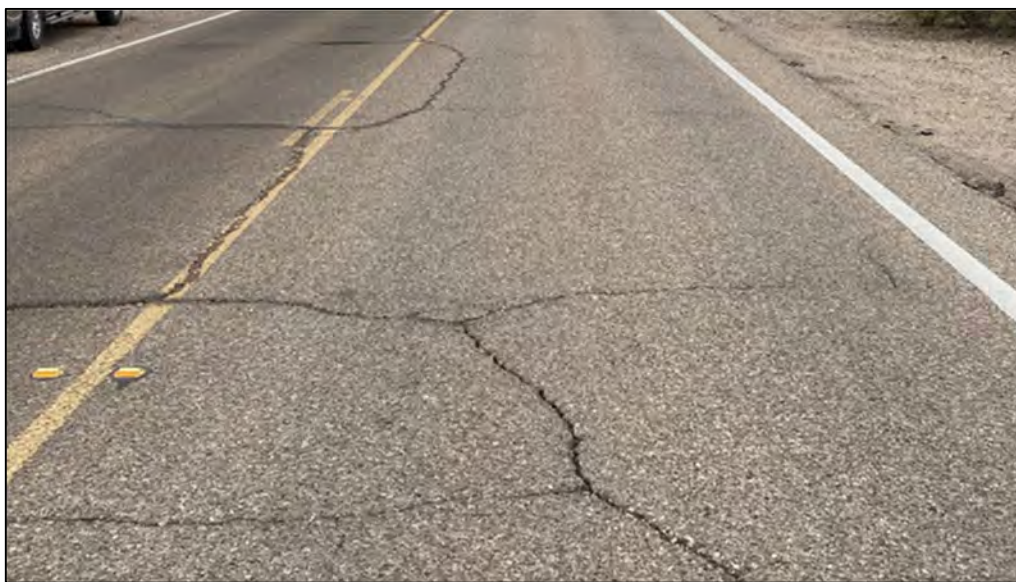
Cracking and pitting on Route 19

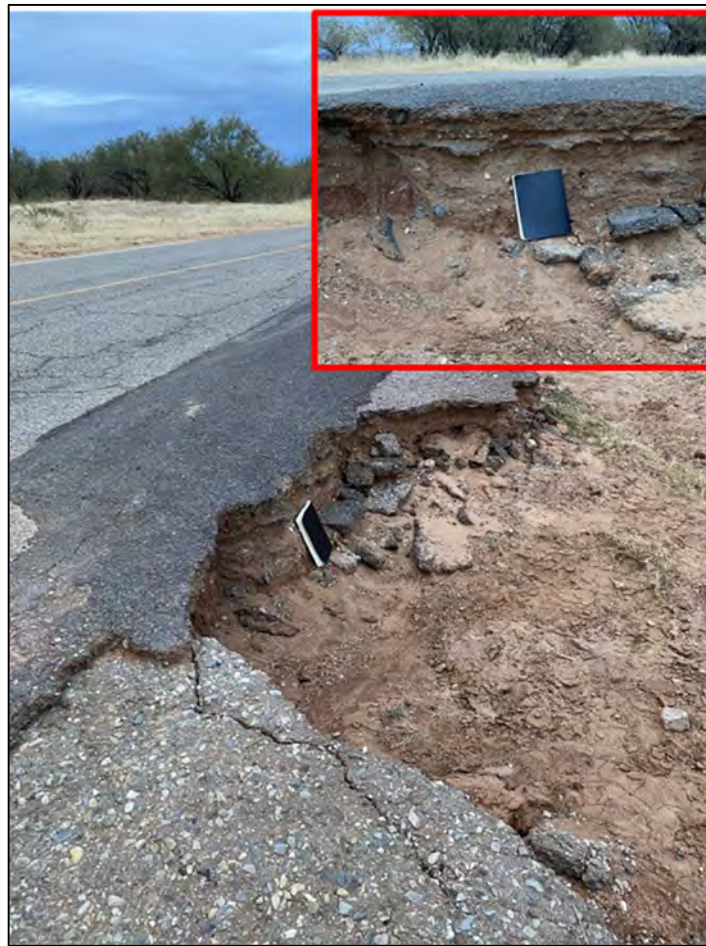
Roadside and sub-road soil erosion was discovered at mile markers 1.5, 3.75, and 4.75 near most roadside culverts. At mile marker 18.25, sub-road soil erosion may begin to compromise the roadway pavement.

Sub road soil erosion at mile marker 18.25 on Route 19

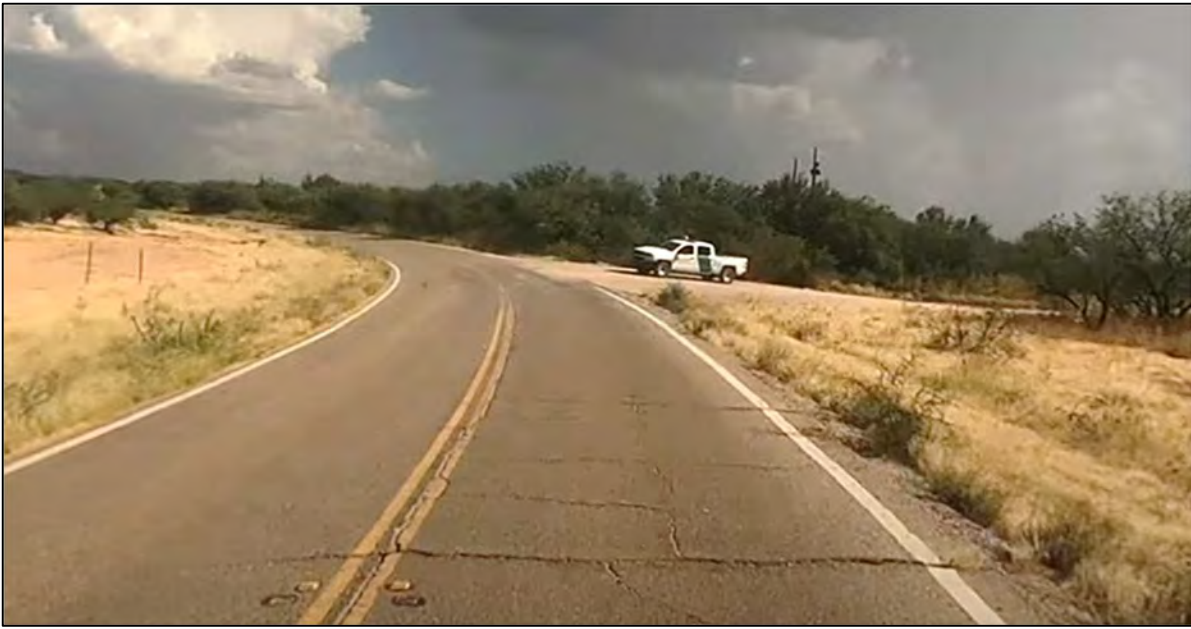
Hard shoulder edges and drop-offs were observed throughout the corridor. A driveway in a roadway curve is also observed at the intersection of Route 19 and Route 191.

Driveway in a curve at the intersection of Route 19 and Route 191

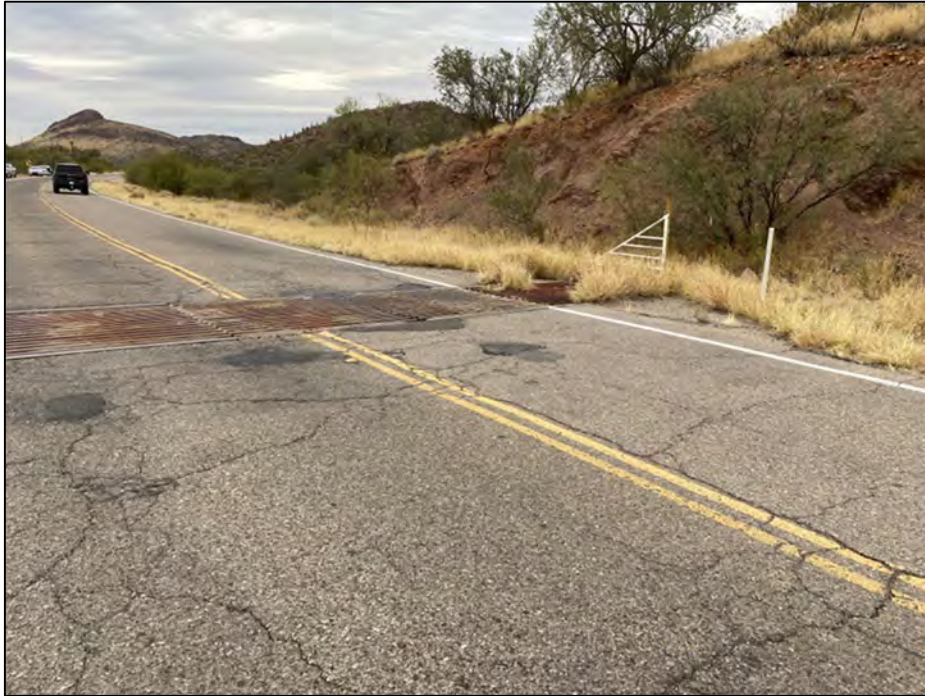
The RSA team observed a cattle guard in a curve at mile marker 23.5. Some areas have low superelevation at tight curves throughout the route, primarily at mile marker 23.5. Areas with tight curves did not have any advance notice of the curves.

Existing cattle guard in the curve at mile marker 23.5 on route 19

- Increased or added superelevation (a.k.a. banking) to tight curves
- Advanced rumble strips and warning signs advanced of curves
- Reduced speeds in advance of cattle guards in the roadway and install cattle guard warning signs

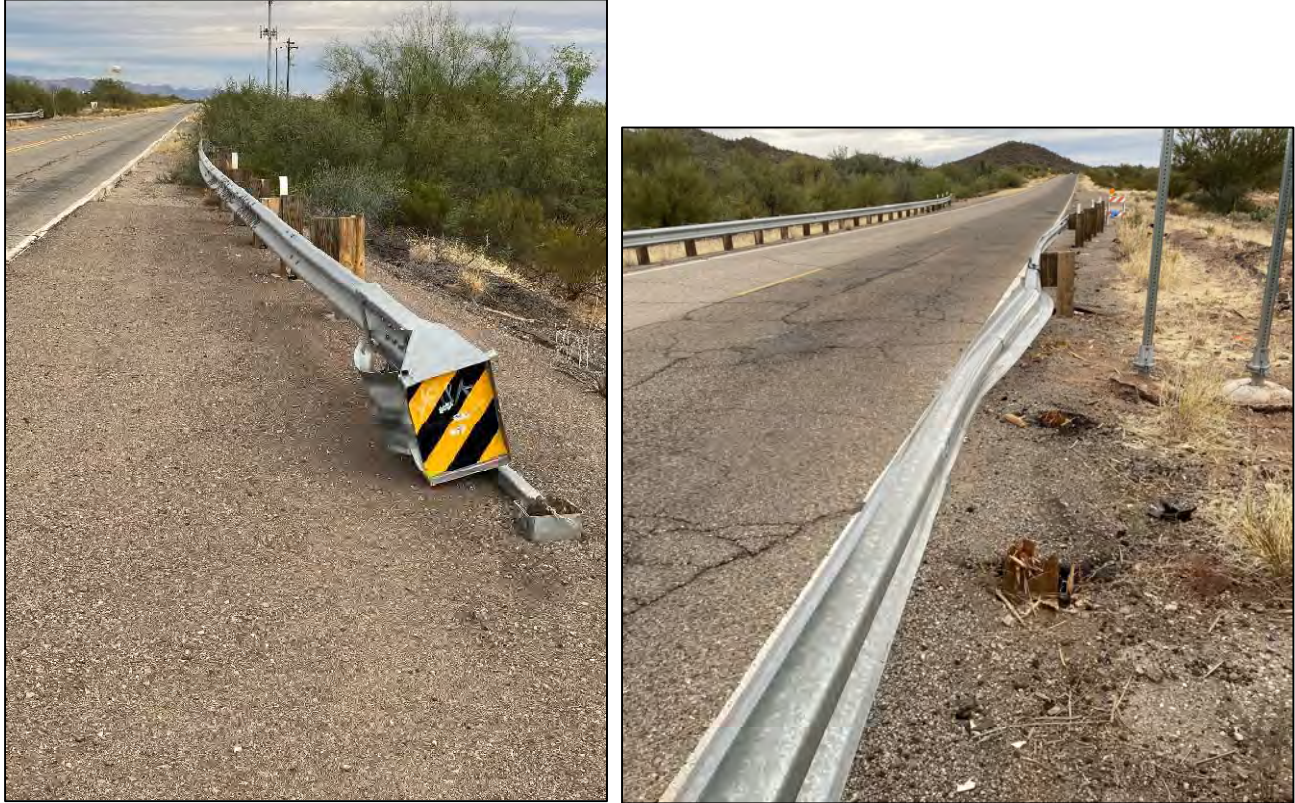
The RSA team observed damaged guard rails at mile markers 25.5, 20.5, 19, and 9.5. Some of the damages appear to be the result of a crash. The damaged rails pose a safety hazard to pedestrians and provide reduced safety effects for the guard rail countermeasures.

Existing damaged guard rails at mile markers 25.5, 20.5, 19, and 9.5 on route 19

- Repair damaged guard rails
- Reflectors on guard rails close to the roadway

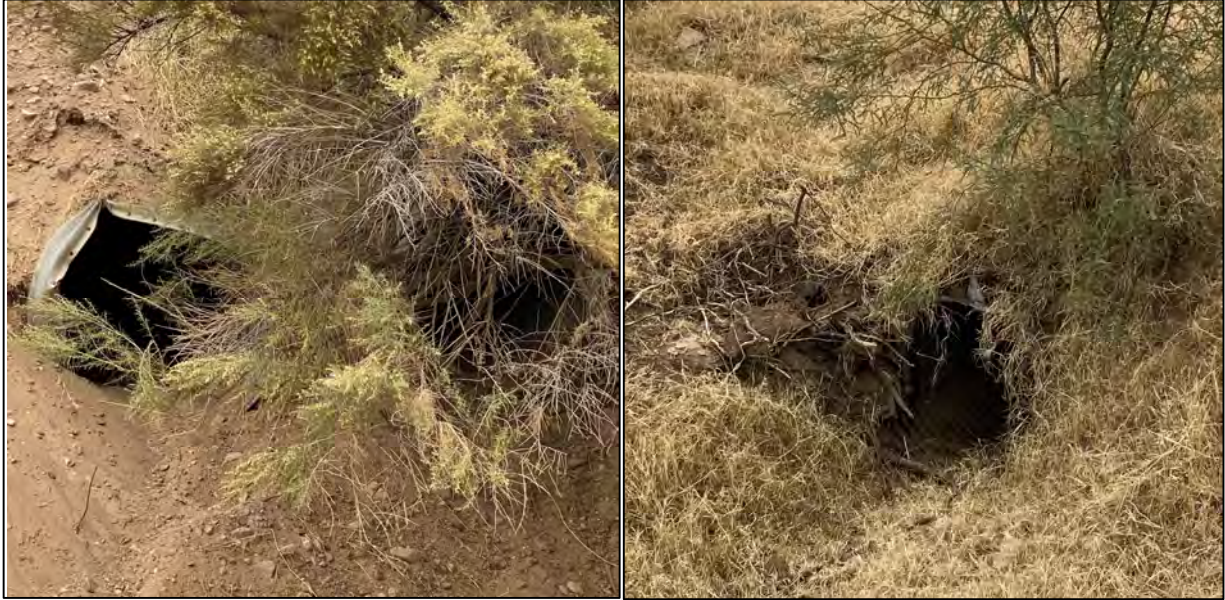
The RSA team observed clogging of existing wash drainage culverts in general. In general, the existing culverts on the route appear to be undersized for the apparent drainage volume they experience and need object markers. Culverts at mile markers 18.25 and 17 are covered by vegetation and appear damaged.

Existing wash drainage culverts at mile markers 18.25 and 17 under route 19

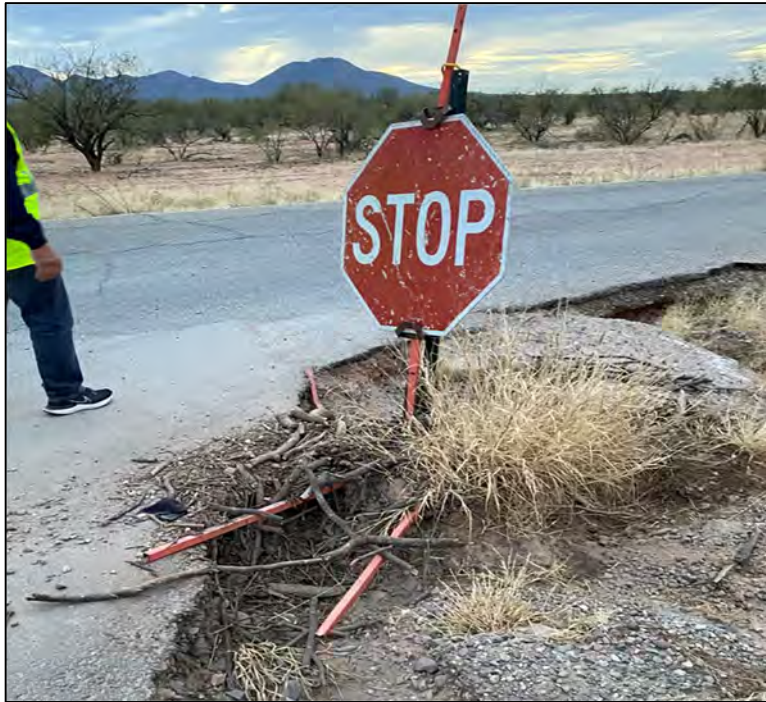
A non-standard mounting and placement of a stop sign are found outside of the US Border Patrol facility driveway near mile marker 2.5.

Roadway signage is obscured with paint.

- Install standard community signs
- Install roadside object marker signs
- Install advanced cattle guard warning signs
- Intersection warning signs
- Replace nonstandard signage
- Install pedestrian warning signs with a supplemental sign stating “next XX miles” every 10 miles
- Install flash flood signs next XX miles
- Install a pedestrian crosswalk with advance warning signage at the driveway of the Baboquivari High School on Route 19

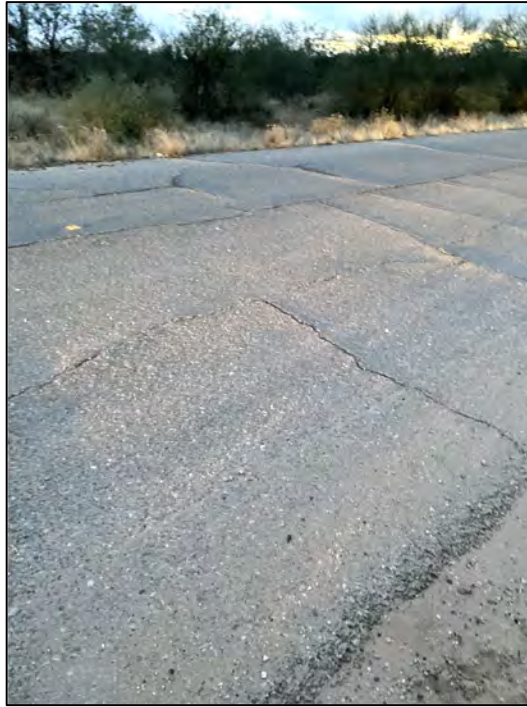
The roadway striping on the route appears in good condition on Route 19 but is in poor condition or absent on Route 191. Route 191 has high enough speeds to justify the installation of centerline markings to ensure the separation of opposing traffic.

The blank pavement on Route 191
