BIA Rt 21: SR 86 to Papago Farm Road Road Safety Assessment

Prepared for:
The Tohono O'odham Nation

May 2023

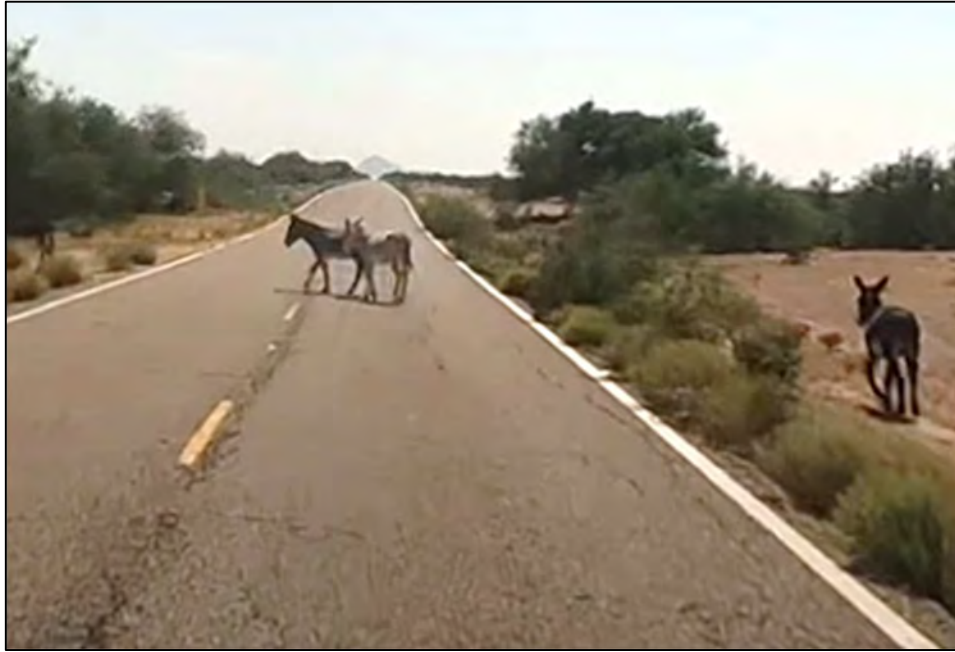
It was observed that cattle and donkeys were periodically wandering in the roadway. The RSA team was able to observe additional cattle and donkeys congregating on the sides of the roadway where vegetation could potentially obstruct the view of them. It was noted that nighttime conditions would potentially exacerbate the risk of animal crashes occurring.

Donkeys in the roadway

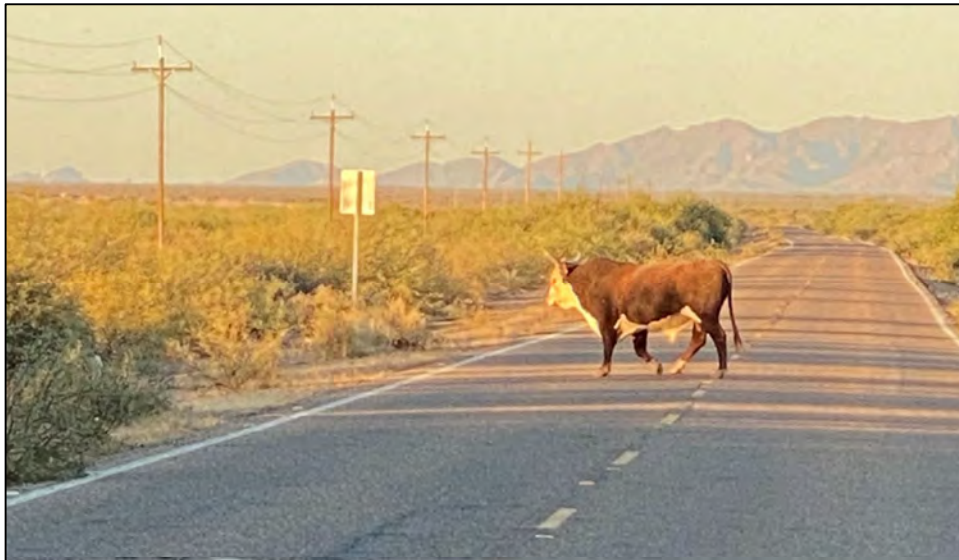
Cow/bull in the roadway

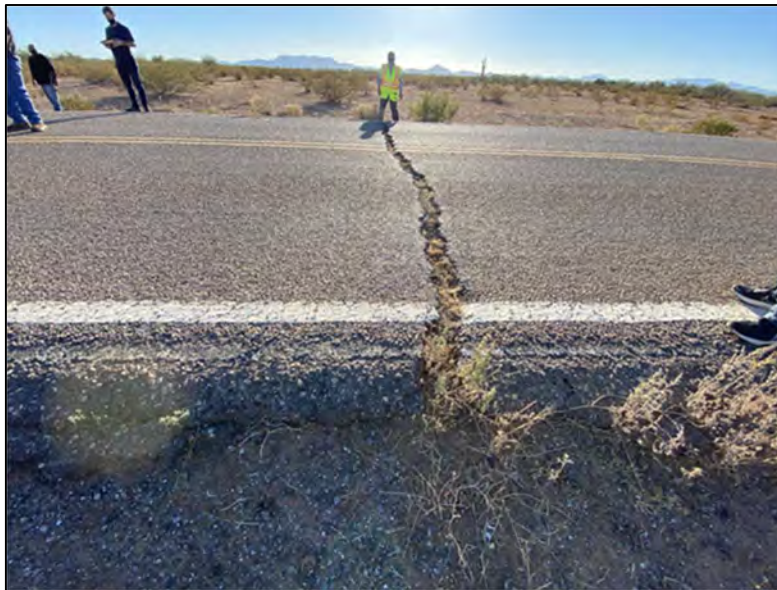
Records indicate the last pavement maintenance that was completed on the corridor was completed in the 1990s. The pavement surface on the route between the SR 86 intersection and mile marker 11.5 appears to have large cracks, superficial cracks, and surface pitting with few or no potholes. Between mile marker 11.5 and the end of the road, the pavement appears to be recently refreshed, with little to no pavement imperfections observed.

Pavement damage on Route 21

- Conduct pavement maintenance (i.e., Chip Seal) between SR 86 and mile marker 11.5
- Remove soil from the roadway
- Implement Safety Edge or recoverable sloped shoulder
- Remove shoulder vegetation
- Ensure a 4 ft paved shoulder minimum

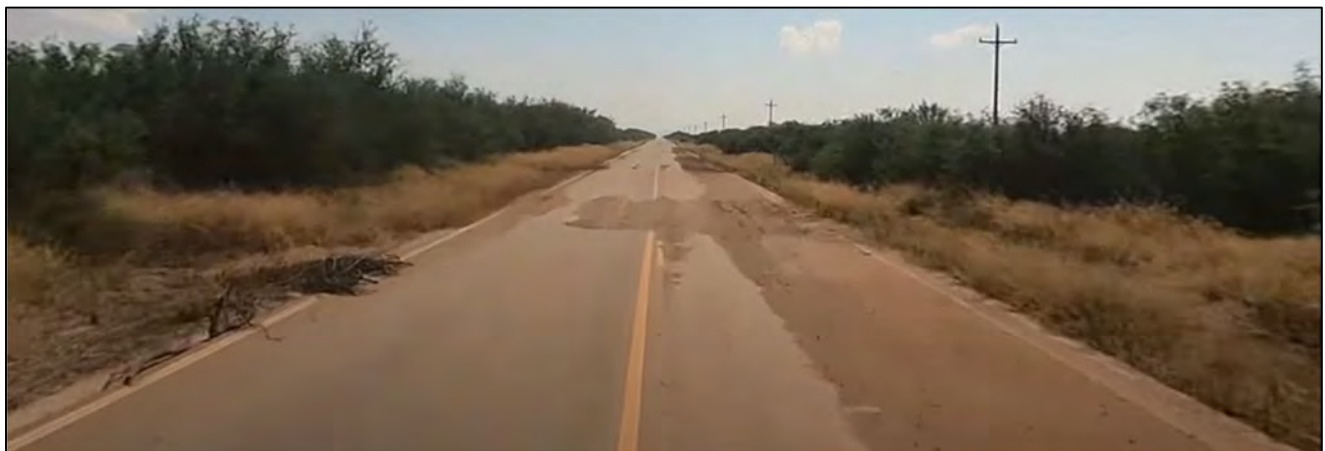
Soil accumulation on Route 21 at mile marker 11

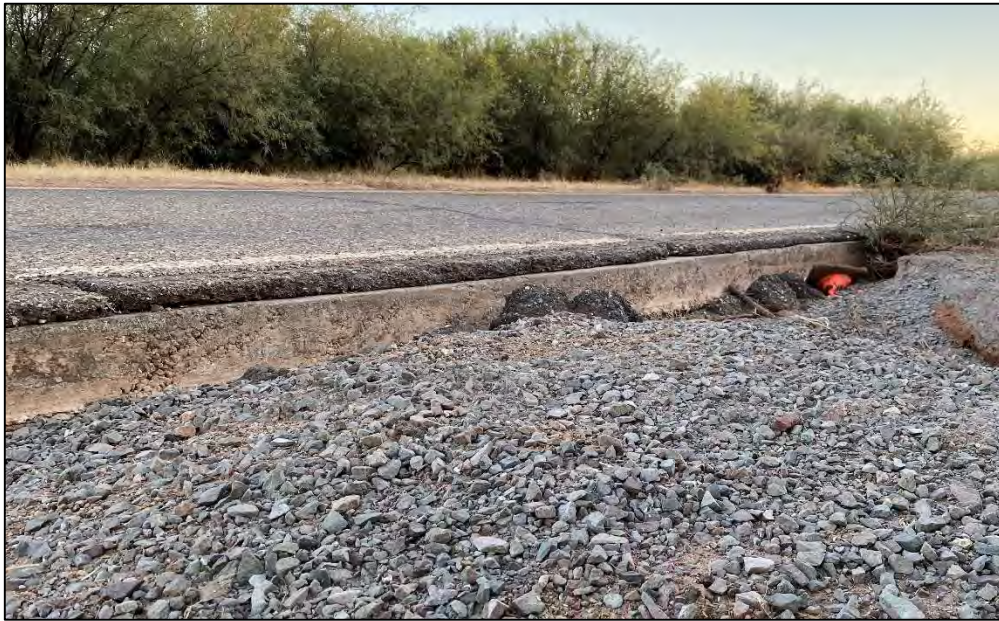
Shoulders throughout the corridor vary from approximately one foot to four feet in width. Edge drop-offs were observed throughout the corridor and specifically at the intersection of SR 86 and Rt 21 and at mile marker 19. It is noted that there are periodic erosion control measures between mile marker 11.5 and the end of the road, including riprap and gabion baskets.

Large pavement edge drop-off on Route 21

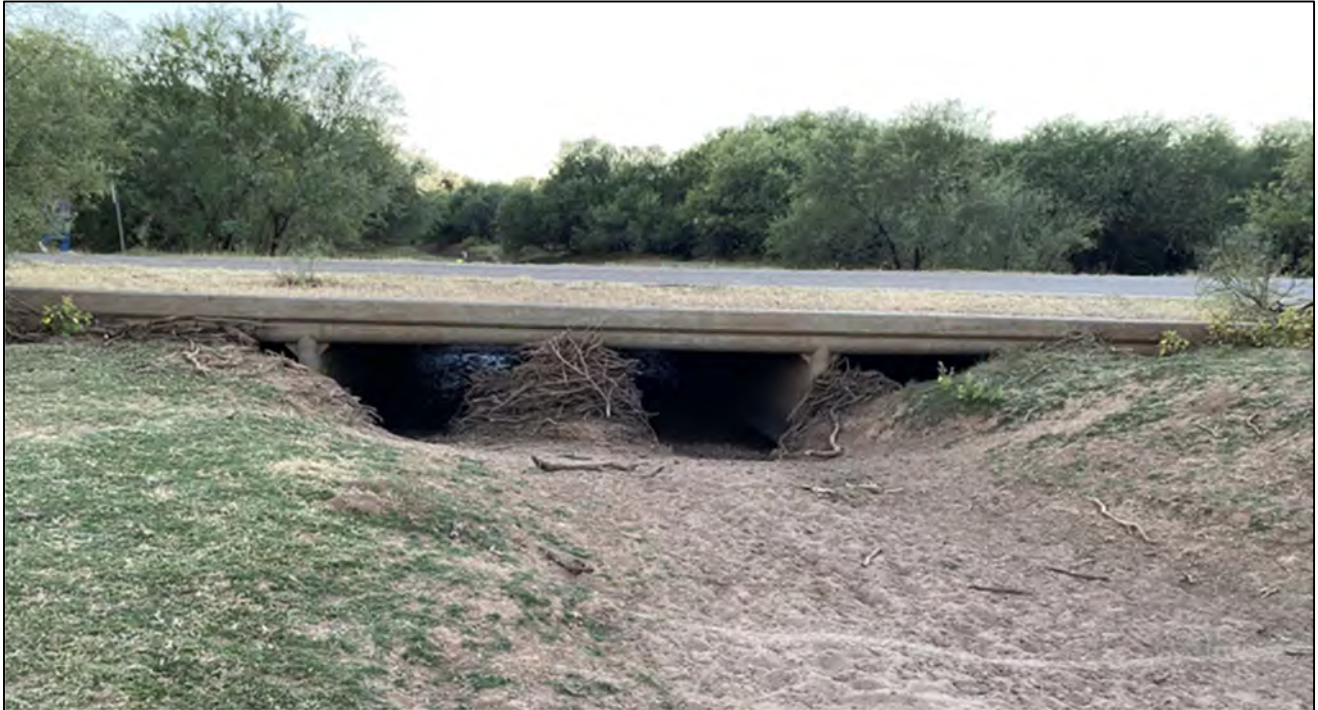
The RSA team observed clogging of existing wash drainage culverts. Culverts at mile markers 19 and 15 appear to be clogged or damaged. In general, the existing culverts on the route appear to be undersized for the apparent volume of drainage that they experience. A five-span box culvert-style bridge at mile marker 12 was observed to be clogged, with three of the spans being completely blocked.

Clogged and blocked 5 span box culverts under Route 21

- Install culverts at sag curves that experience flooding at mile markers 15 and 19
- Maintenance on damaged and clogging in culverts and under bridges at mile marker 12
- Depth gauges at wash locations

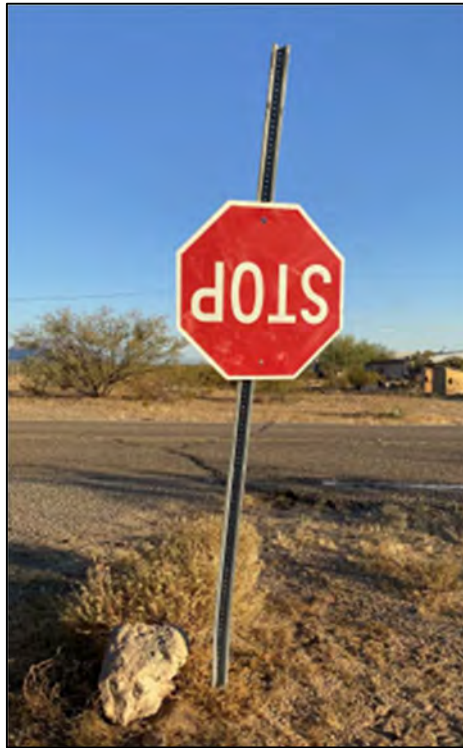
Damaged signage at the RT 21 and RT 28 intersection

- Install intersection warning signs at roadway intersections
- Removal of sign graffiti or replacement near mile marker 18
- Removal of signs obstructing vegetation near mile markers 13, 17, and 20
- Install standard community signs
- Add bus stop warning signs at mile marker 18.25 or the new bus stop location
- Relocate bus stops away from the road curve near mile marker 18.25
- Install advanced sag curve warning dip signs
- Install edge of roadway delineators
- Install RPMs from mile marker 11.5 to the end of the road
- Add chevron signs through sharp curves

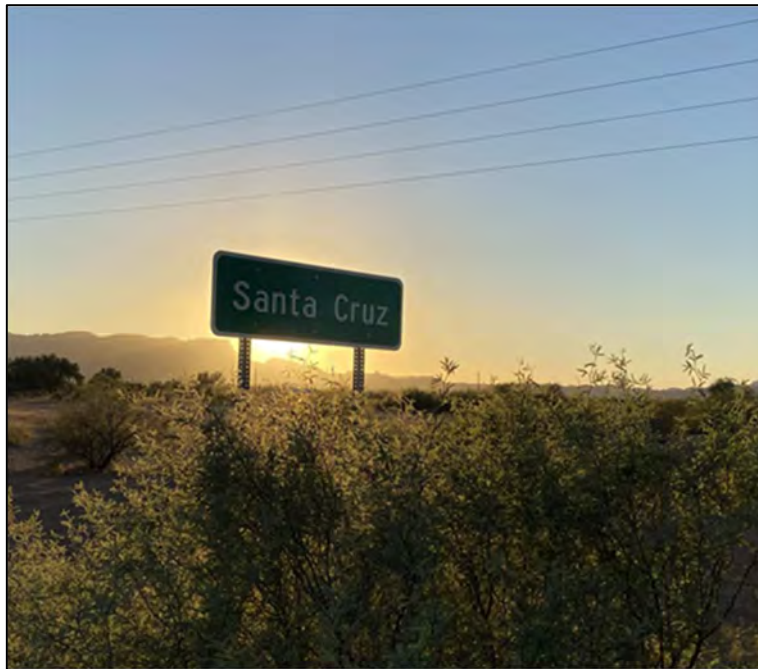
During the daytime and nighttime reviews, vegetation was observed obstructing the view of the shoulder of the roadway and signs. The locations at mile markers 13, 17, and 20 were noted to be in the worst condition.

Roadway signage is obscured with vegetation.

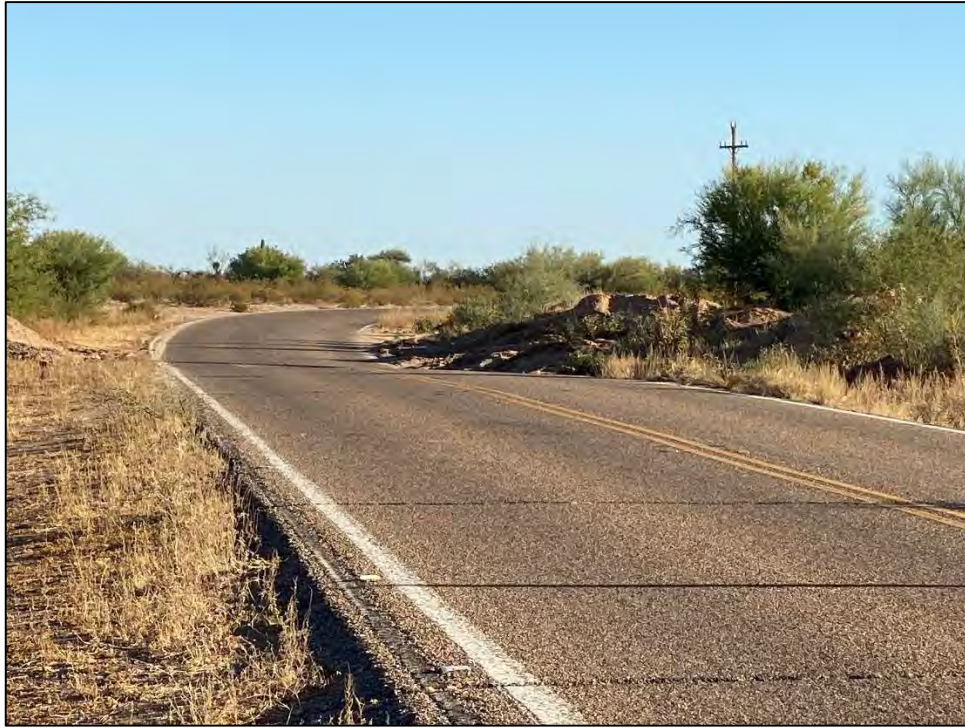
No chevron signs were observed at tight curves in the roadway alignment to warn drivers of coming tight curves. Additionally, no edge of roadway delineators is present throughout the corridor. These delineators can help reduce the risk of road departure on the corridor.

Example of existing road curve with a lack of delineation/chevrons
