BIA Rt 19: SR 86 to End of Road Road Safety Assessment

Prepared for:
The Tohono O'odham Nation

May 2023

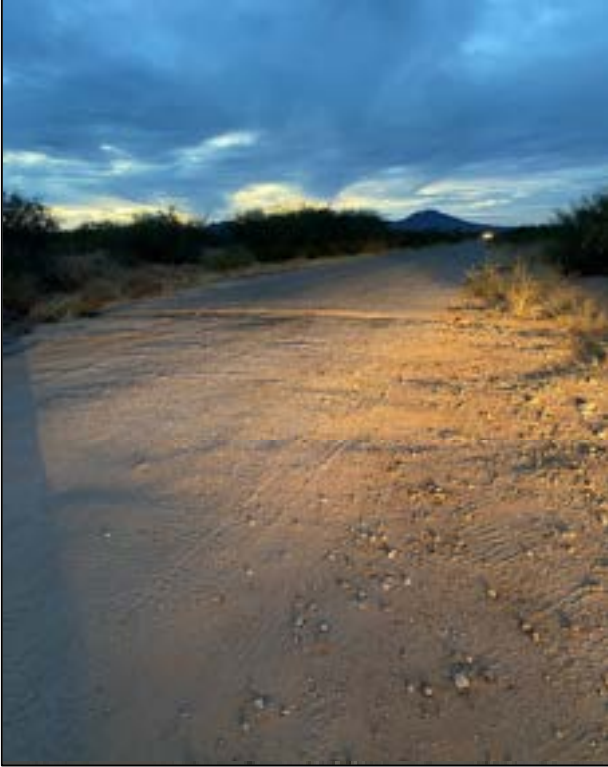
The lighting in the corridor was observed to be absent throughout the team's nighttime review. The observed low lighting conditions appear to allow for the potential of cattle to congregate on the roadway unseen by vehicles until they approach. No driveways or unsignalized intersections were observed to have lighting.

End of the road of Route 19 in low-level lighting conditions and sample solar-powered streetlight

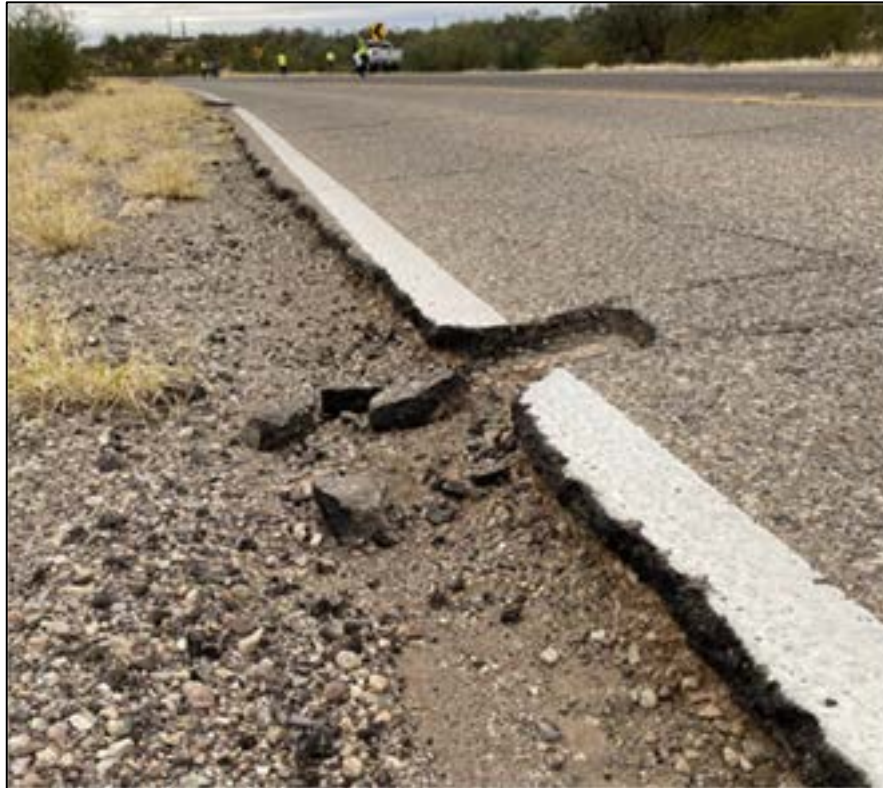
The pavement on most of the route appears to have dropped to a “poor” level of repair.

Pavement potholes and cracking on the shoulder of Route 19

- Conduct pavement maintenance (i.e., Chip Seal)
- Ensure a 4 ft paved shoulder minimum
- Improve all shoulder recovery zones to AASHTO standards
- Repair eroded soil and shoulder pavement
- Restore shoulder and side slope where the soil has eroded
- Rumble strips
- Safety EdgesSM
- Relocate driveways located in curves

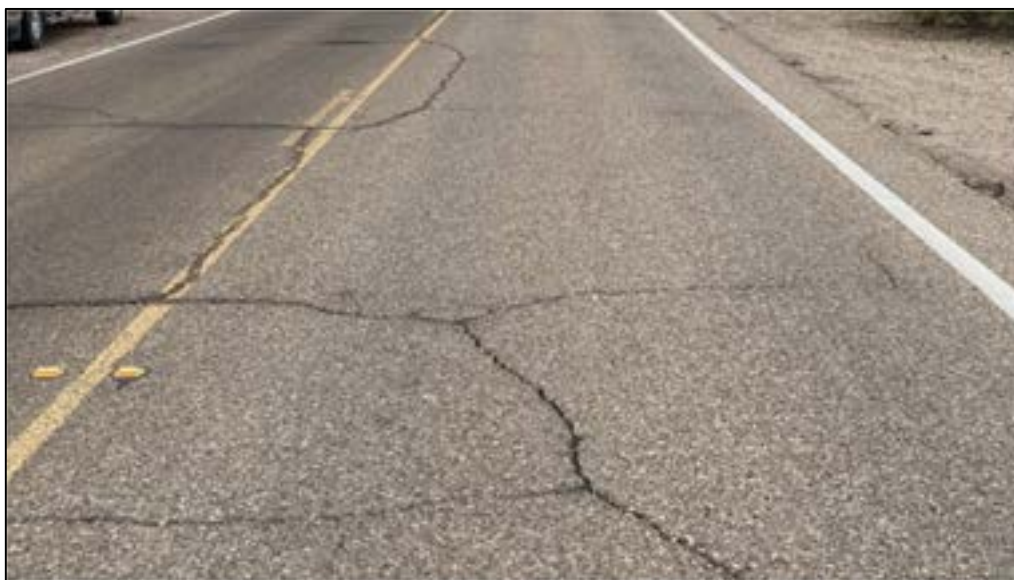
Cracking and pitting on Route 19

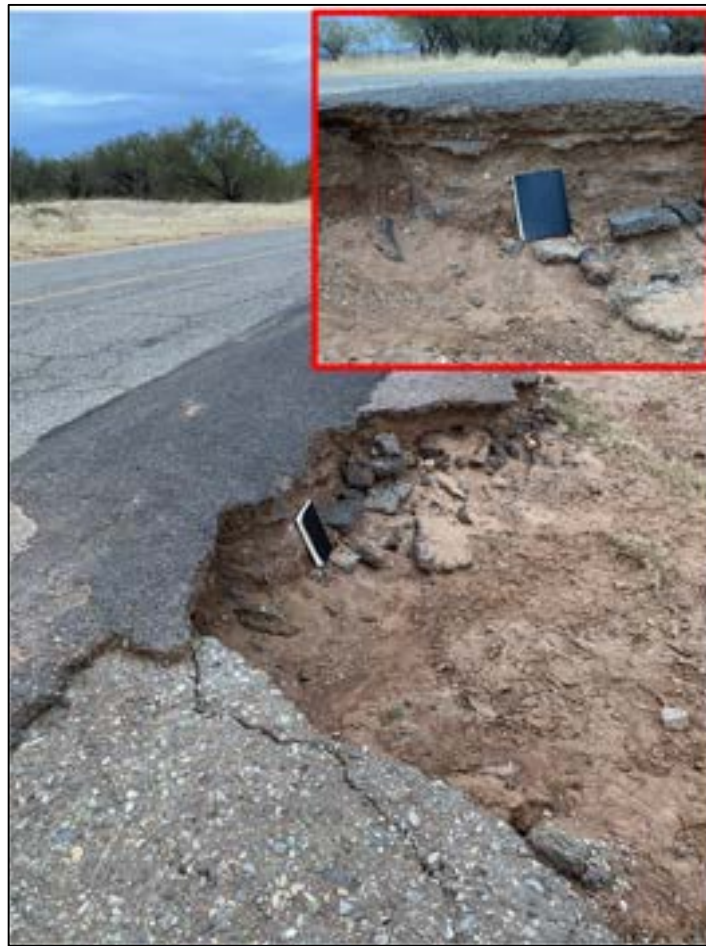
Roadside and sub-road soil erosion was discovered at mile markers 1.5, 3.75, and 4.75 near most roadside culverts. At mile marker 18.25, sub-road soil erosion may begin to compromise the roadway pavement.

Sub road soil erosion at mile marker 18.25 on Route 19

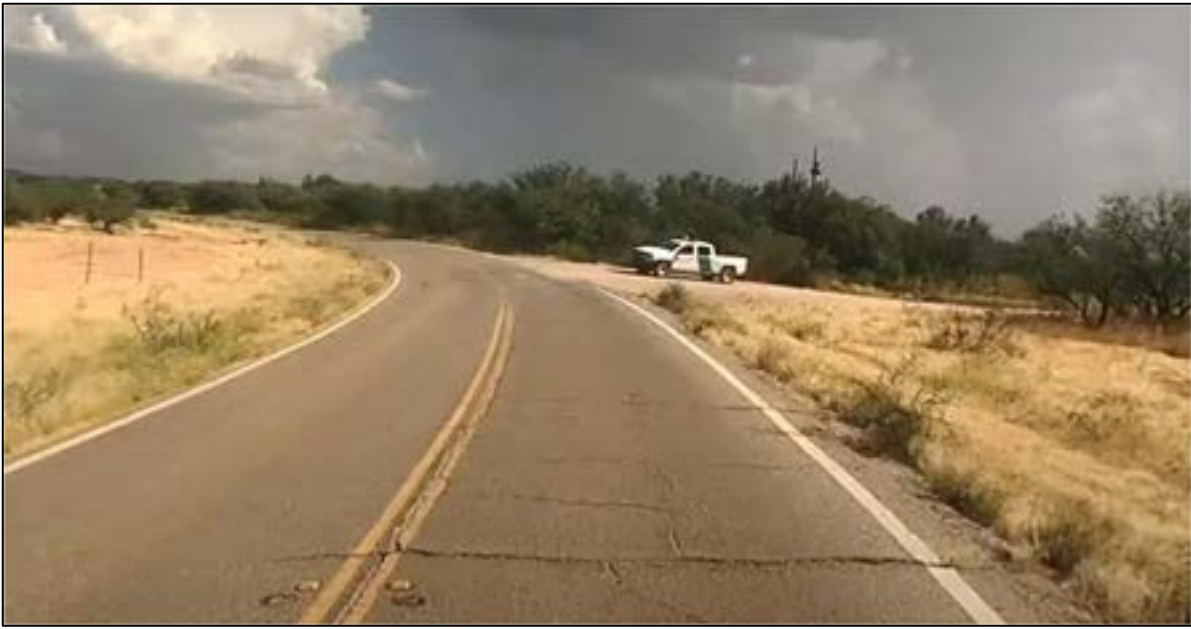
Hard shoulder edges and drop-offs were observed throughout the corridor. A driveway in a roadway curve is also observed at the intersection of Route 19 and Route 191.

Driveway in a curve at the intersection of Route 19 and Route 191

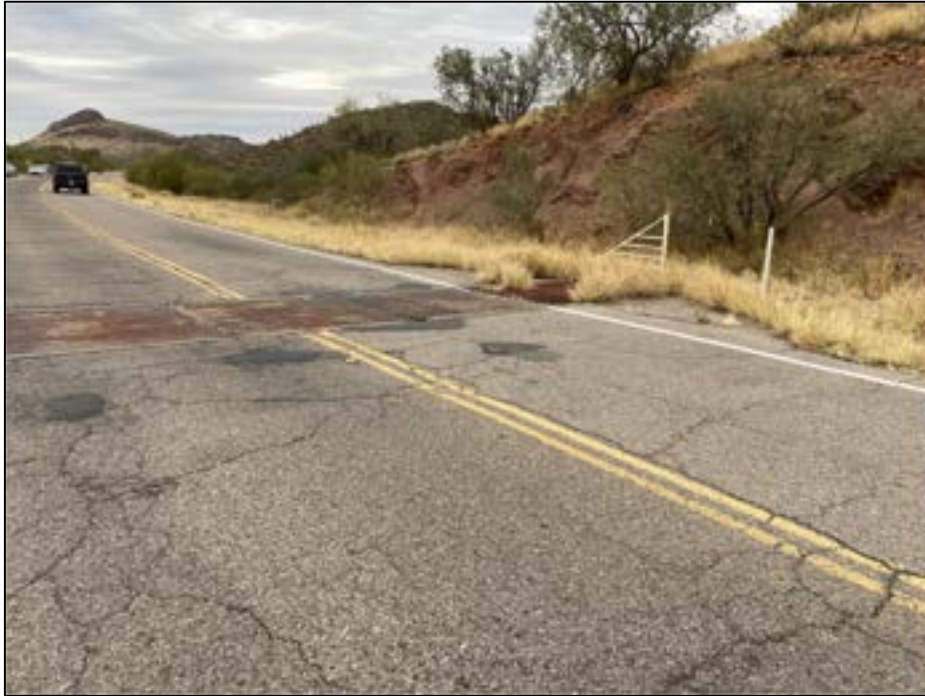
The RSA team observed a cattle guard in a curve at mile marker 23.5. Some areas have low superelevation at tight curves throughout the route, primarily at mile marker 23.5. Areas with tight curves did not have any advance notice of the curves.

Existing cattle guard in the curve at mile marker 23.5 on route 19

- Increased or added superelevation (a.k.a. banking) to tight curves
- Advanced rumble strips and warning signs advanced of curves
- Reduced speeds in advance of cattle guards in the roadway and install cattle guard warning signs

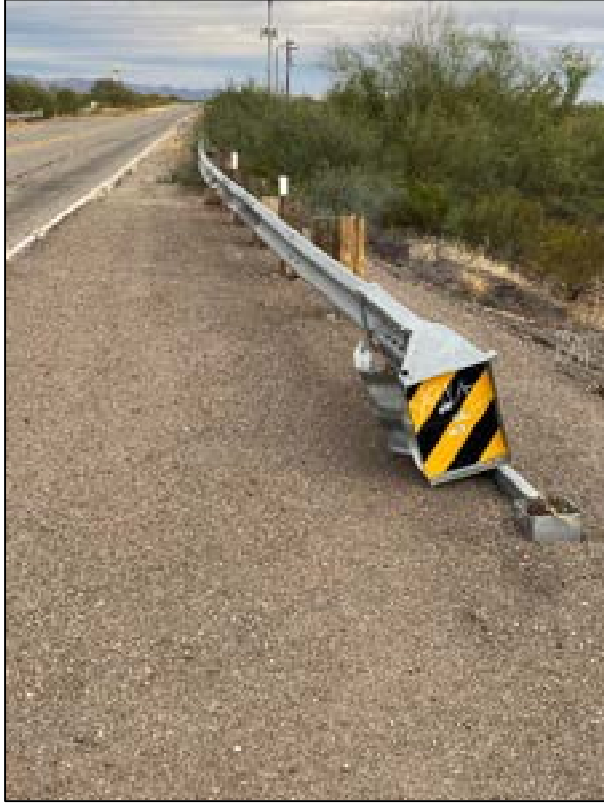
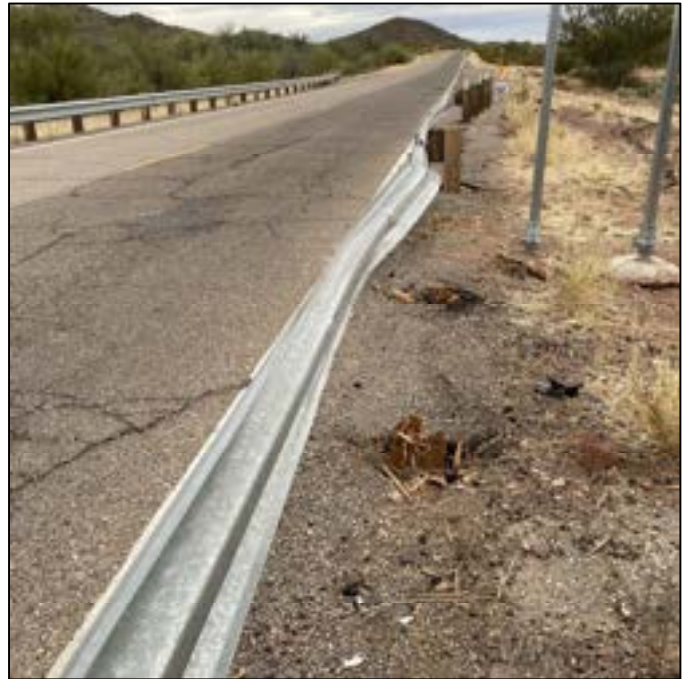
The RSA team observed damaged guard rails at mile markers 25.5, 20.5, 19, and 9.5. Some of the damages appear to be the result of a crash. The damaged rails pose a safety hazard to pedestrians and provide reduced safety effects for the guard rail countermeasures.

Existing damaged guard rails at mile markers 25.5, 20.5, 19, and 9.5 on route 19

- Repair damaged guard rails
- Reflectors on guard rails close to the roadway

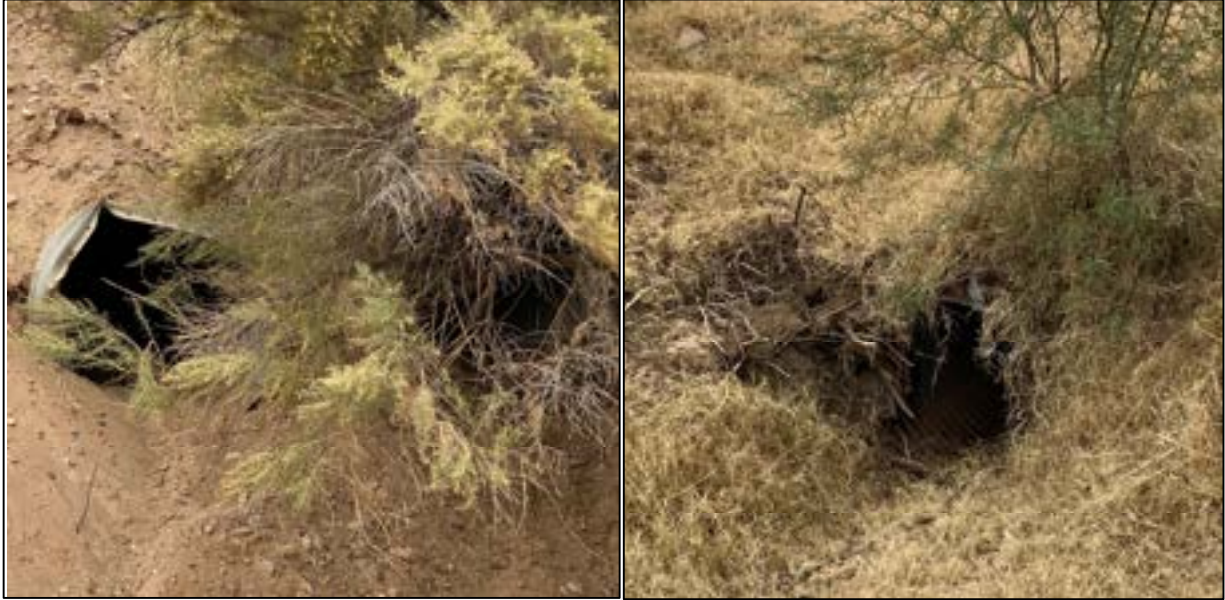
The RSA team observed clogging of existing wash drainage culverts in general. In general, the existing culverts on the route appear to be undersized for the apparent drainage volume they experience and need object markers. Culverts at mile markers 18.25 and 17 are covered by vegetation and appear damaged.

Existing wash drainage culverts at mile markers 18.25 and 17 under route 19

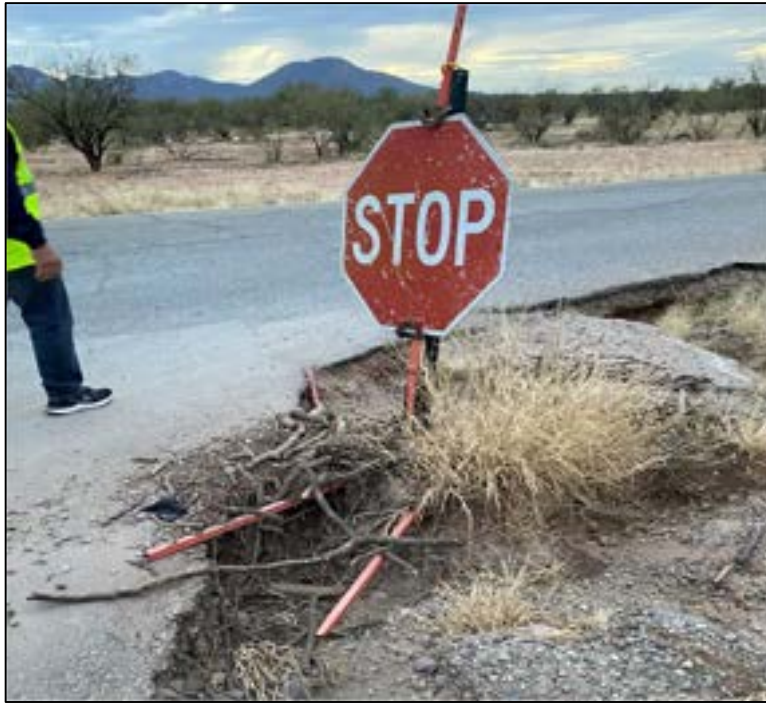
A non-standard mounting and placement of a stop sign are found outside of the US Border Patrol facility driveway near mile marker 2.5.

Roadway signage is obscured with paint.

- Install standard community signs
- Install roadside object marker signs
- Install advanced cattle guard warning signs
- Intersection warning signs
- Replace nonstandard signage
- Install pedestrian warning signs with a supplemental sign stating "next XX miles" every 10 miles
- Install flash flood signs next XX miles
- Install a pedestrian crosswalk with advance warning signage at the driveway of the Baboquivari High School on Route 19

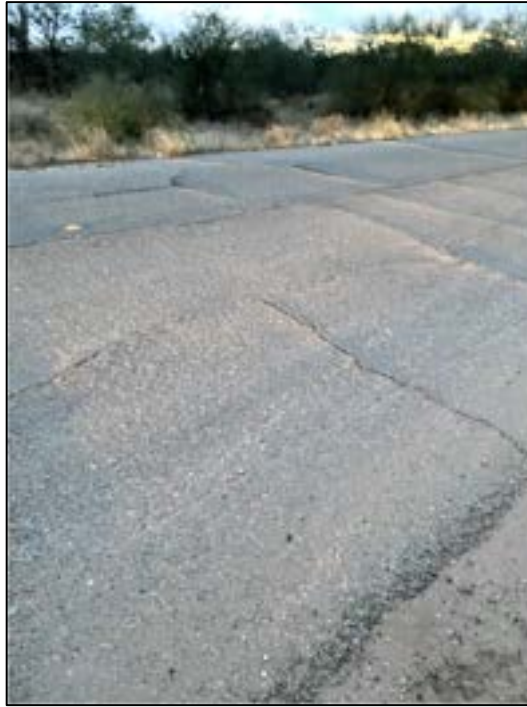
The roadway striping on the route appears in good condition on Route 19 but is in poor condition or absent on Route 191. Route 191 has high enough speeds to justify the installation of centerline markings to ensure the separation of opposing traffic.

The blank pavement on Route 191
