BIA Rt 21: SR 86 to Papago Farm Road Road Safety Assessment

Prepared for:
The Tohono O'odham Nation

May 2023

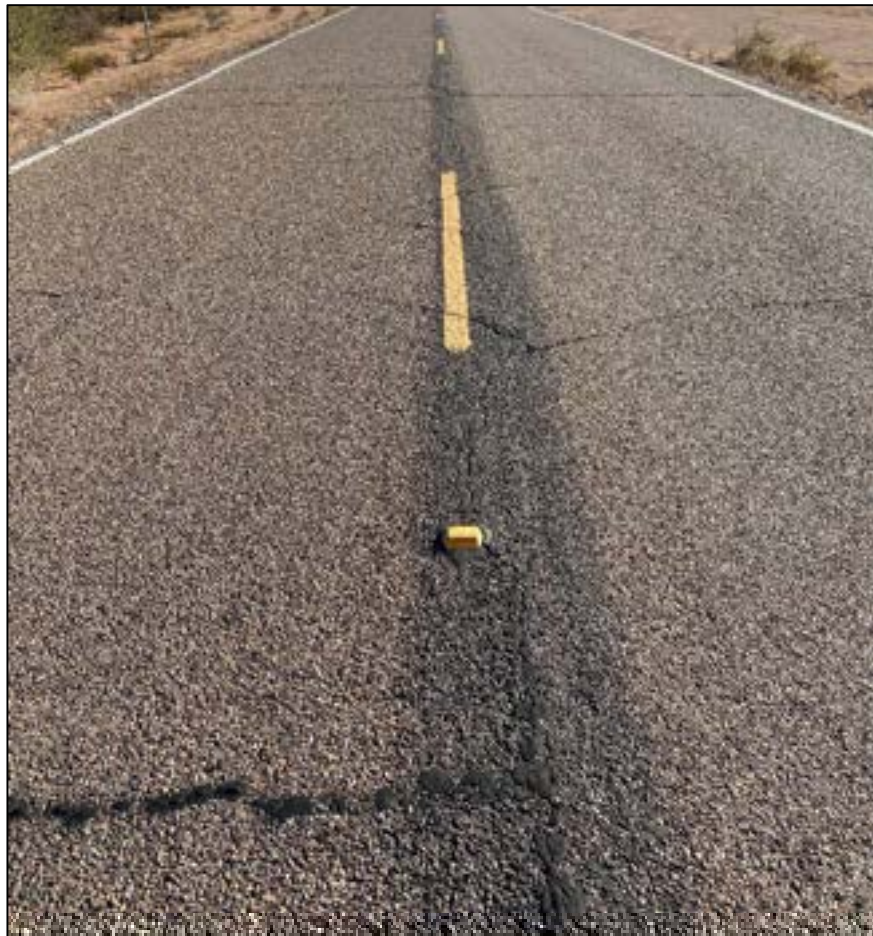
RPMs in road centerline and edge lines

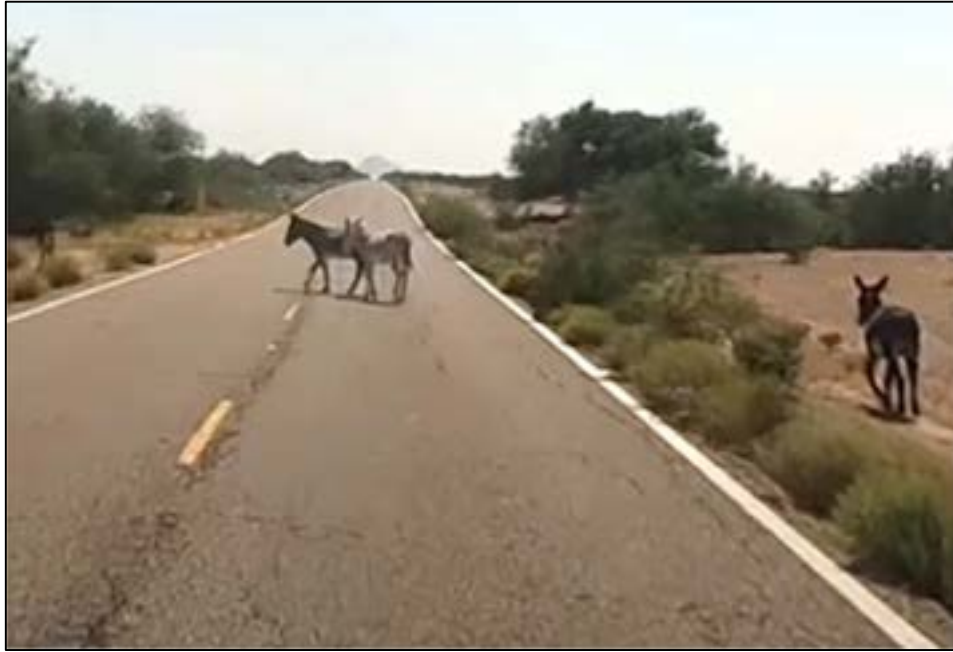
It was observed that cattle and donkeys were periodically wandering in the roadway. The RSA team was able to observe additional cattle and donkeys congregating on the sides of the roadway where vegetation could potentially obstruct the view of them. It was noted that nighttime conditions would potentially exacerbate the risk of animal crashes occurring.

Donkeys in the roadway

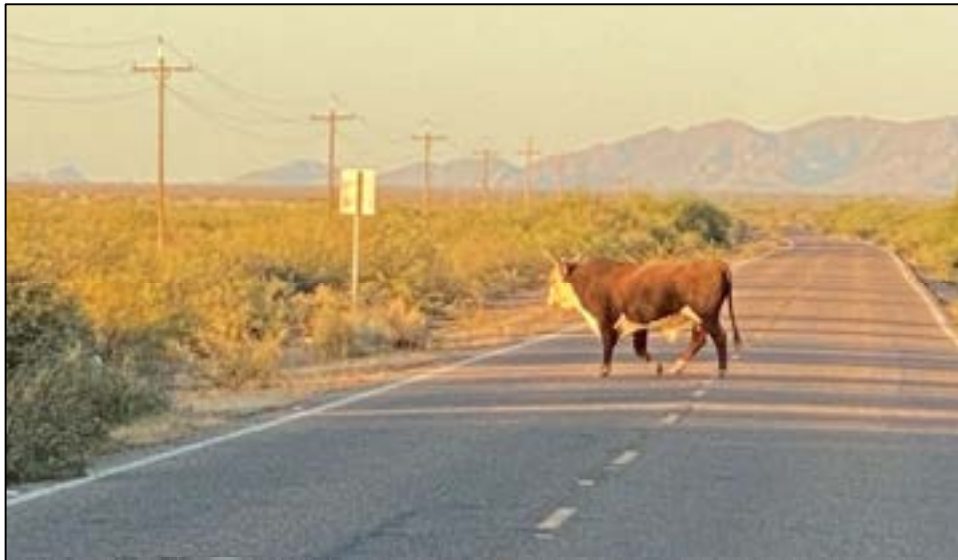
Cow/bull in the roadway

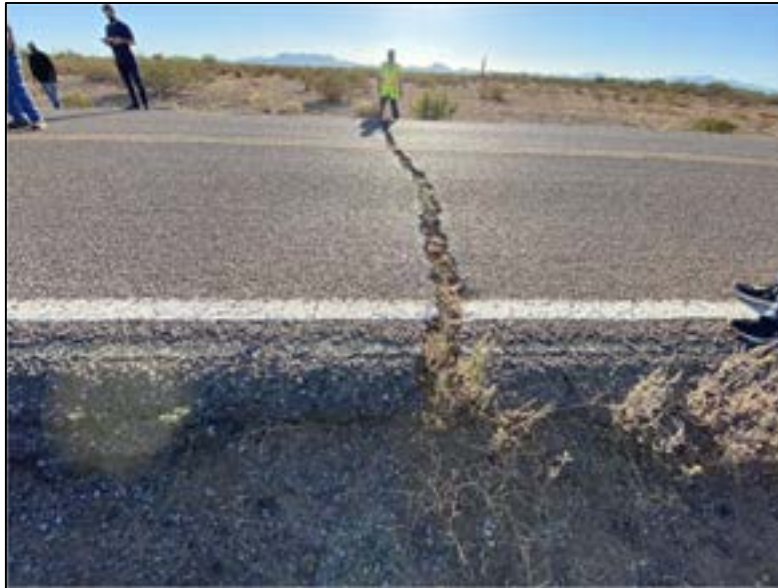
Records indicate the last pavement maintenance that was completed on the corridor was completed in the 1990s. The pavement surface on the route between the SR 86 intersection and mile marker 11.5 appears to have large cracks, superficial cracks, and surface pitting with few or no potholes. Between mile marker 11.5 and the end of the road, the pavement appears to be recently refreshed, with little to no pavement imperfections observed.

Pavement damage on Route 21

- Conduct pavement maintenance (i.e., Chip Seal) between SR 86 and mile marker 11.5
- Remove soil from the roadway
- Implement Safety Edge or recoverable sloped shoulder
- Remove shoulder vegetation
- Ensure a 4 ft paved shoulder minimum

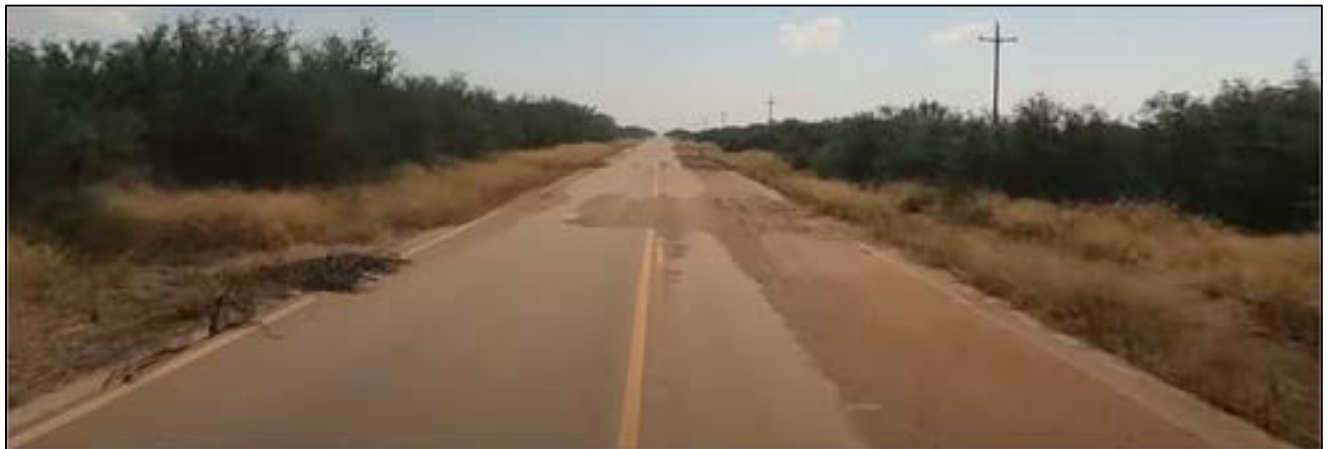
Soil accumulation on Route 21 at mile marker 11

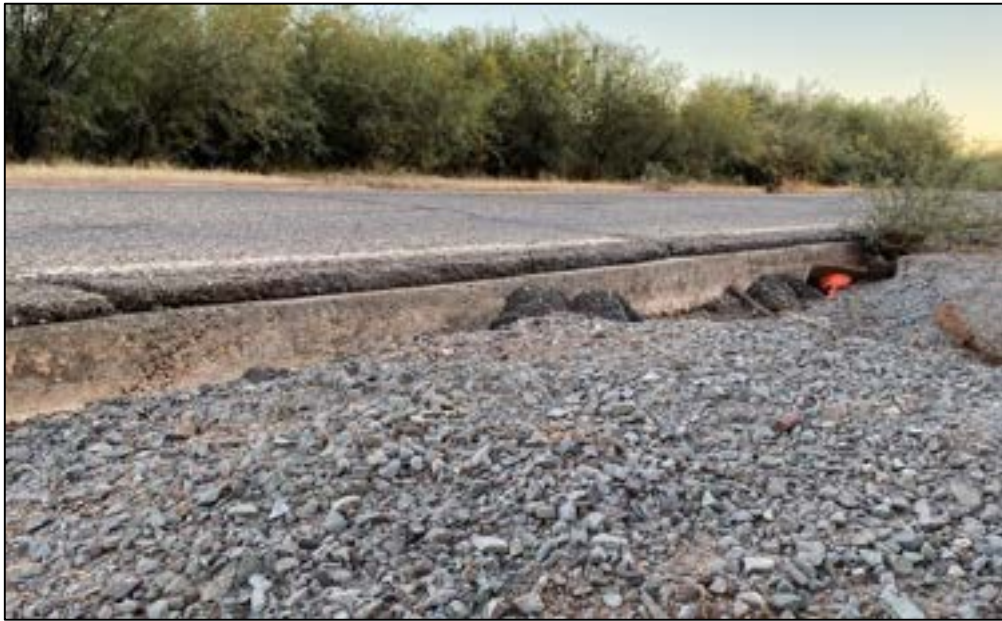
Shoulders throughout the corridor vary from approximately one foot to four feet in width. Edge drop-offs were observed throughout the corridor and specifically at the intersection of SR 86 and Rt 21 and at mile marker 19. It is noted that there are periodic erosion control measures between mile marker 11.5 and the end of the road, including riprap and gabion baskets.

Large pavement edge drop-off on Route 21

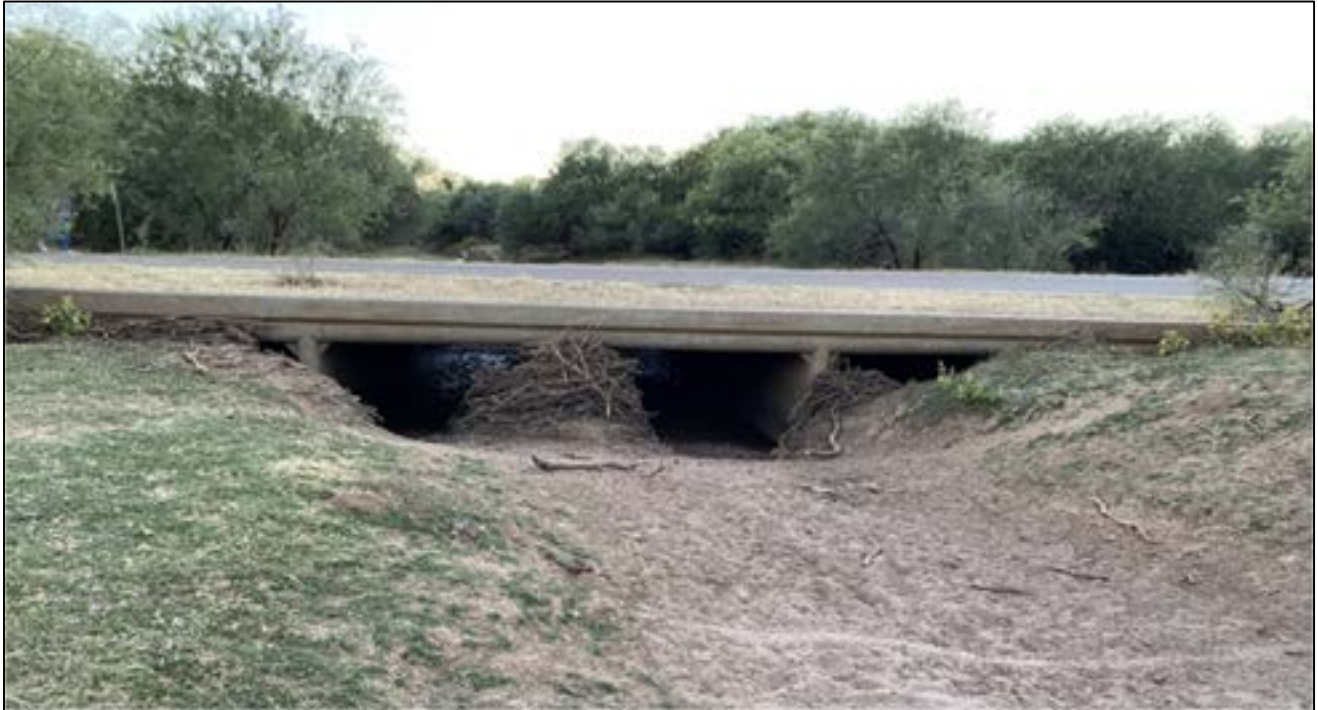
The RSA team observed clogging of existing wash drainage culverts. Culverts at mile markers 19 and 15 appear to be clogged or damaged. In general, the existing culverts on the route appear to be undersized for the apparent volume of drainage that they experience. A five-span box culvert-style bridge at mile marker 12 was observed to be clogged, with three of the spans being completely blocked.

Clogged and blocked 5 span box culverts under Route 21

- Install culverts at sag curves that experience flooding at mile markers 15 and 19
- Maintenance on damaged and clogging in culverts and under bridges at mile marker 12
- Depth gauges at wash locations

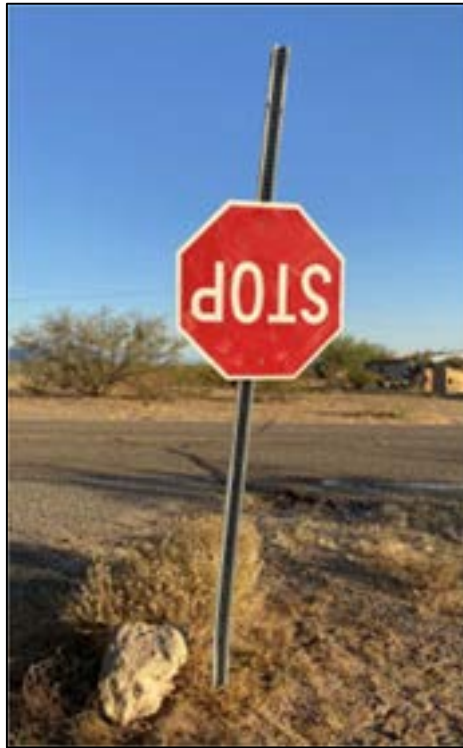
Damaged signage at the RT 21 and RT 28 intersection

- Install intersection warning signs at roadway intersections
- Removal of sign graffiti or replacement near mile marker 18
- Removal of signs obstructing vegetation near mile markers 13, 17, and 20
- Install standard community signs
- Add bus stop warning signs at mile marker 18.25 or the new bus stop location
- Relocate bus stops away from the road curve near mile marker 18.25
- Install advanced sag curve warning dip signs
- Install edge of roadway delineators
- Install RPMs from mile marker 11.5 to the end of the road
- Add chevron signs through sharp curves

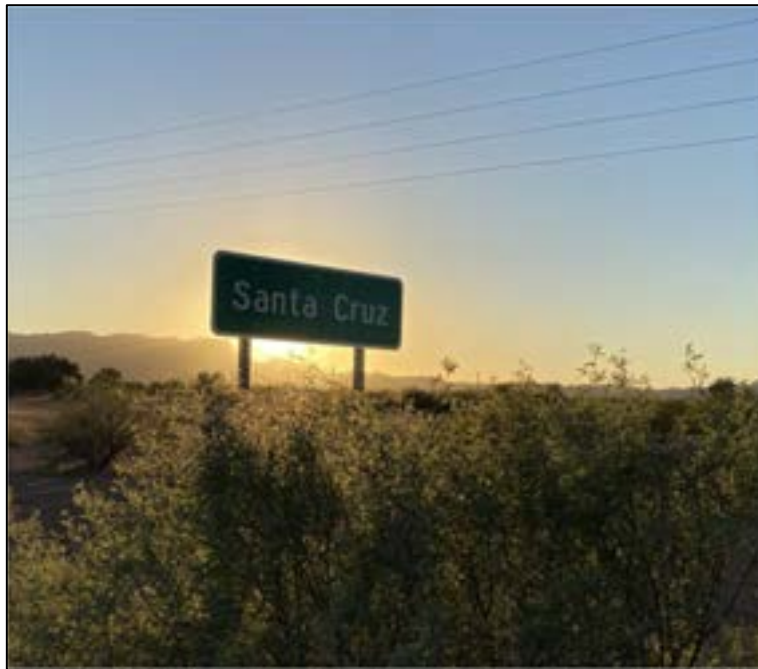
Roadway signage is obscured with vegetation.

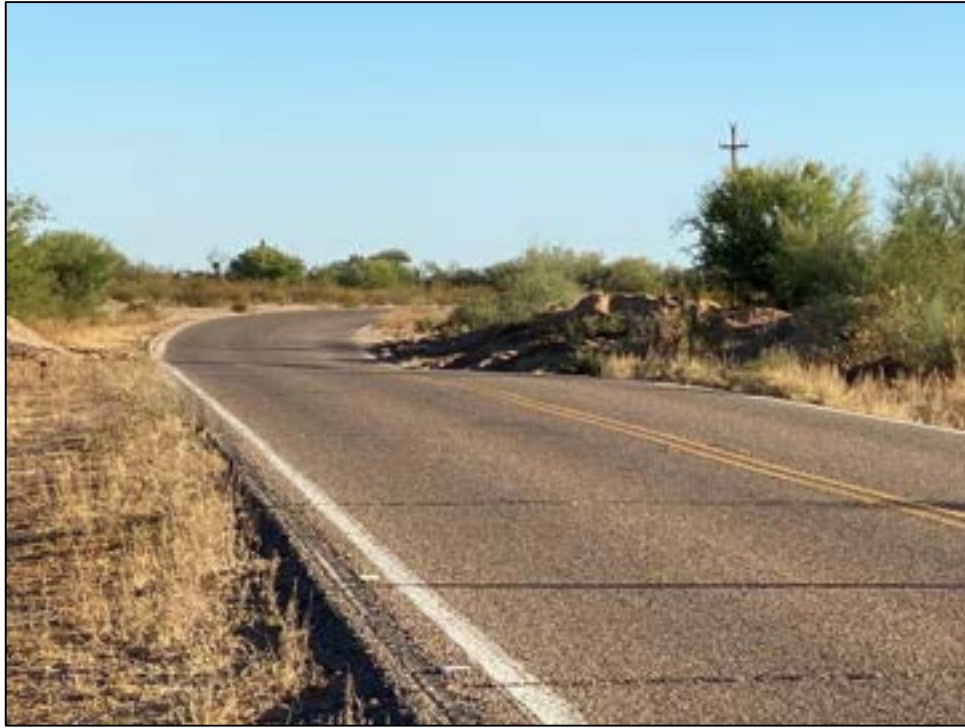
No chevron signs were observed at tight curves in the roadway alignment to warn drivers of coming tight curves. Additionally, no edge of roadway delineators is present throughout the corridor. These delineators can help reduce the risk of road departure on the corridor.

Example of existing road curve with a lack of delineation/chevrons
