BIA Rt 19: SR 86 to End of Road Road Safety Assessment

Prepared for:
The Tohono O'odham Nation

May 2023

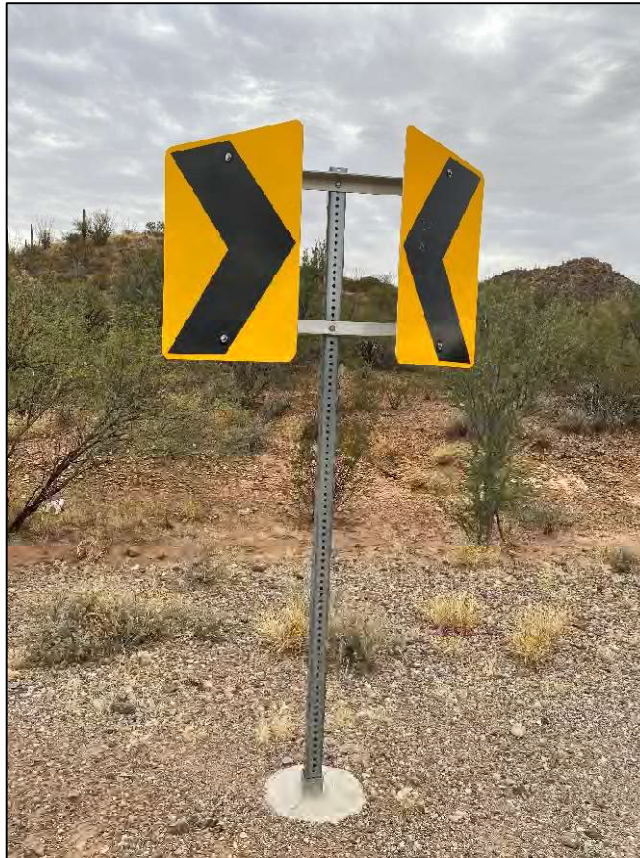
Chevron warning signs

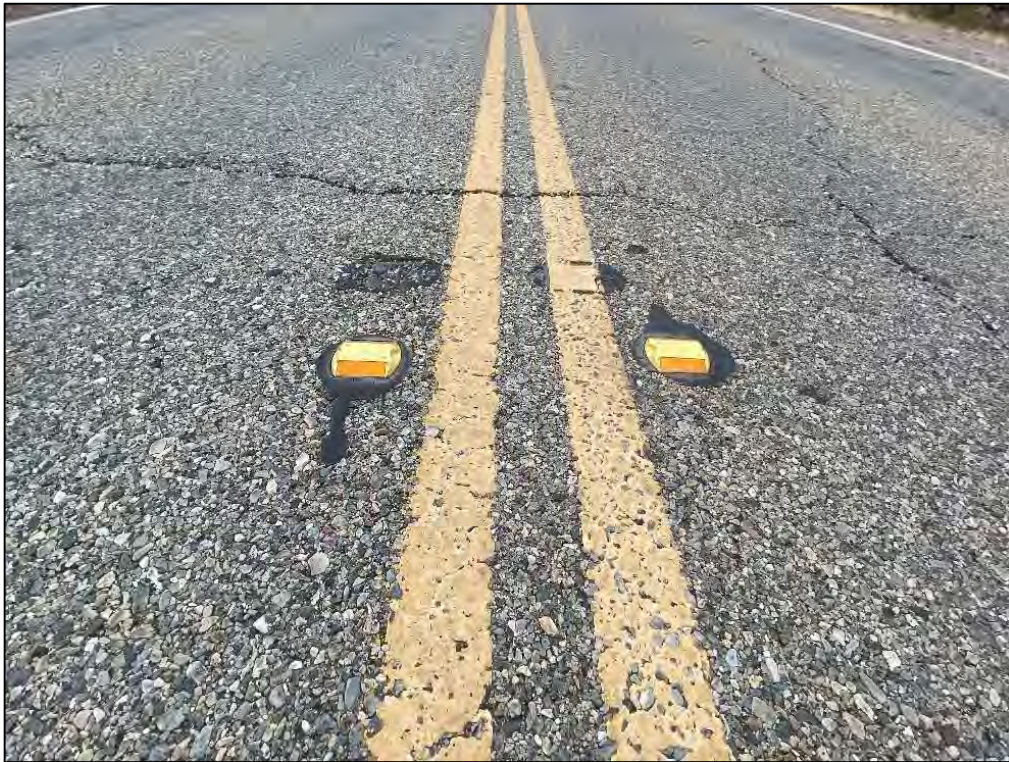
Centerline reflective pavement markers

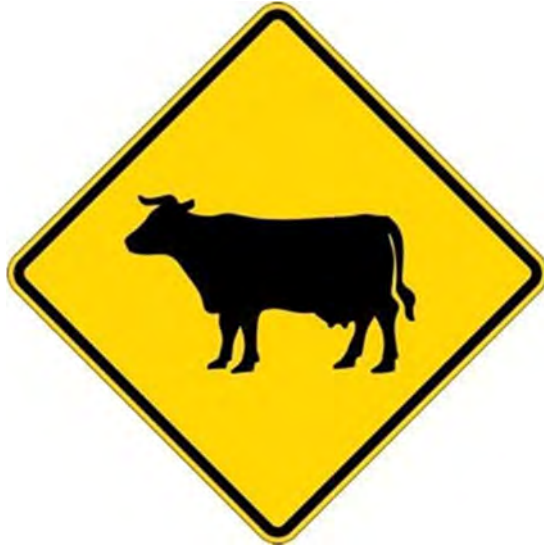
Cattle warning sign (MUTCD W11-4)

It was also observed that cattle were periodically wandering in the roadway. The RSA team observed other cattle congregating on the side of the roadway where vegetation could potentially obstruct their view.

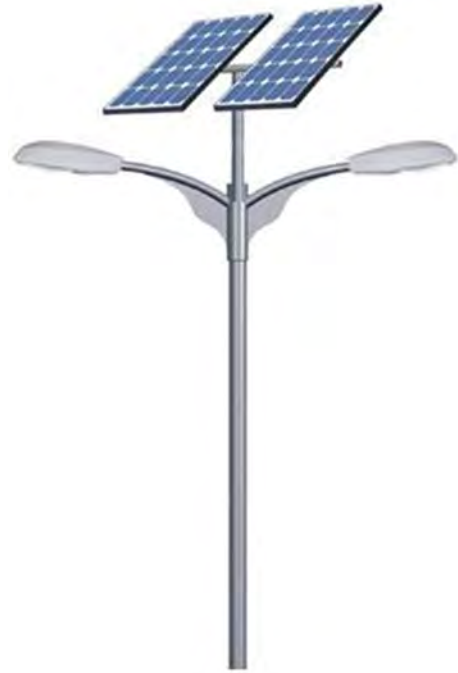
The lighting in the corridor was observed to be absent throughout the team's nighttime review. The observed low lighting conditions appear to allow for the potential of cattle to congregate on the roadway unseen by vehicles until they approach. No driveways or unsignalized intersections were observed to have lighting.

End of the road of Route 19 in low-level lighting conditions and sample solar-powered streetlight
