BIA Rt 21: SR 86 to Papago Farm Road Road Safety Assessment

Prepared for:
The Tohono O'odham Nation

May 2023

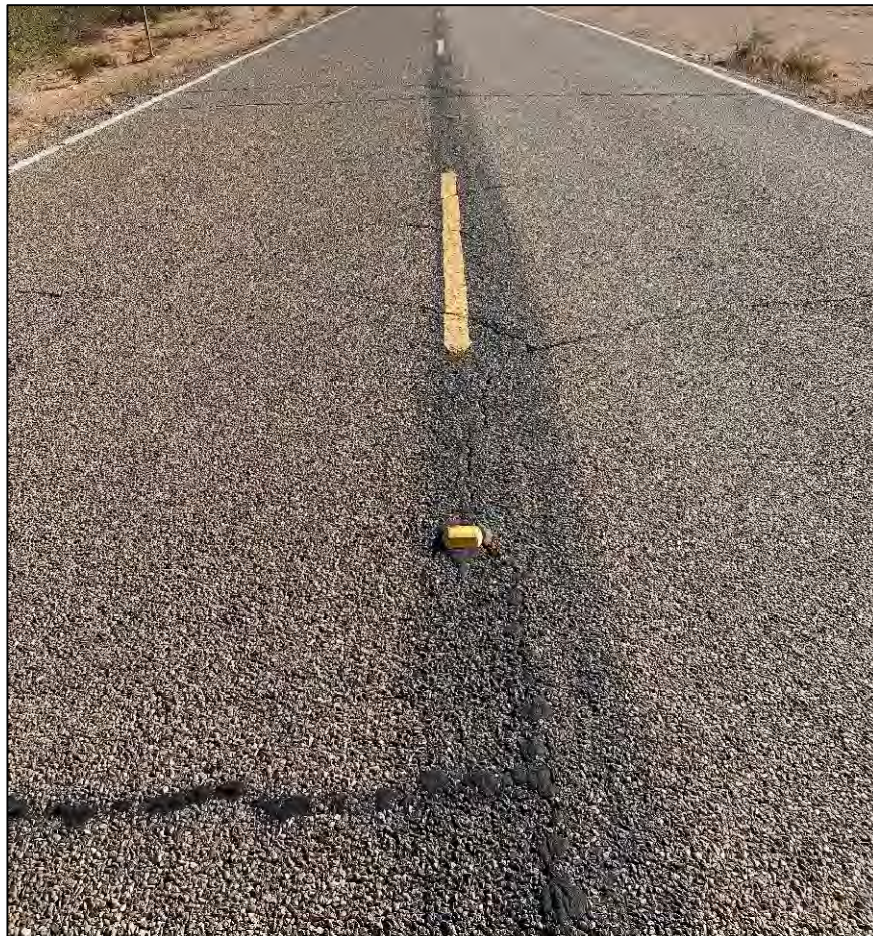
RPMs in road centerline and edge lines

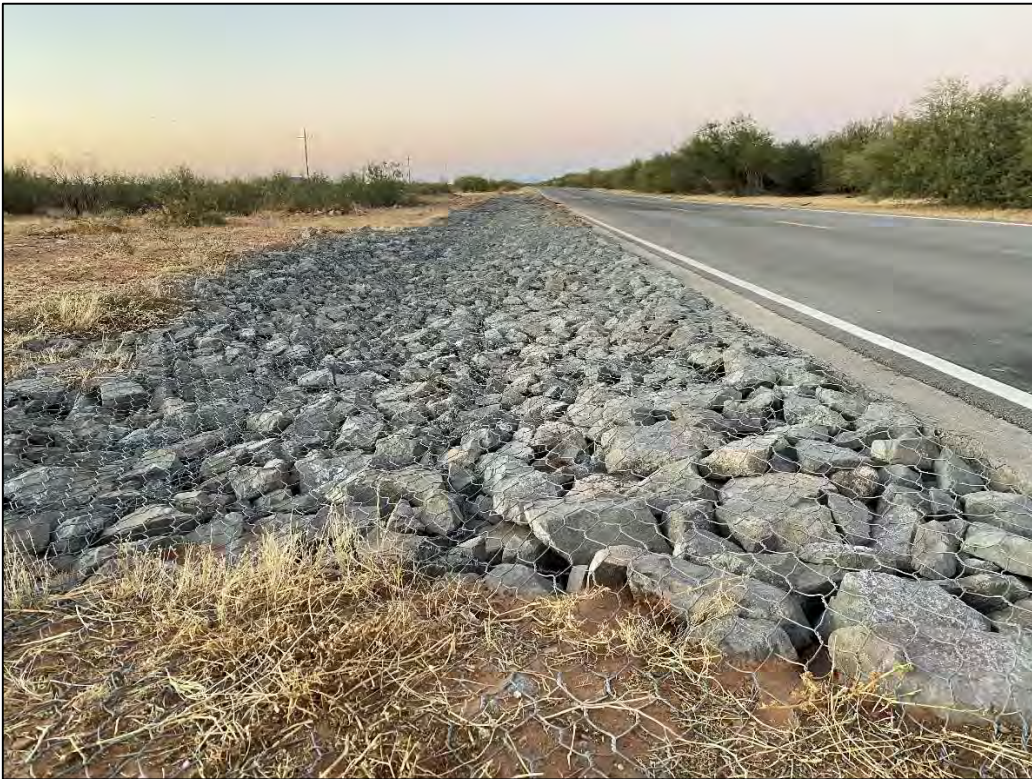
Roadside gabion baskets and refreshed pavement

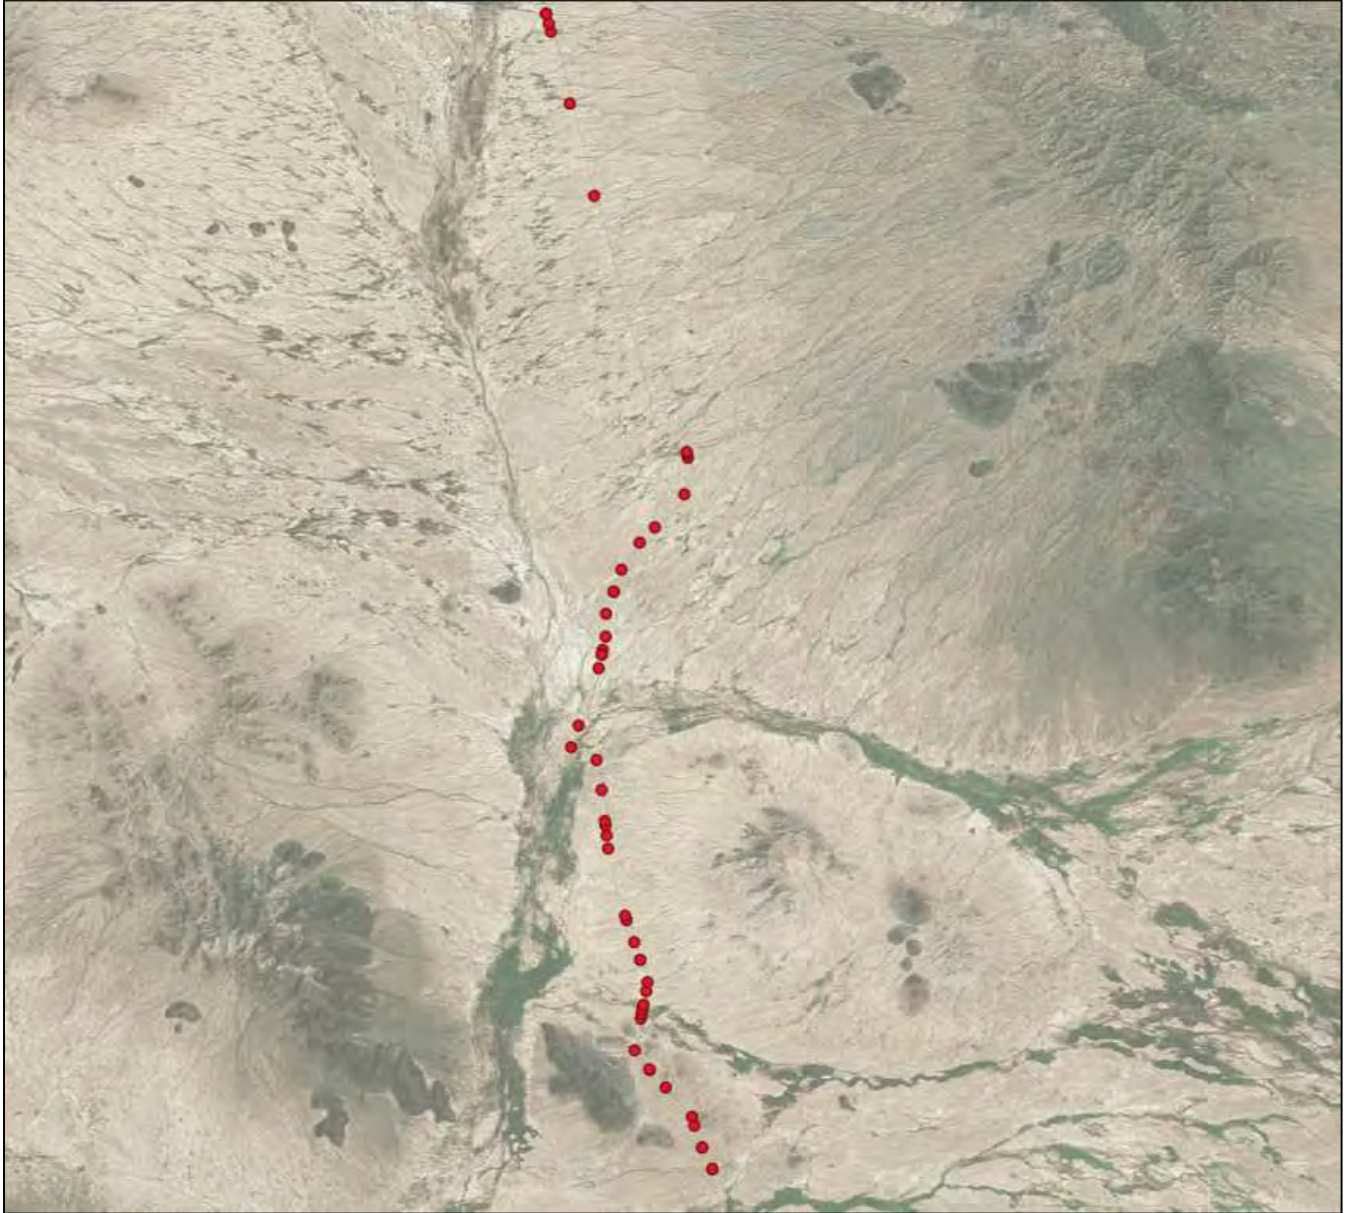
Figure 77: BIA Route 21 2011 to 2020 animal-related crashes

The RSA team observed intermittent no fencing along both sides of the roadway. In the crash data from 2011 to 2020, animal crashes are the top crash type, with animal crashes occurring throughout the corridor. The locations with animal-related crashes are shown in **Figure 77** below.

It was observed that cattle and donkeys were periodically wandering in the roadway. The RSA team was able to observe additional cattle and donkeys congregating on the sides of the roadway where vegetation could potentially obstruct the view of them. It was noted that nighttime conditions would potentially exacerbate the risk of animal crashes occurring.

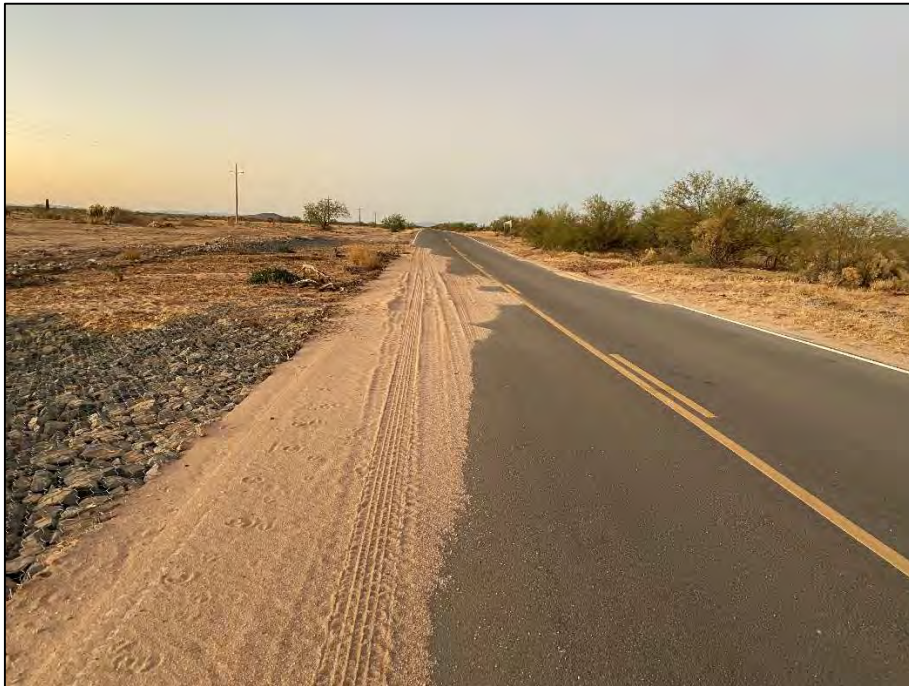
Records indicate the last pavement maintenance that was completed on the corridor was completed in the 1990s. The pavement surface on the route between the SR 86 intersection and mile marker 11.5 appears to have large cracks, superficial cracks, and surface pitting with few or no potholes. Between mile marker 11.5 and the end of the road, the pavement appears to be recently refreshed, with little to no pavement imperfections observed.

Sand on roadway

- Conduct pavement maintenance (i.e., Chip Seal) between SR 86 and mile marker 11.5
- Remove soil from the roadway
- Implement Safety Edge or recoverable sloped shoulder
- Remove shoulder vegetation
- Ensure a 4 ft paved shoulder minimum

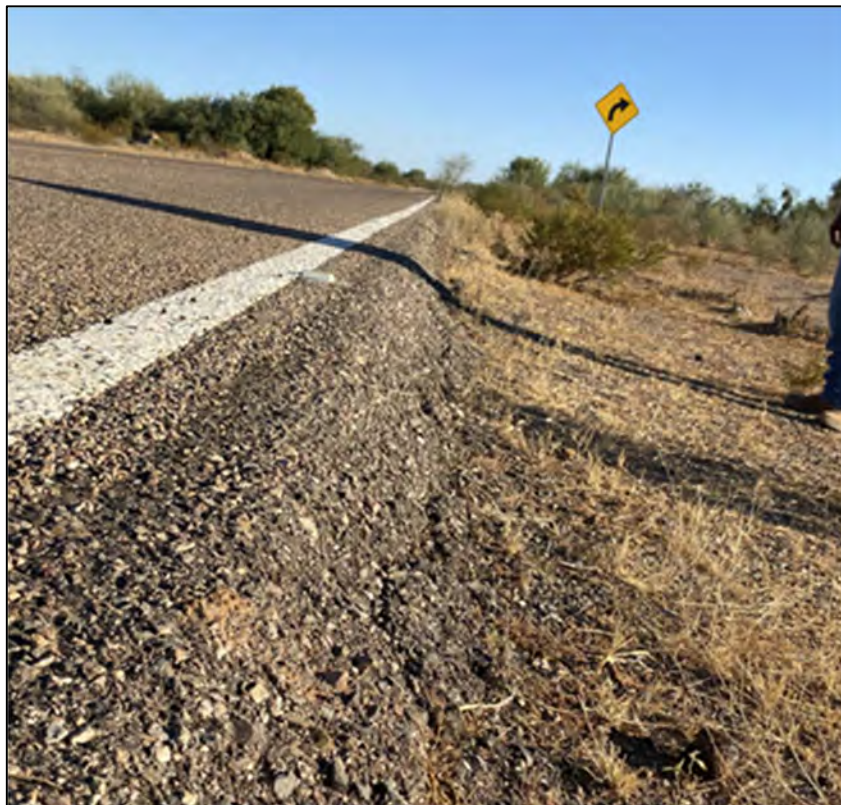
Shoulders throughout the corridor vary from approximately one foot to four feet in width. Edge drop-offs were observed throughout the corridor and specifically at the intersection of SR 86 and Rt 21 and at mile marker 19. It is noted that there are periodic erosion control measures between mile marker 11.5 and the end of the road, including riprap and gabion baskets.

Typical pavement edge drop-off on Route 21

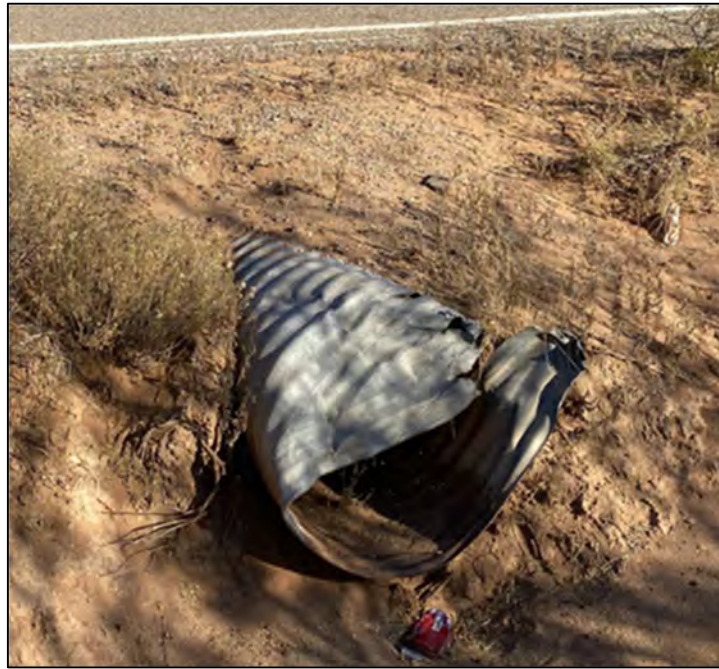
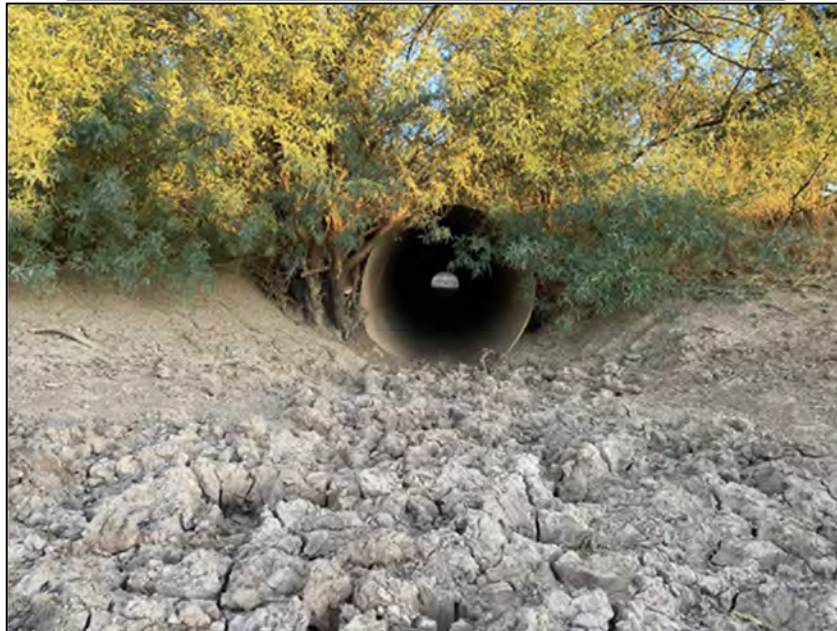
The RSA team observed clogging of existing wash drainage culverts. Culverts at mile markers 19 and 15 appear to be clogged or damaged. In general, the existing culverts on the route appear to be undersized for the apparent volume of drainage that they experience. A five-span box culvert-style bridge at mile marker 12 was observed to be clogged, with three of the spans being completely blocked.

Existing wash drainage culverts under Route 21

- Install culverts at sag curves that experience flooding at mile markers 15 and 19
- Maintenance on damaged and clogging in culverts and under bridges at mile marker 12
- Depth gauges at wash locations

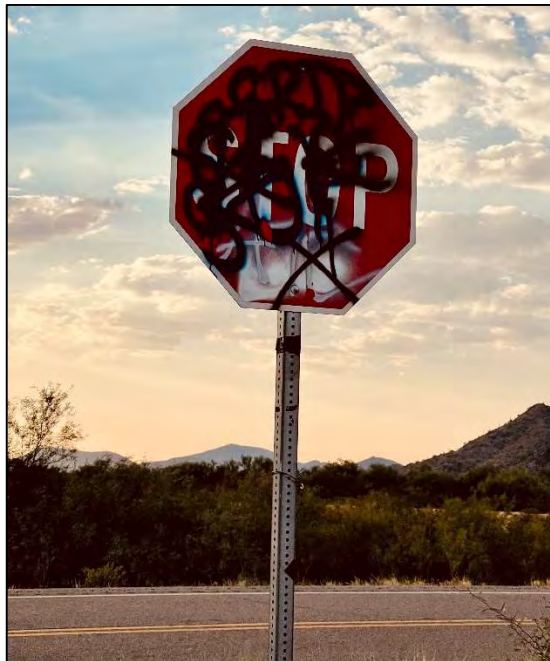
Most signs were visible during the daytime and appeared to have adequate retroreflectivity at night. Signs near mile marker 18 had paint obstructing them. Signs at mile markers 13, 17, and 20 were also obstructed with vegetation.

Roadway signage is obscured with paint.

- Install intersection warning signs at roadway intersections
- Removal of sign graffiti or replacement near mile marker 18
- Removal of signs obstructing vegetation near mile markers 13, 17, and 20
- Install standard community signs
- Add bus stop warning signs at mile marker 18.25 or the new bus stop location
- Relocate bus stops away from the road curve near mile marker 18.25
- Install advanced sag curve warning dip signs
- Install edge of roadway delineators
- Install RPMs from mile marker 11.5 to the end of the road
- Add chevron signs through sharp curves

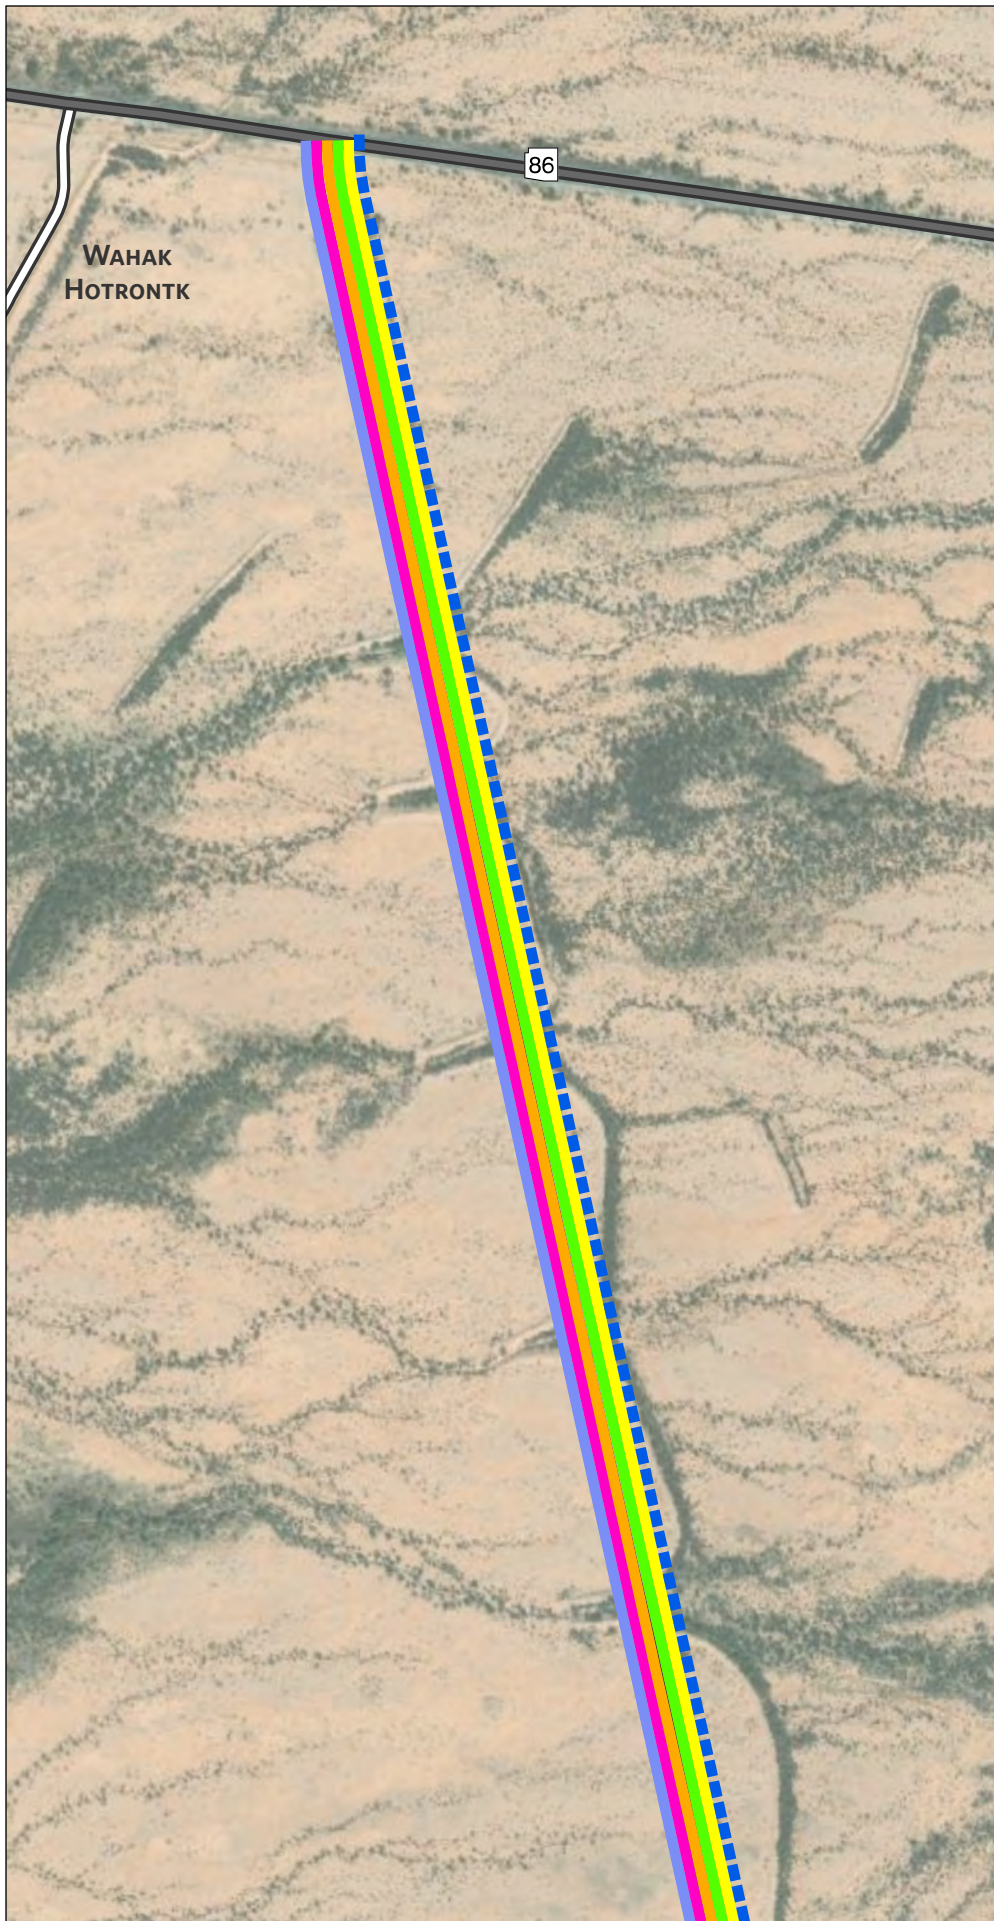
- High Crash Corridor
- Flooding Issue
- No Sidewalks
- Open Range, No Fencing
- No Shoulders
- Deteriorating Striping
- No Lighting
- Poor Pavement
- Curvy Roadway

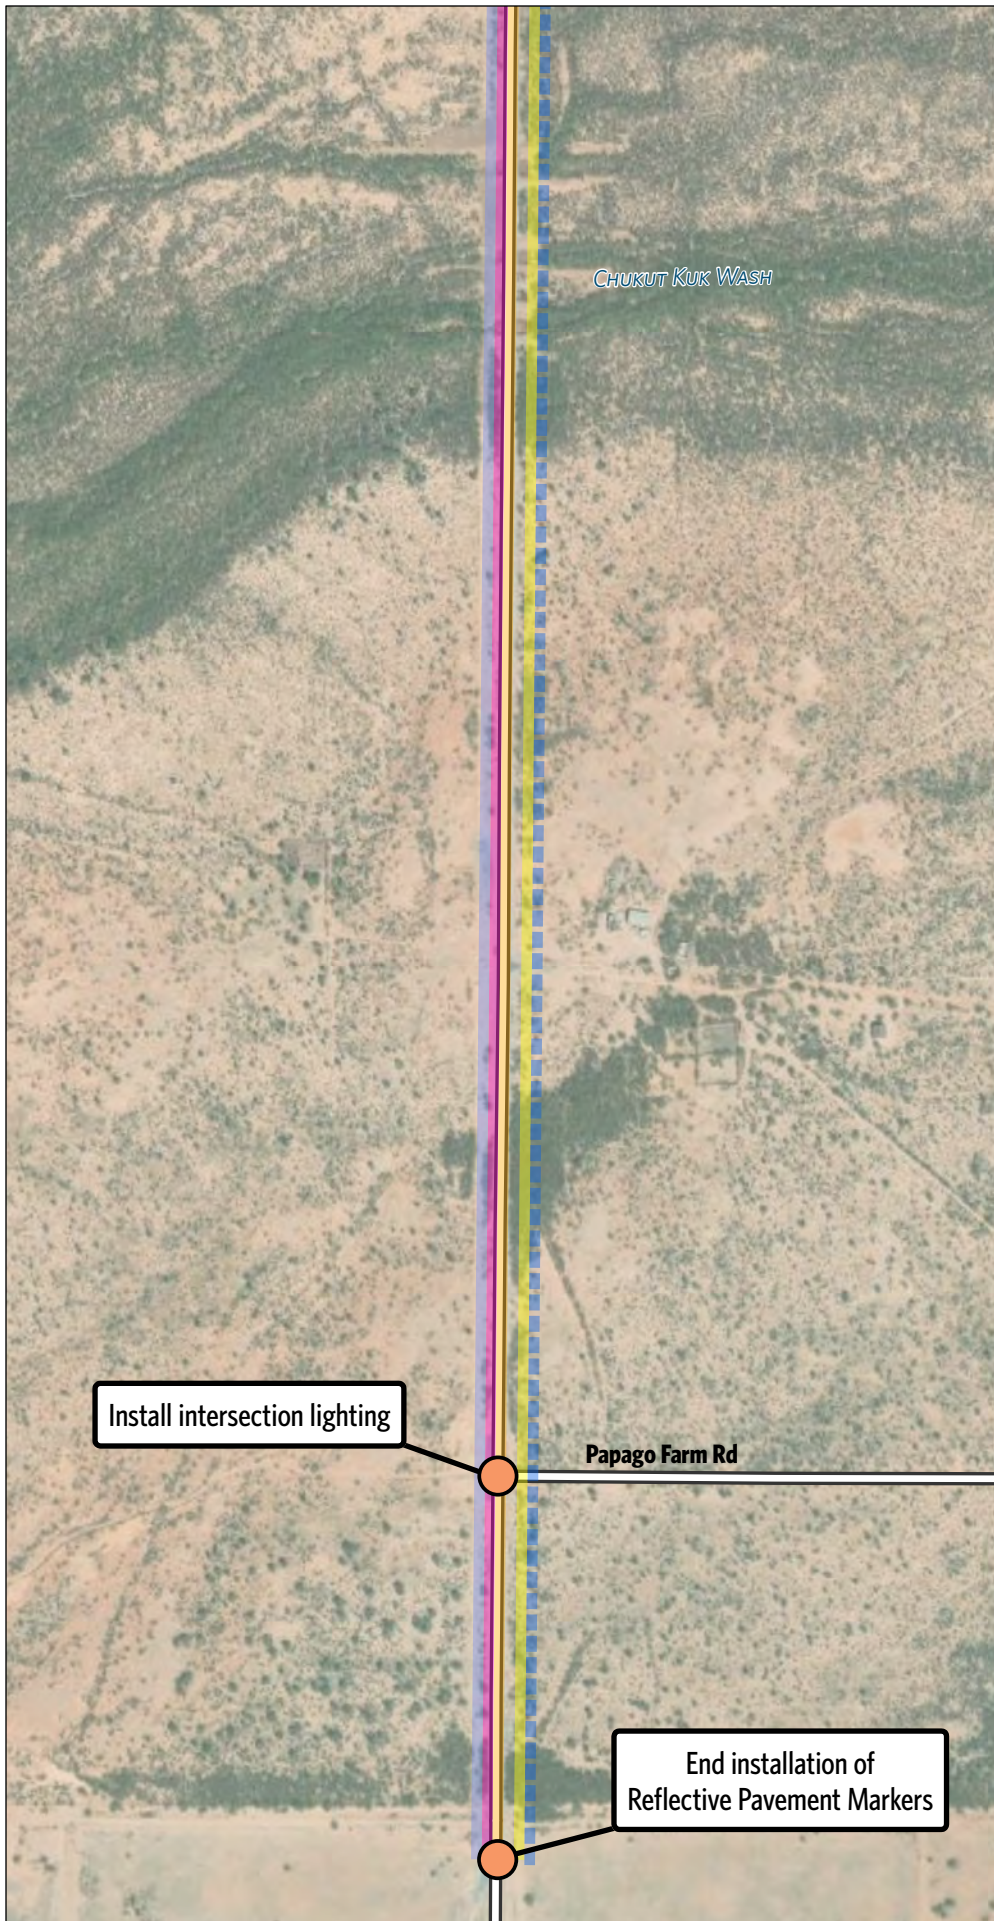
- High Crash Corridor
- Flooding Issue
- No Sidewalks
- Open Range, No Fencing
- No Shoulders
- Deteriorating Striping
- No Lighting
- Poor Pavement
- Curvy Roadway

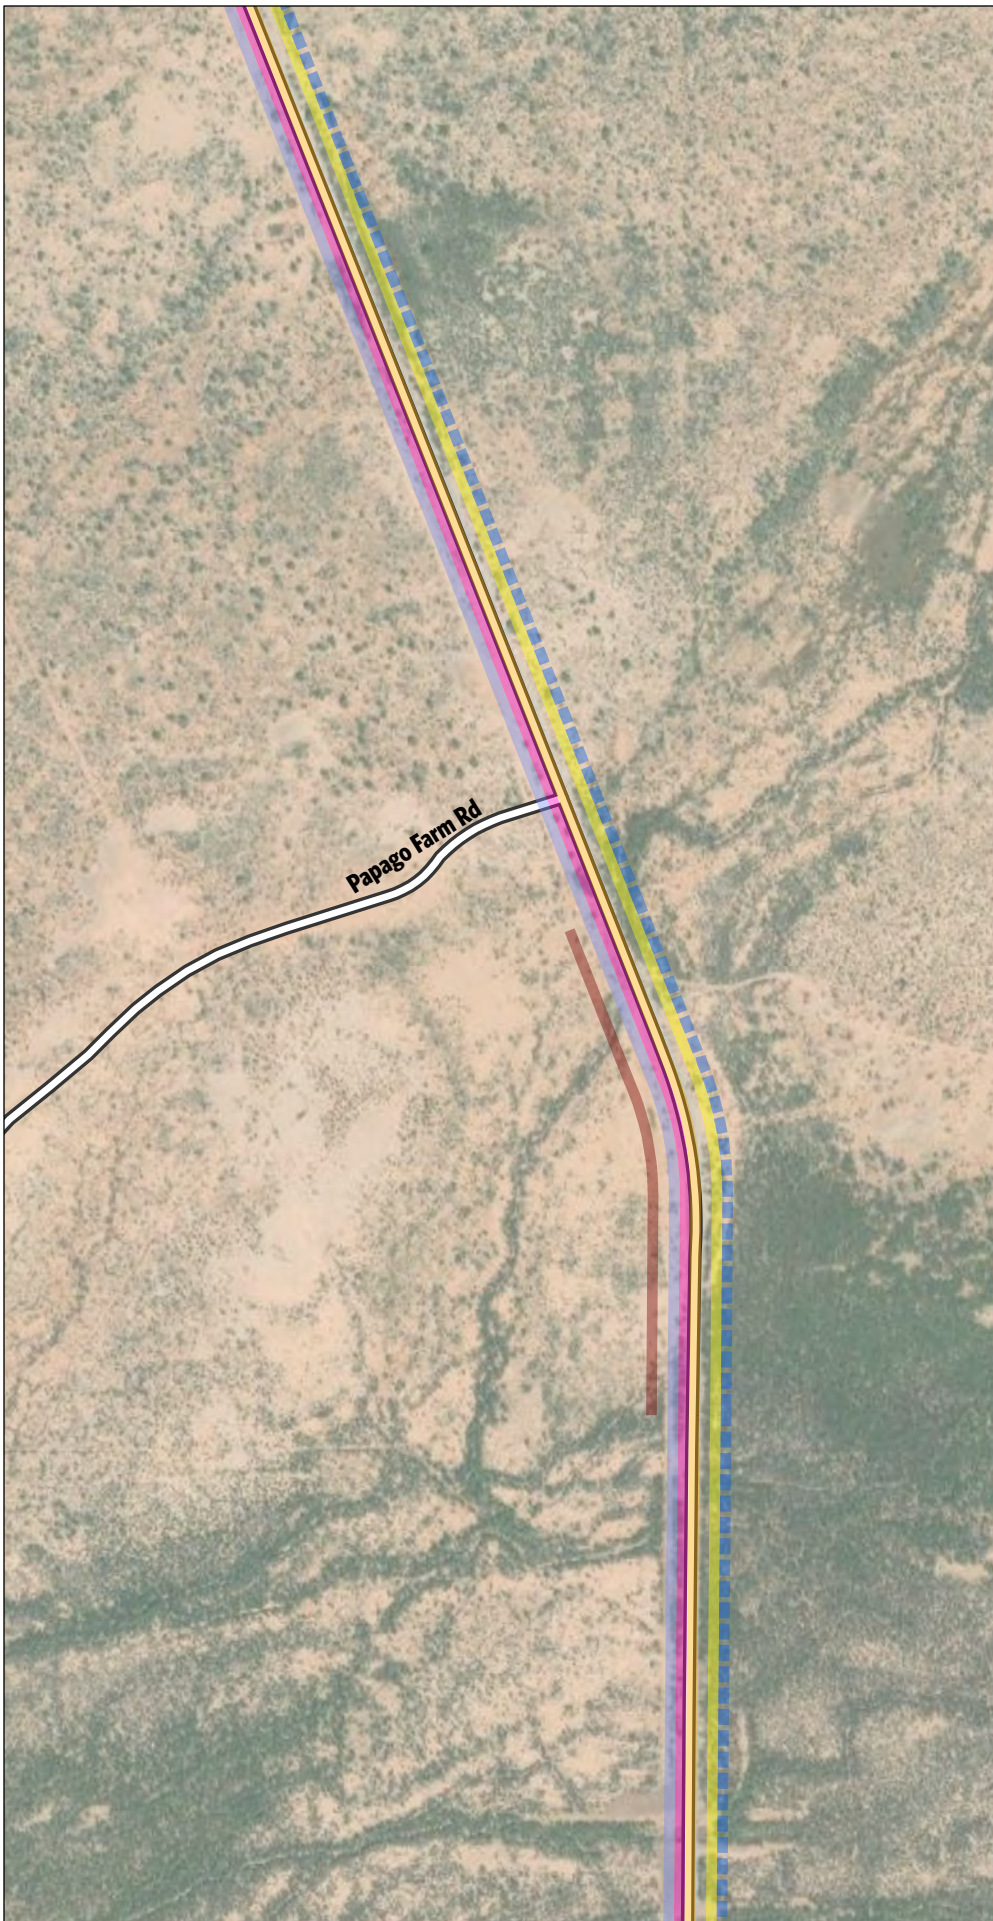
- High Crash Corridor
- Flooding Issue
- No Sidewalks
- Open Range, No Fencing
- No Shoulders
- Deteriorating Striping
- No Lighting
- Poor Pavement
- Curvy Roadway

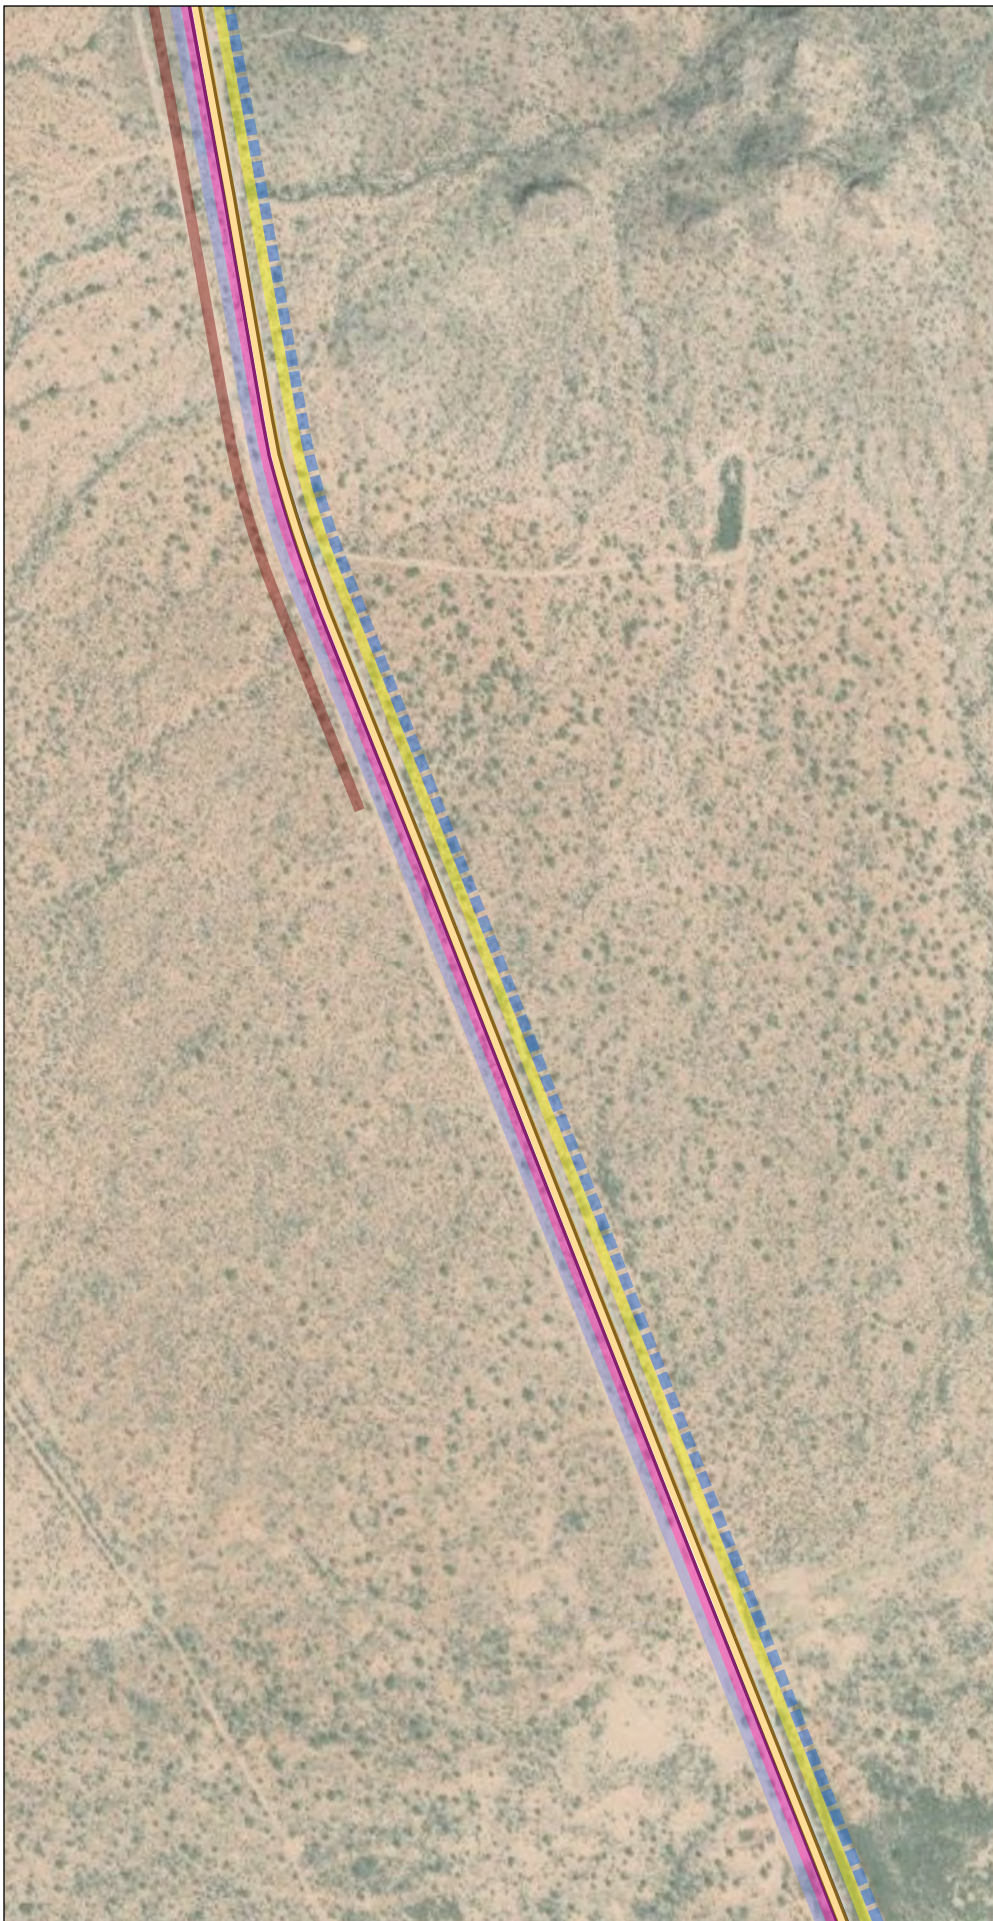
- High Crash Corridor
- Flooding Issue
- No Sidewalks
- Open Range, No Fencing
- No Shoulders
- Deteriorating Striping
- No Lighting
- Poor Pavement
- Curvy Roadway

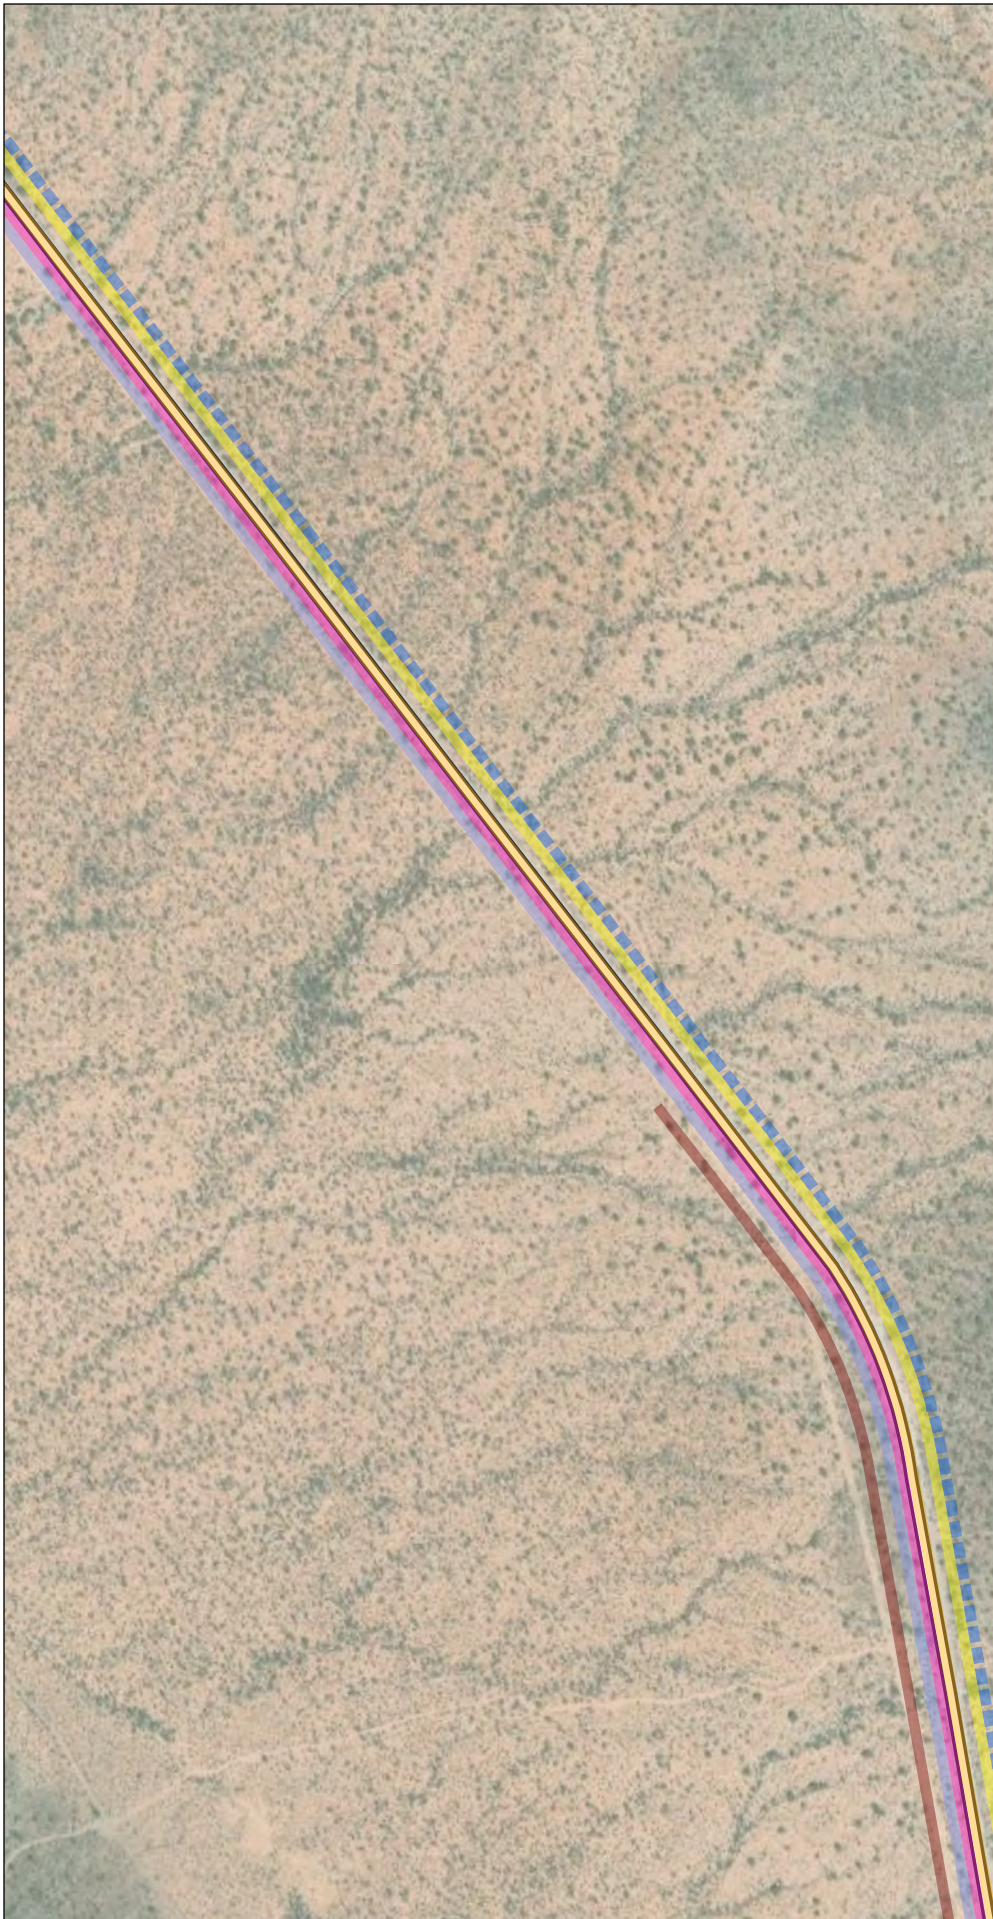
- High Crash Corridor
- Flooding Issue
- No Sidewalks
- Open Range, No Fencing
- No Shoulders
- Deteriorating Striping
- No Lighting
- Poor Pavement
- Curvy Roadway

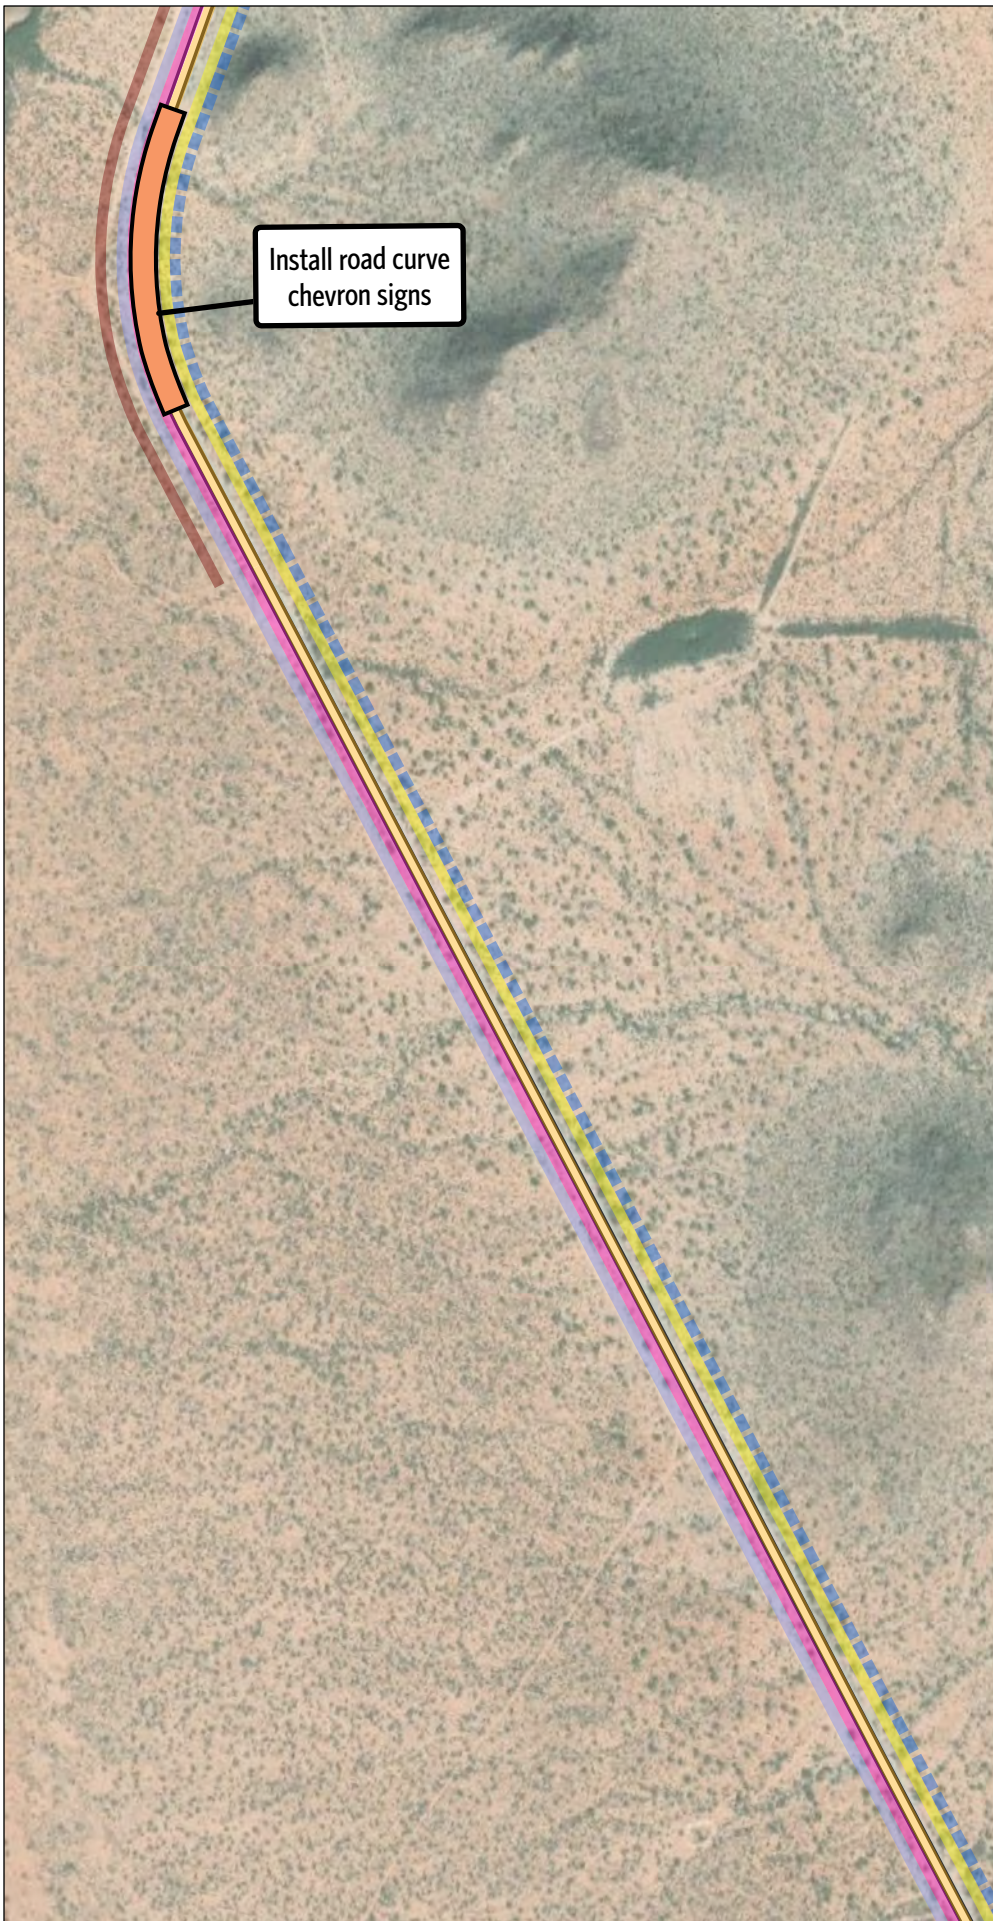
- High Crash Corridor
- Flooding Issue
- No Sidewalks
- Open Range, No Fencing
- No Shoulders
- Deteriorating Striping
- No Lighting
- Poor Pavement
- Curvy Roadway

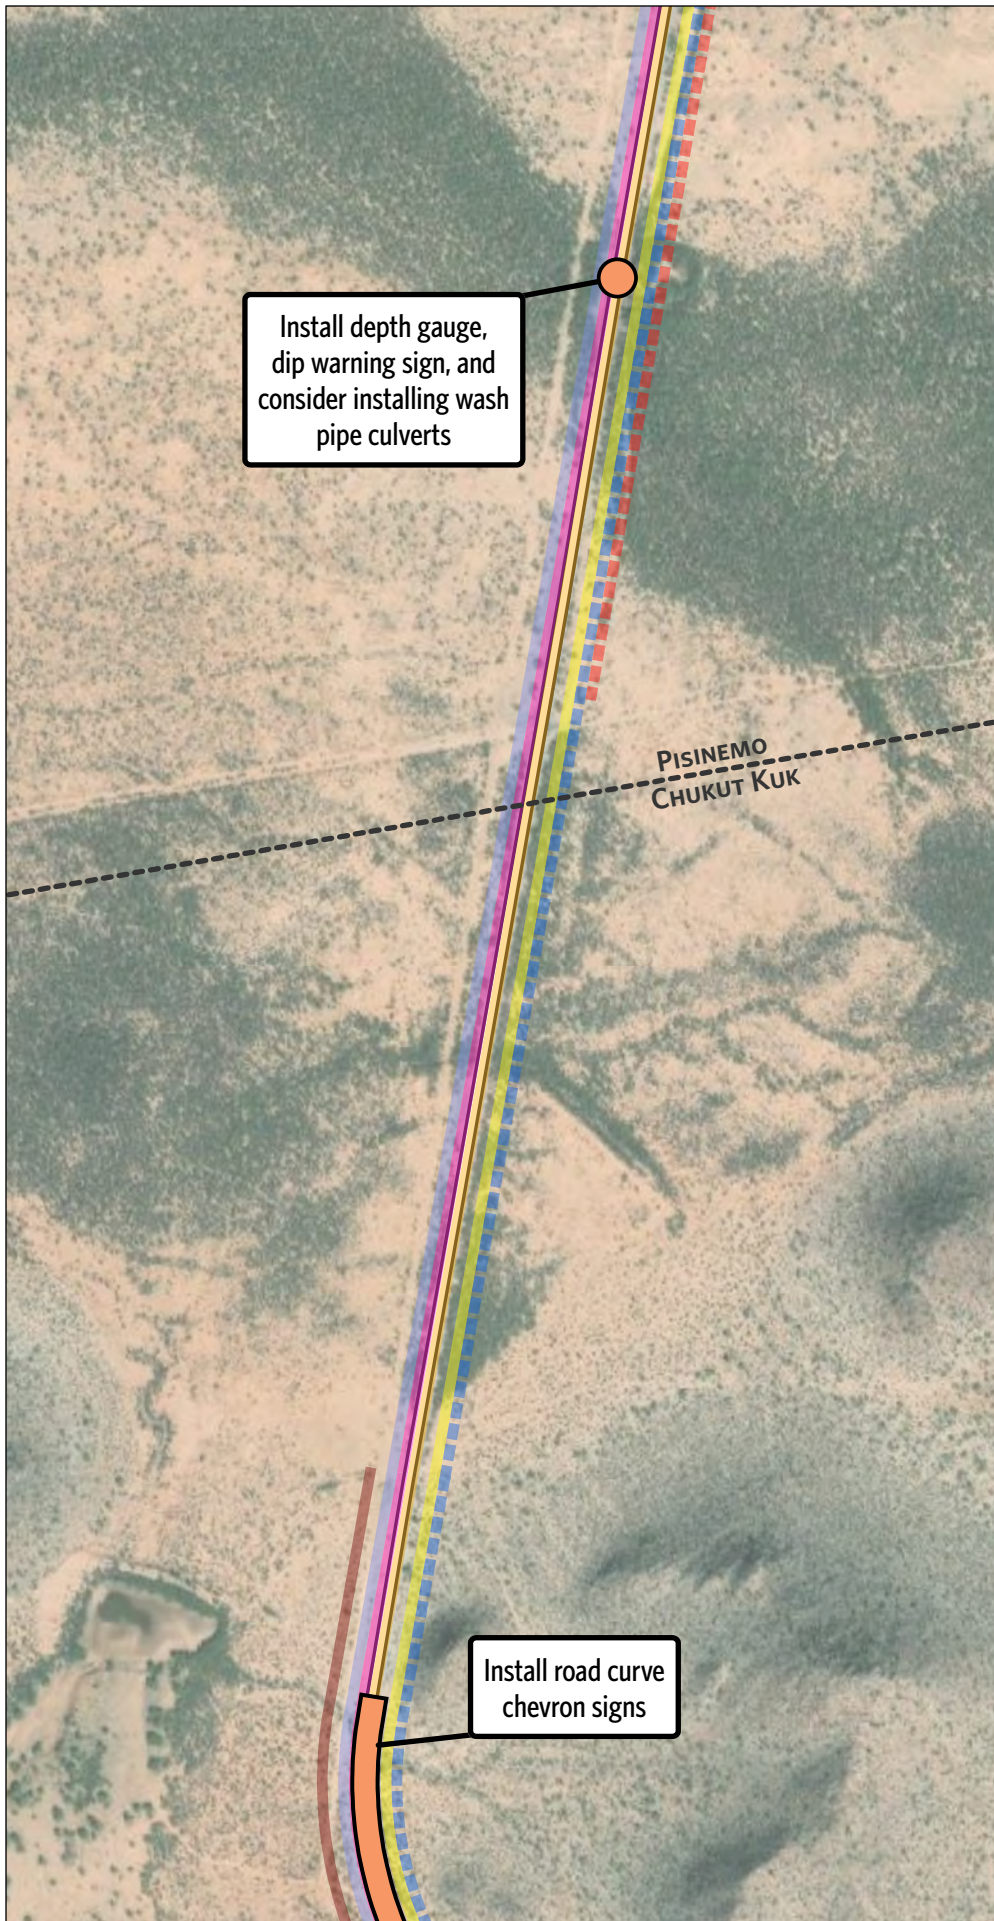
- High Crash Corridor
- Flooding Issue
- No Sidewalks
- Open Range, No Fencing
- No Shoulders
- Deteriorating Striping
- No Lighting
- Poor Pavement
- Curvy Roadway

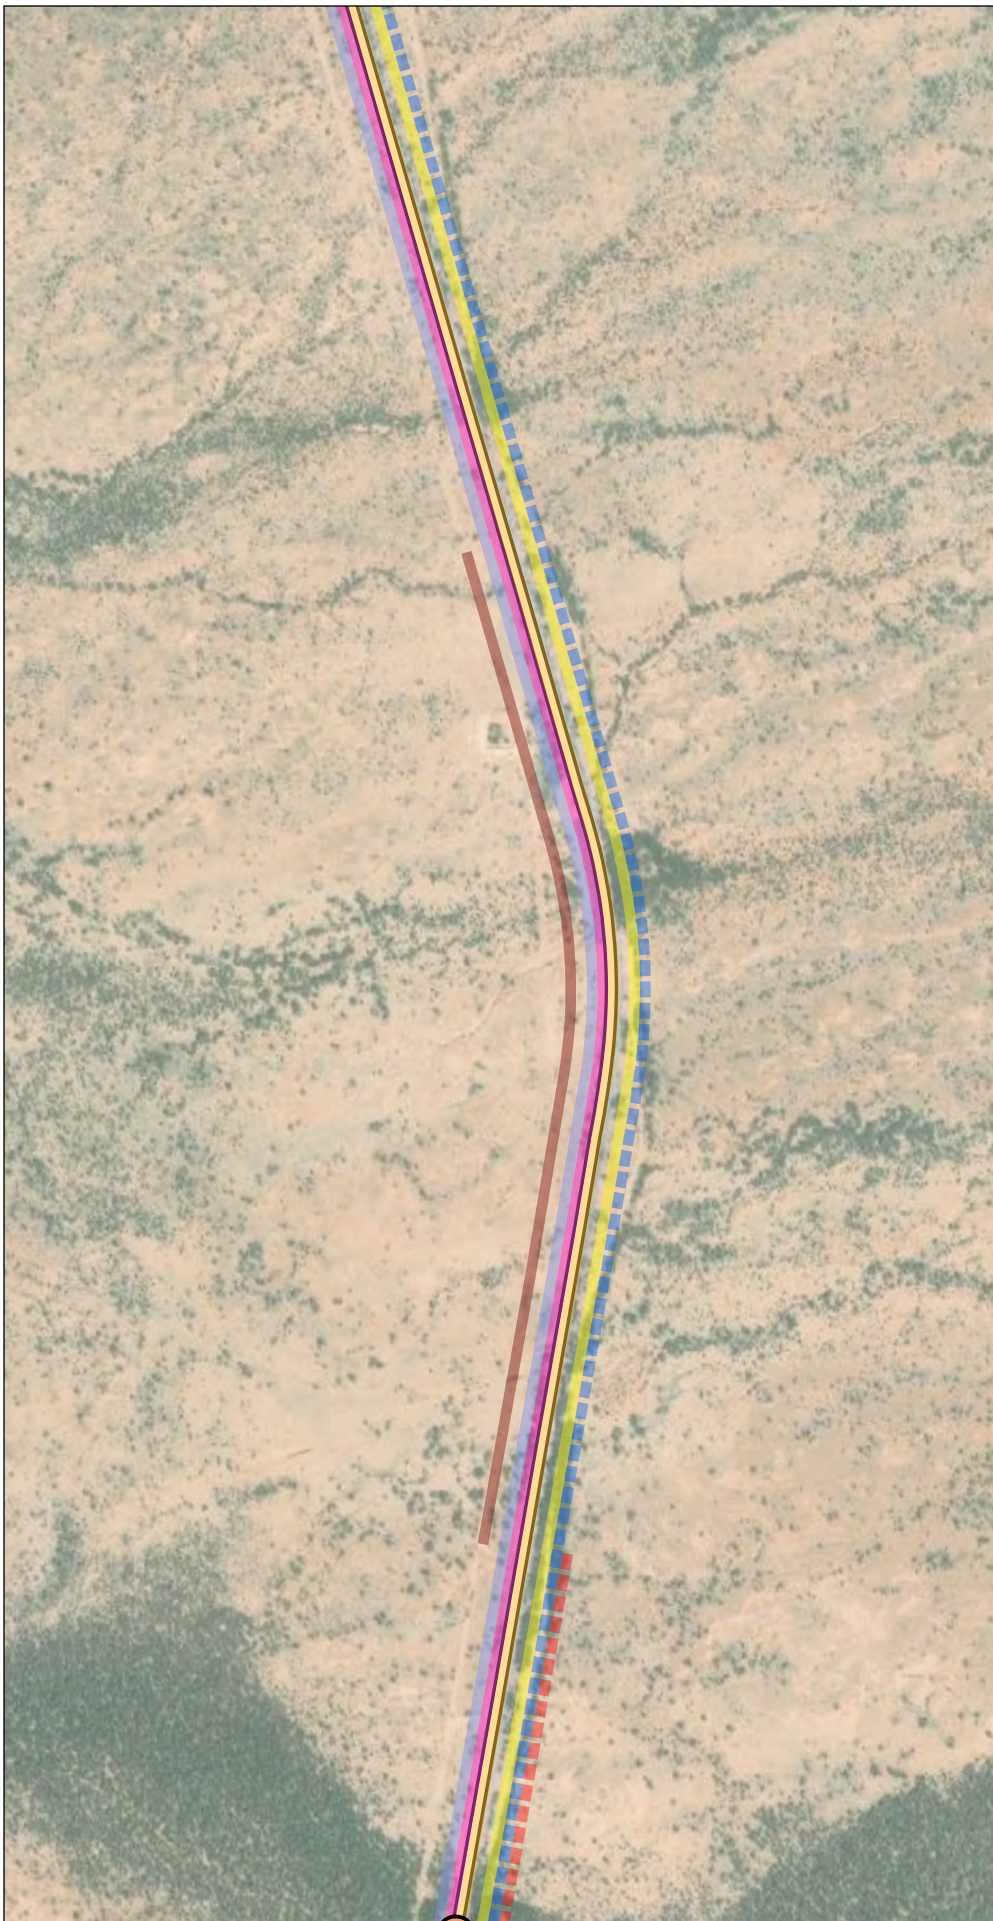
- High Crash Corridor
- Flooding Issue
- No Sidewalks
- Open Range, No Fencing
- No Shoulders
- Deteriorating Striping
- No Lighting
- Poor Pavement
- Curvy Roadway
