BIA Rt 21: SR 86 to Papago Farm Road Road Safety Assessment

Prepared for:
The Tohono O'odham Nation

May 2023

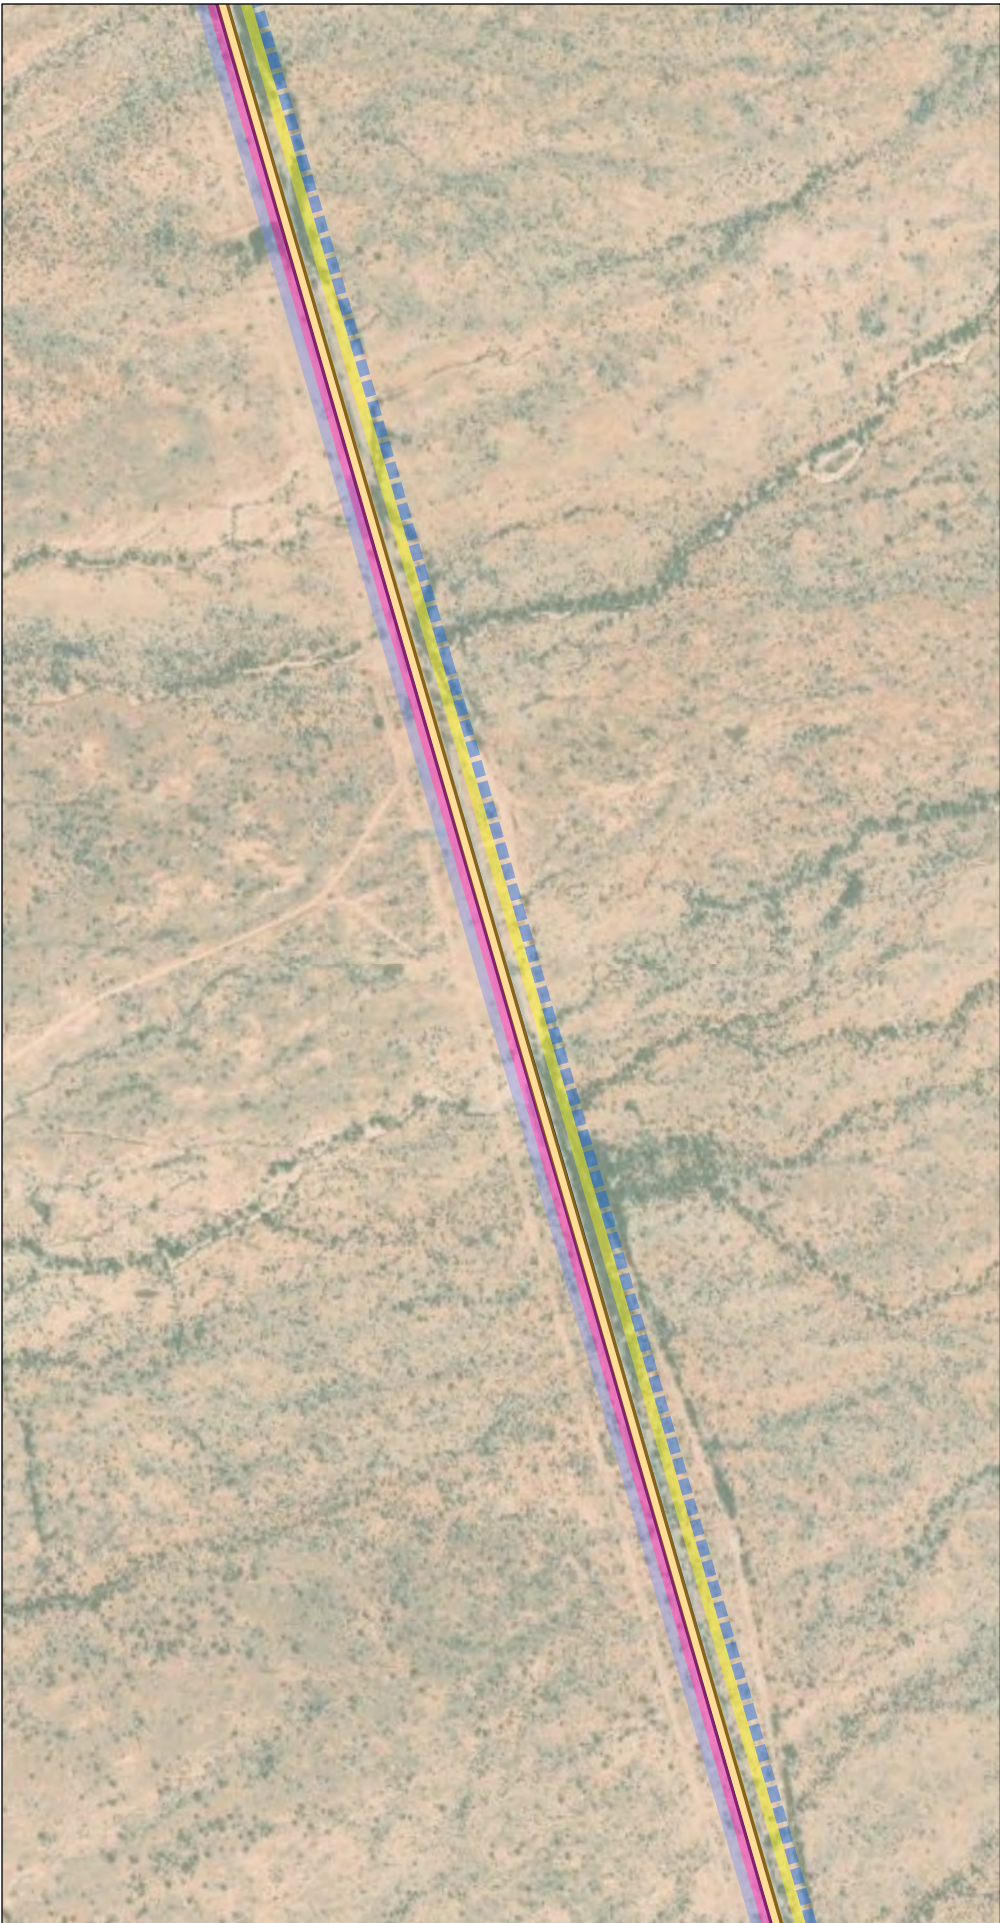
- High Crash Corridor
- Flooding Issue
- No Sidewalks
- Open Range, No Fencing
- No Shoulders
- Deteriorating Striping
- No Lighting
- Poor Pavement
- Curvy Roadway

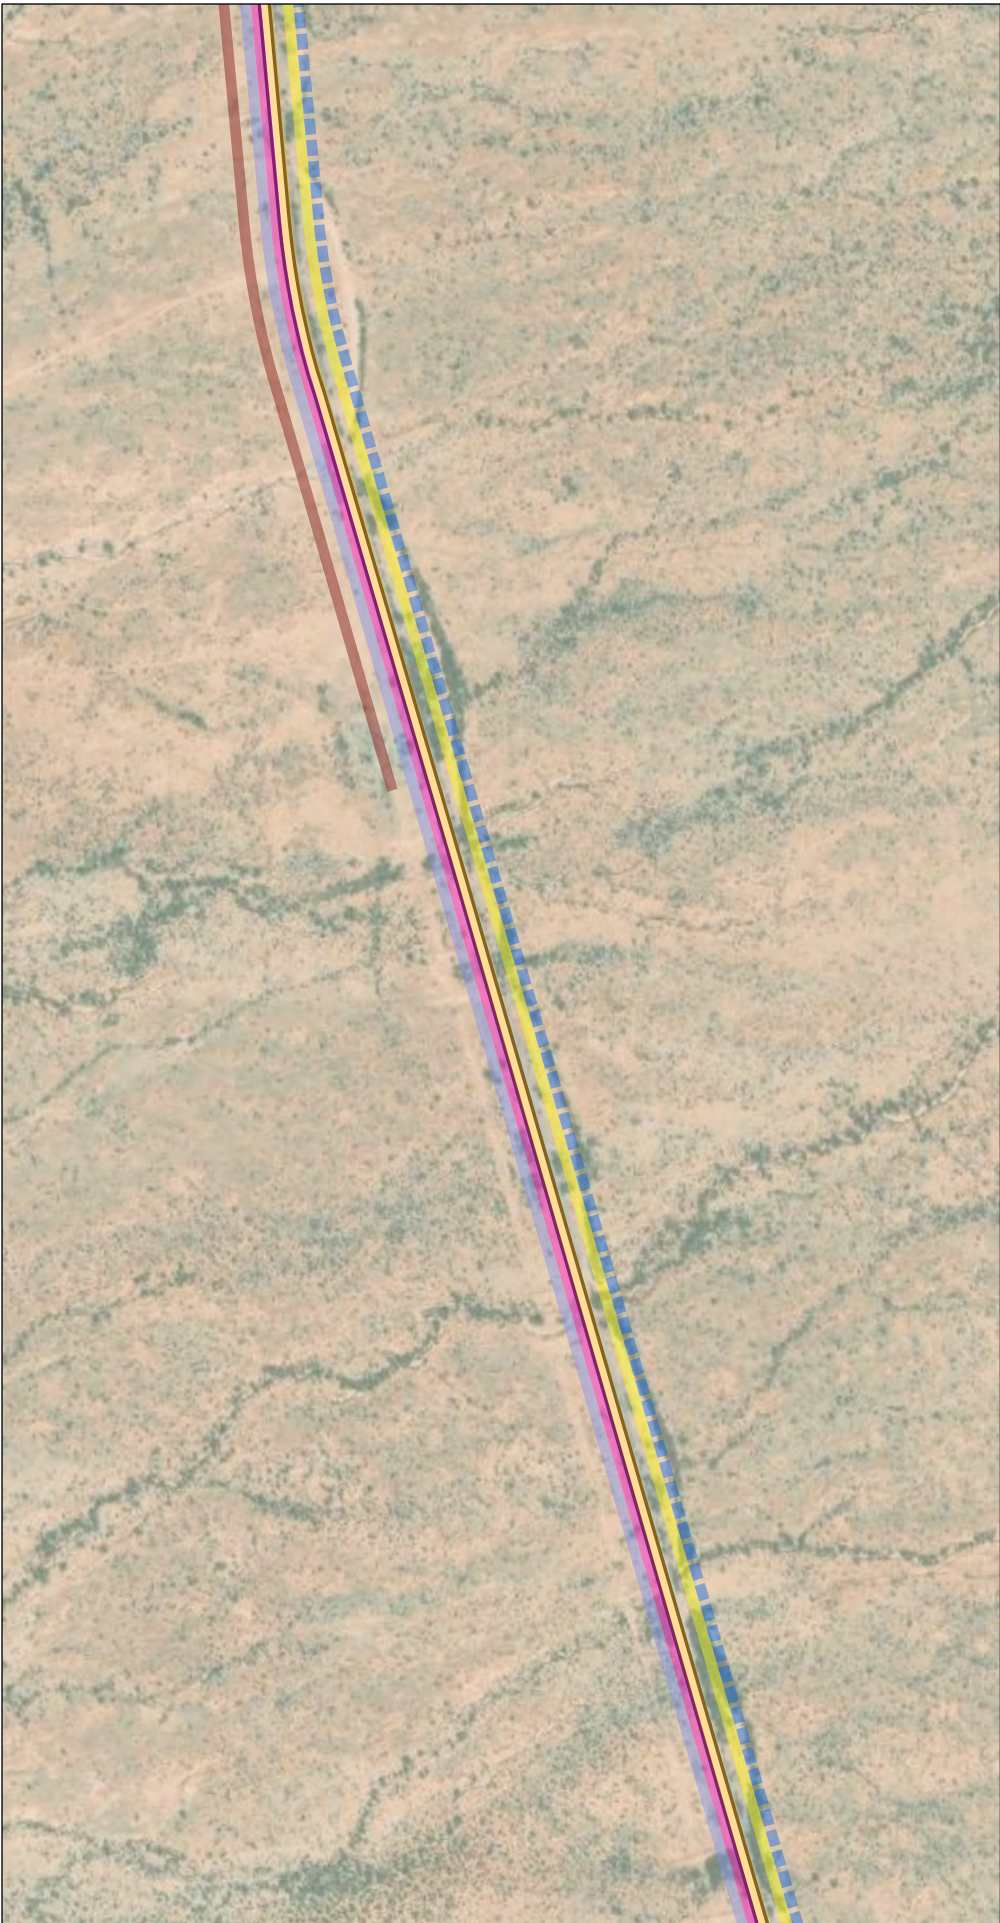
- High Crash Corridor
- Flooding Issue
- No Sidewalks
- Open Range, No Fencing
- No Shoulders
- Deteriorating Striping
- No Lighting
- Poor Pavement
- Curvy Roadway

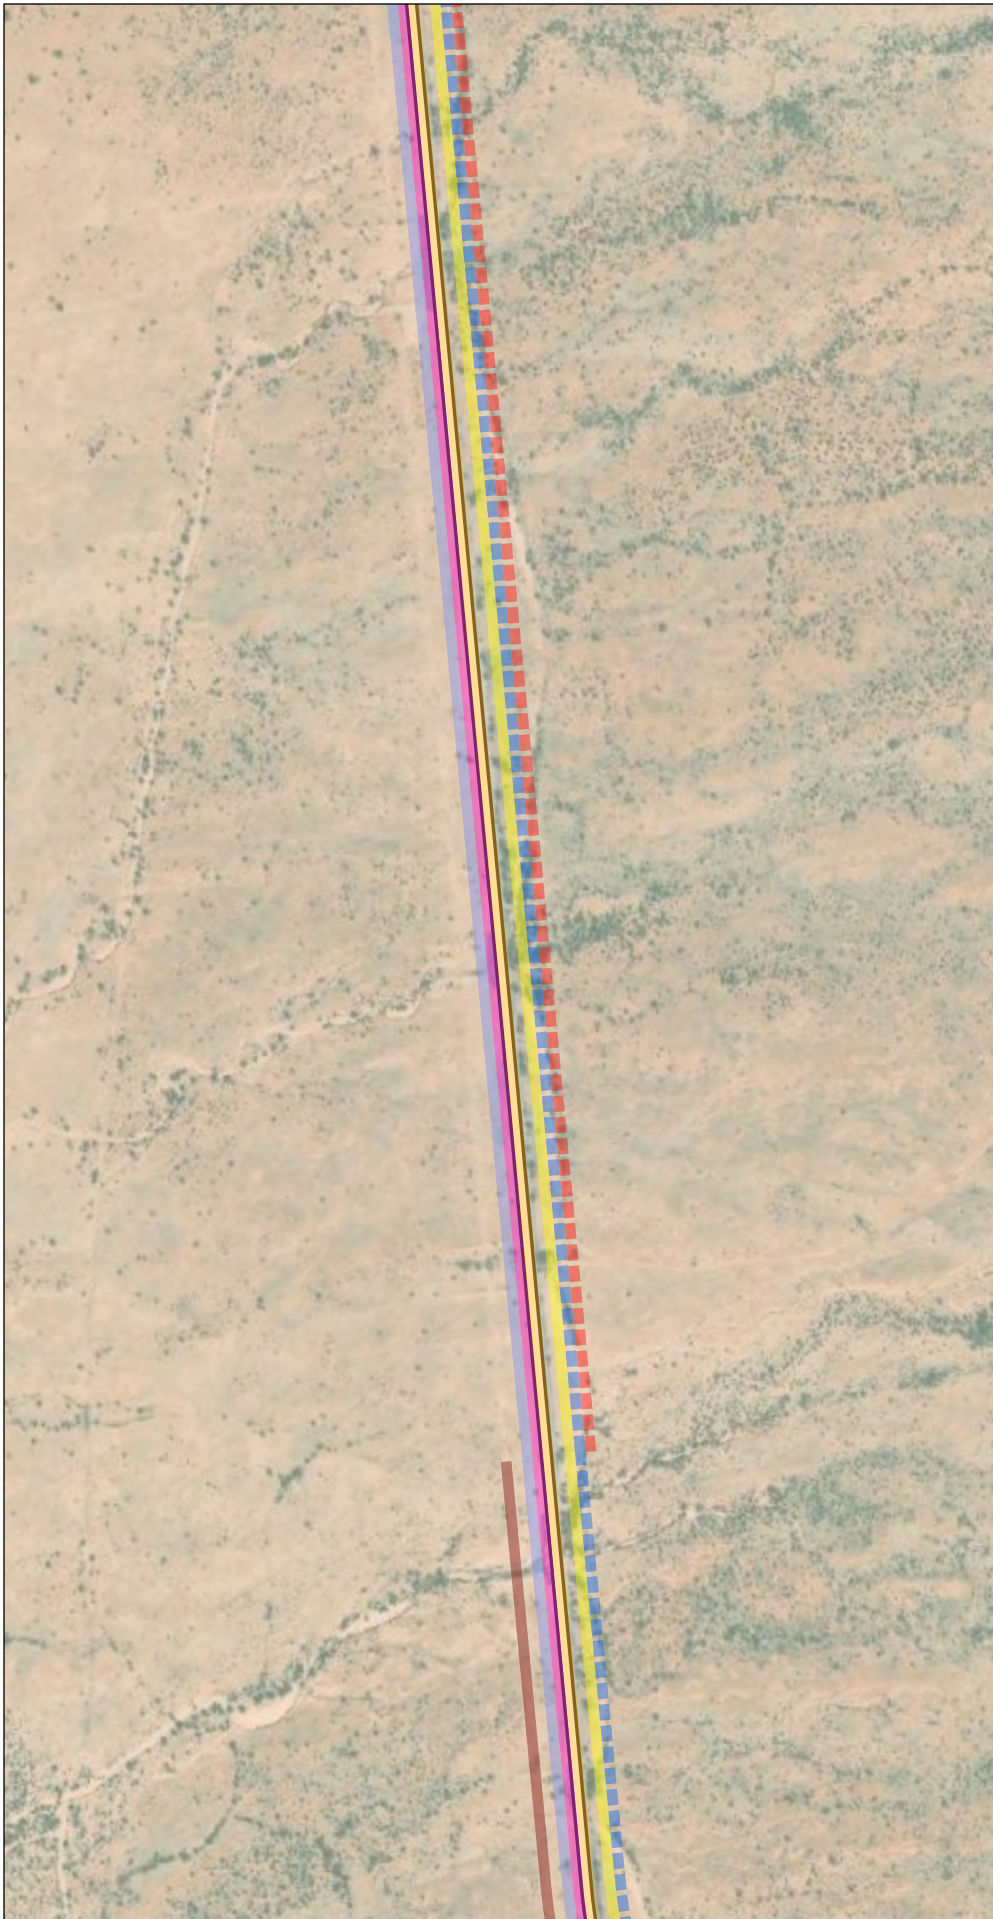
- High Crash Corridor
- Flooding Issue
- No Sidewalks
- Open Range, No Fencing
- No Shoulders
- Deteriorating Striping
- No Lighting
- Poor Pavement
- Curvy Roadway

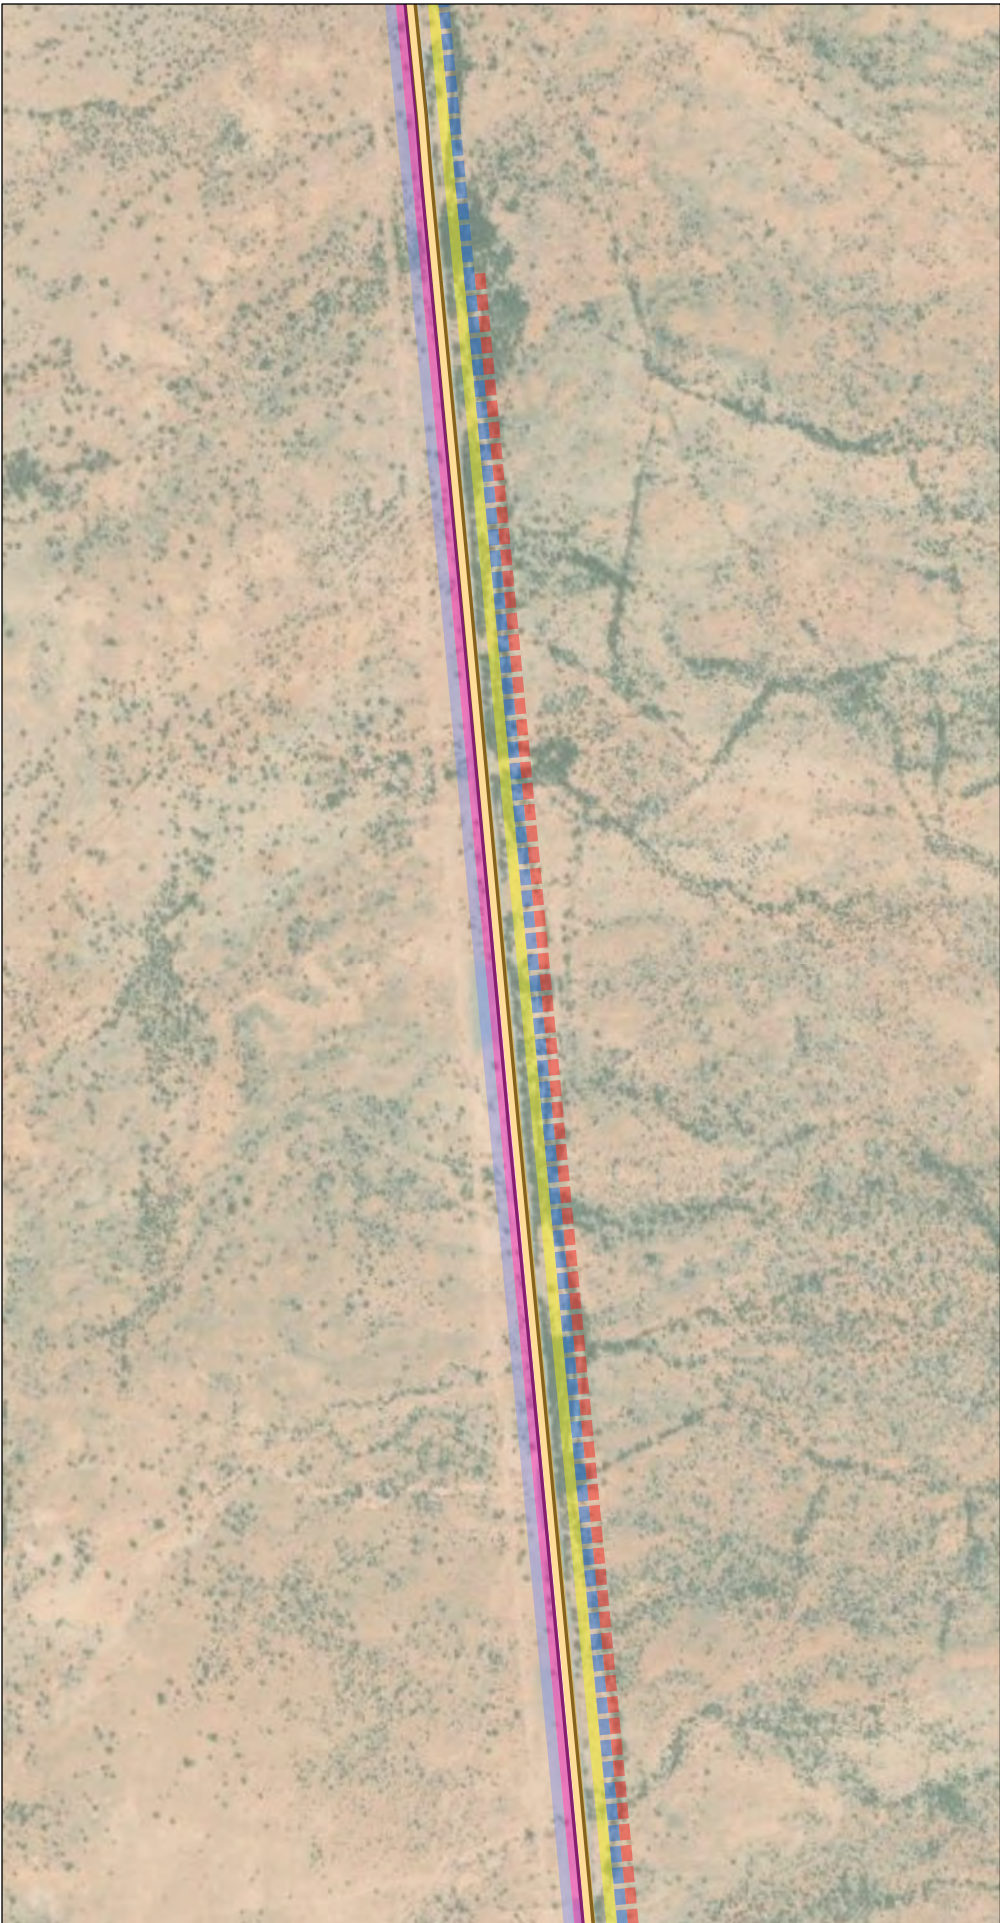
- High Crash Corridor
- Flooding Issue
- No Sidewalks
- Open Range, No Fencing
- No Shoulders
- Deteriorating Striping
- No Lighting
- Poor Pavement
- Curvy Roadway

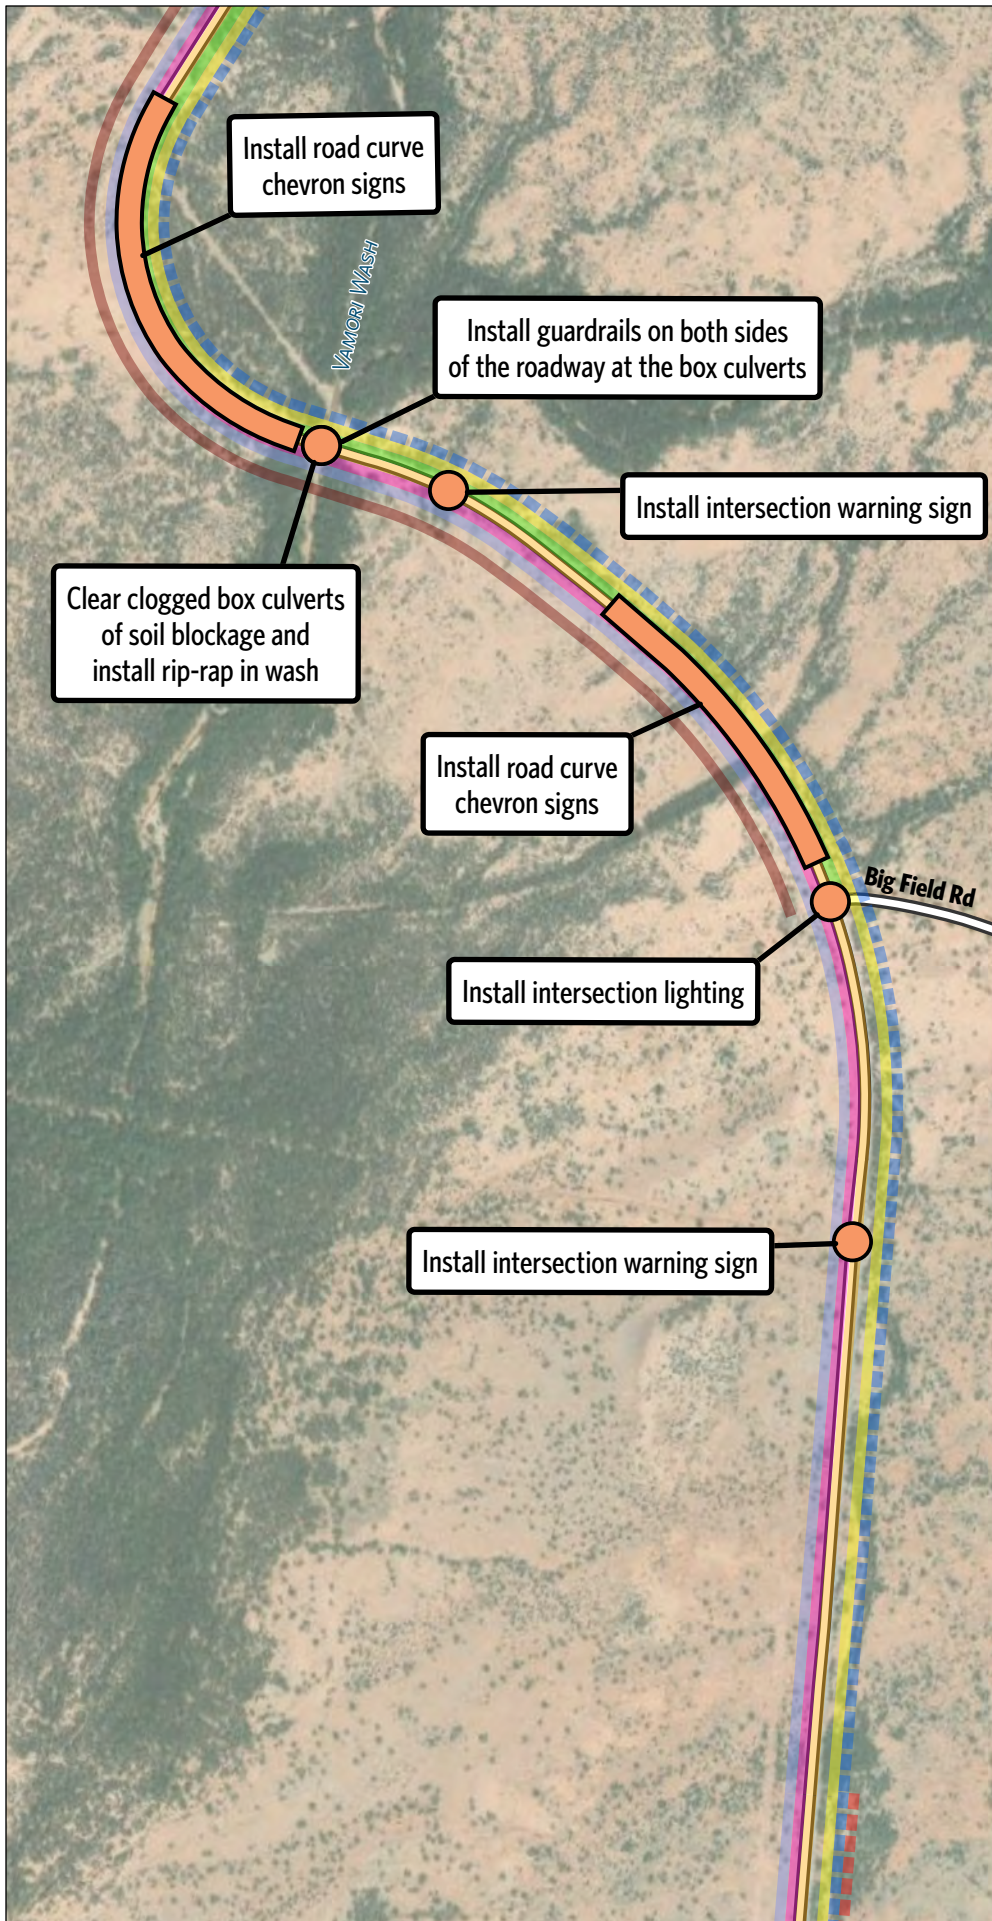
- High Crash Corridor
- Flooding Issue
- No Sidewalks
- Open Range, No Fencing
- No Shoulders
- Deteriorating Striping
- No Lighting
- Poor Pavement
- Curvy Roadway

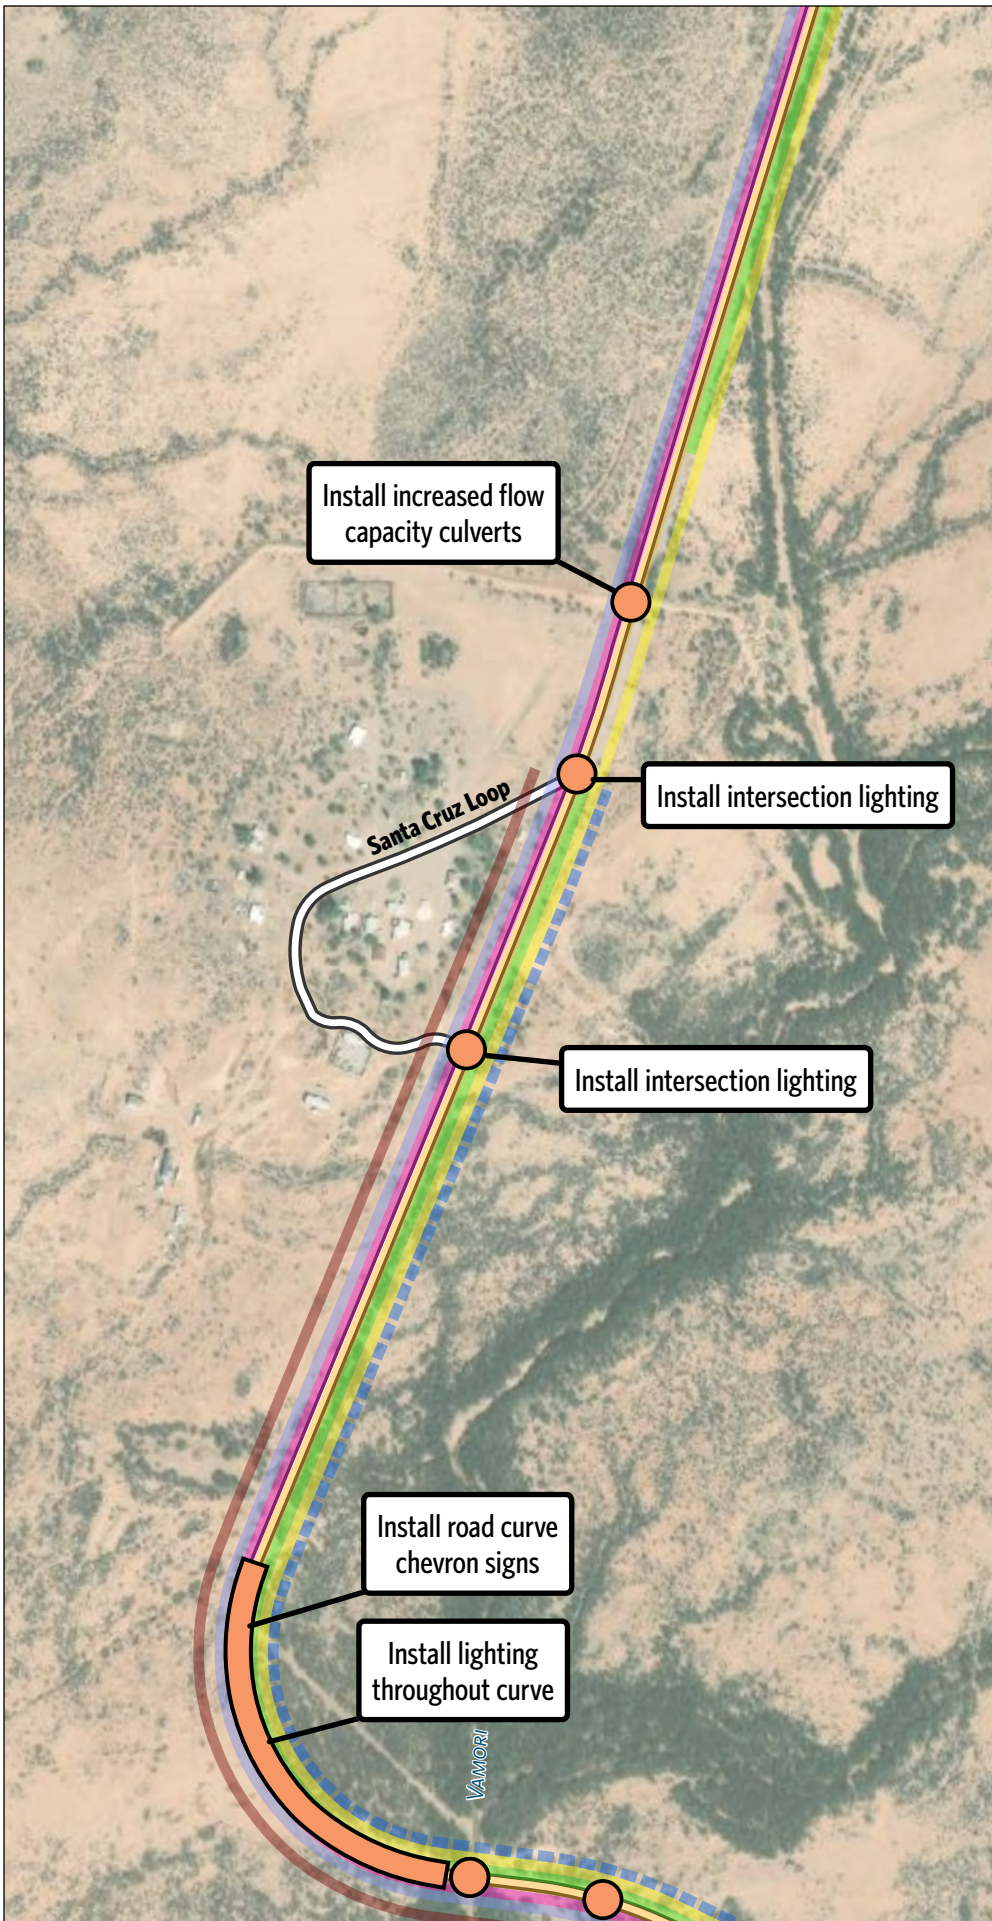
- High Crash Corridor
- Flooding Issue
- No Sidewalks
- Open Range, No Fencing
- No Shoulders
- Deteriorating Striping
- No Lighting
- Poor Pavement
- Curvy Roadway

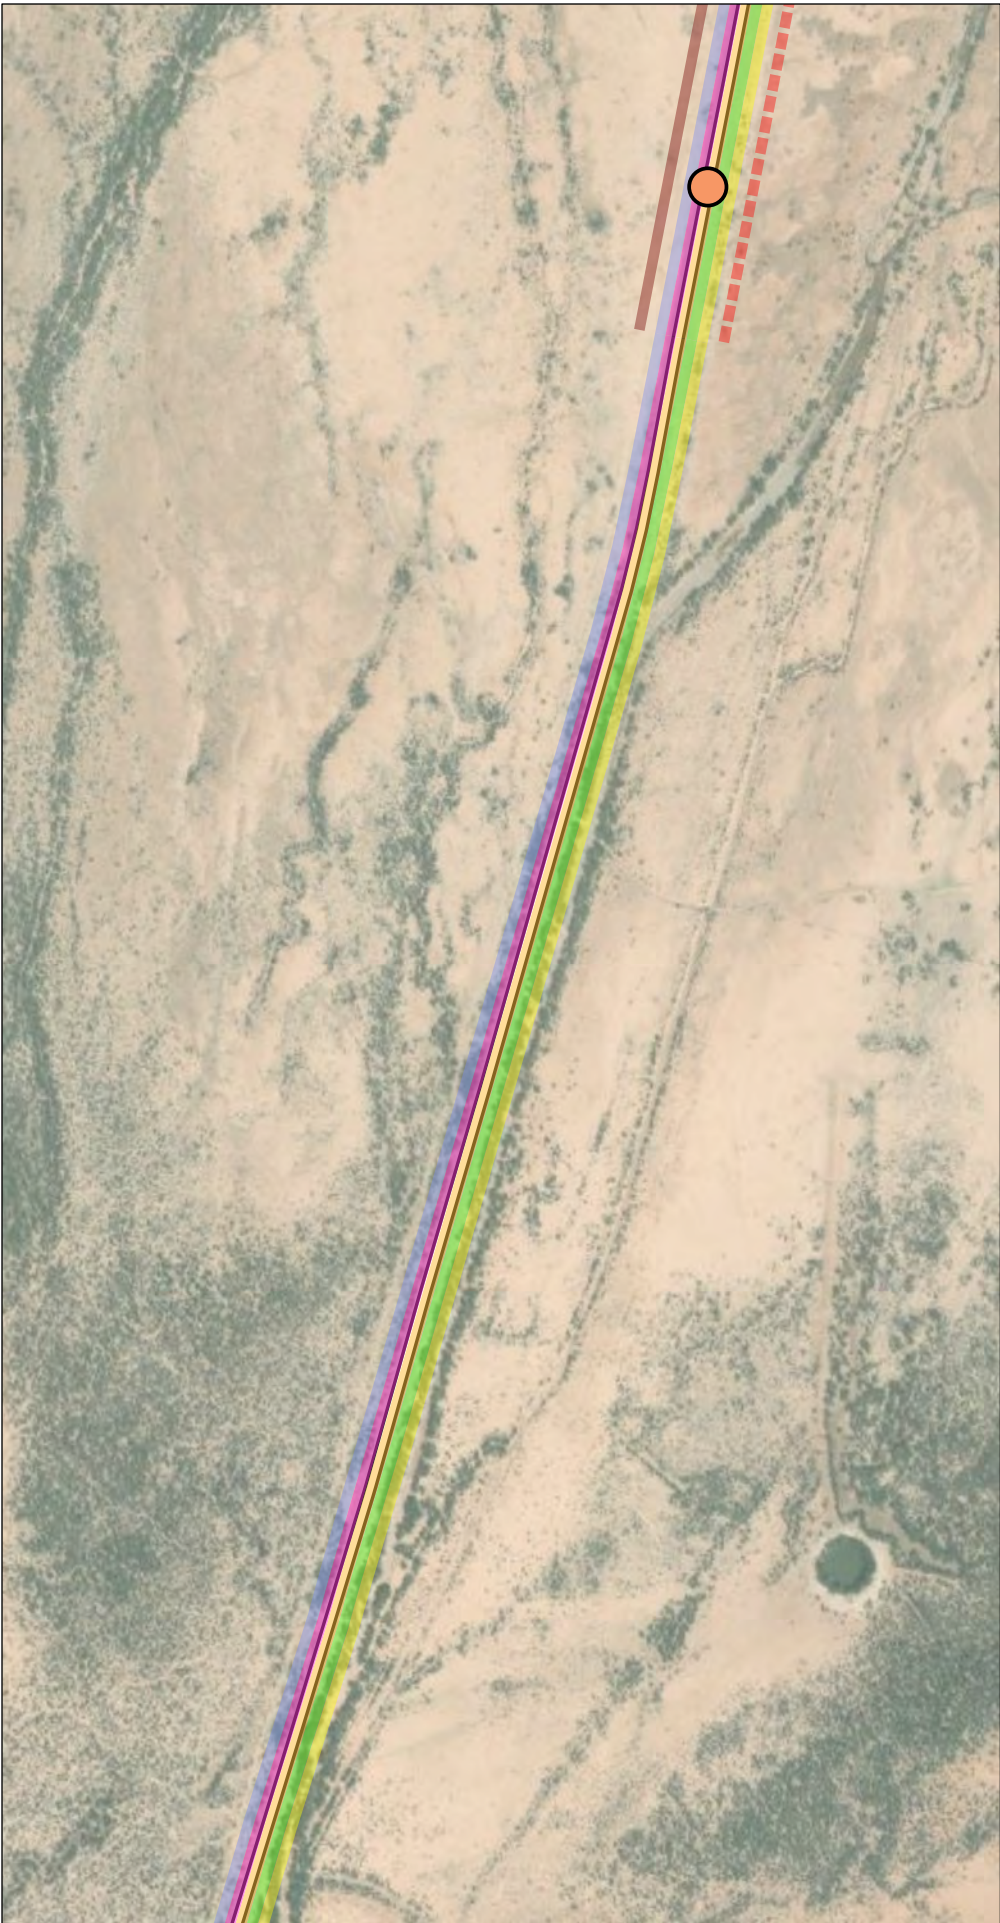
- High Crash Corridor
- Flooding Issue
- No Sidewalks
- Open Range, No Fencing
- No Shoulders
- Deteriorating Striping
- No Lighting
- Poor Pavement
- Curvy Roadway

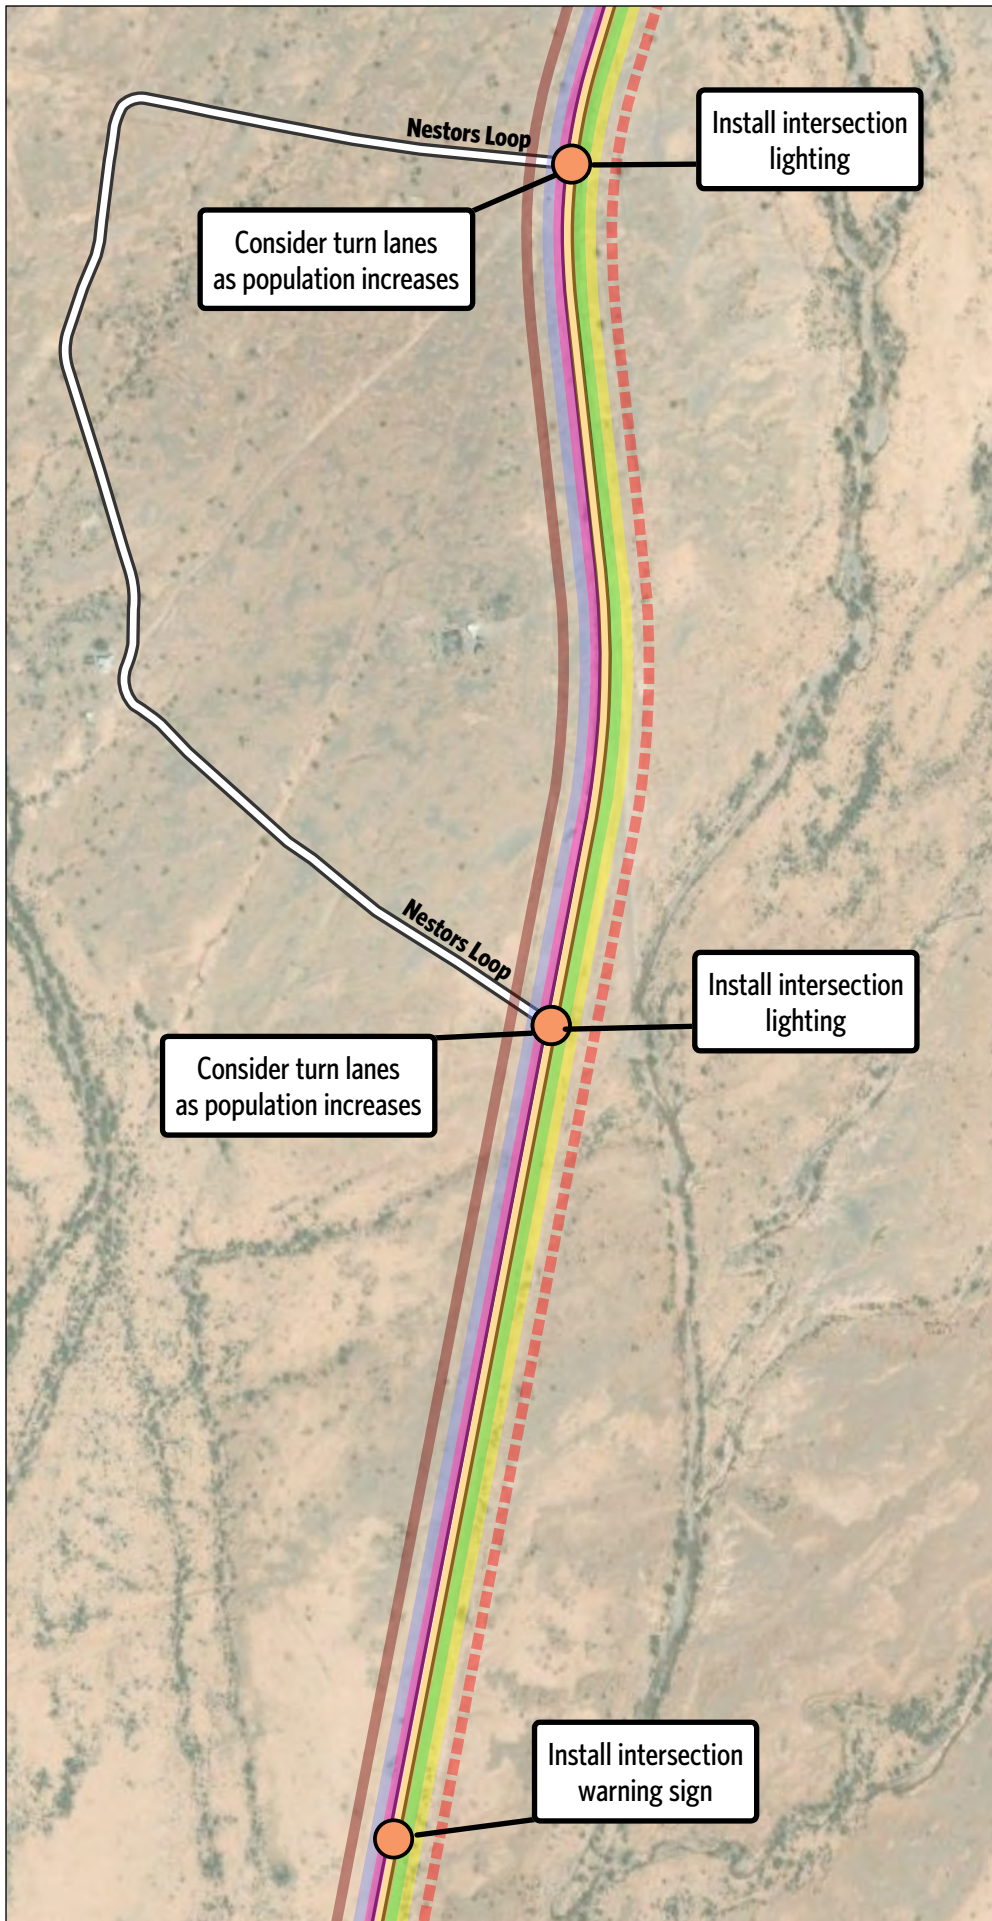
- High Crash Corridor
- Flooding Issue
- No Sidewalks
- Open Range, No Fencing
- No Shoulders
- Deteriorating Striping
- No Lighting
- Poor Pavement
- Curvy Roadway

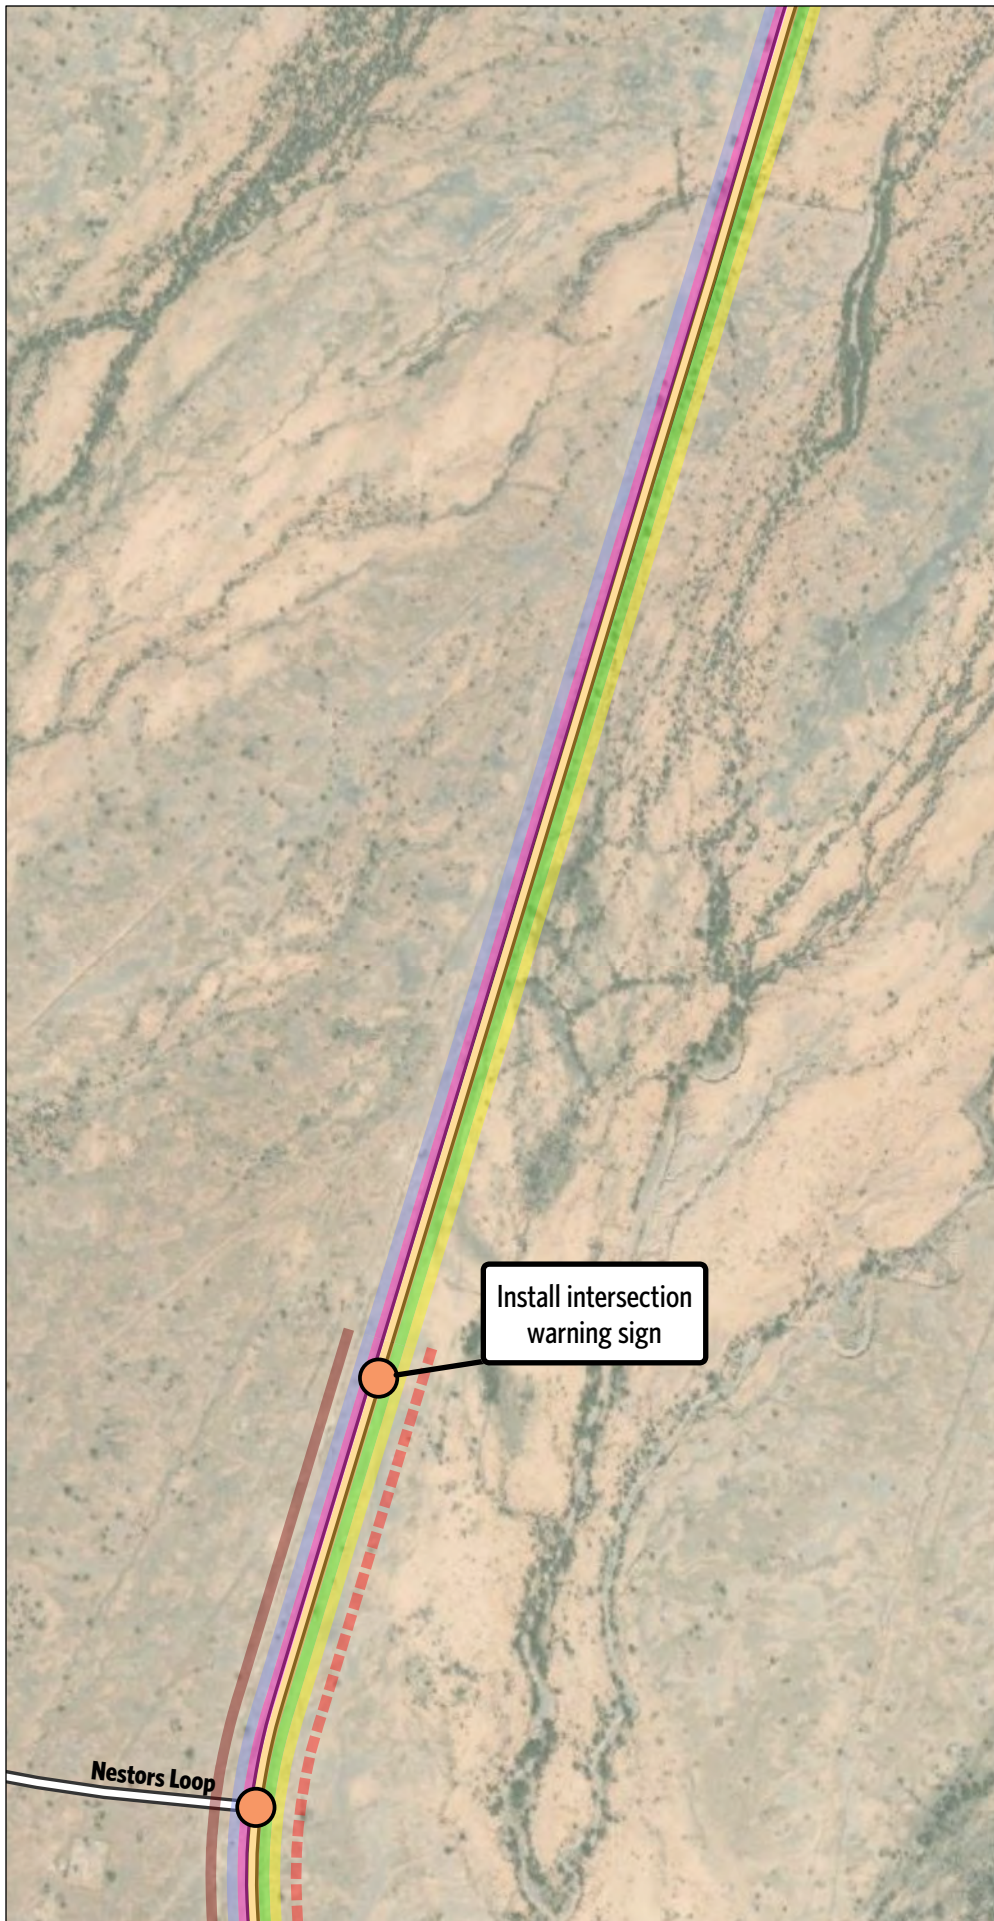
- High Crash Corridor
- Flooding Issue
- No Sidewalks
- Open Range, No Fencing
- No Shoulders
- Deteriorating Striping
- No Lighting
- Poor Pavement
- Curvy Roadway
