BIA Rt 19: SR 86 to End of Road Road Safety Assessment

Prepared for:
The Tohono O'odham Nation

May 2023

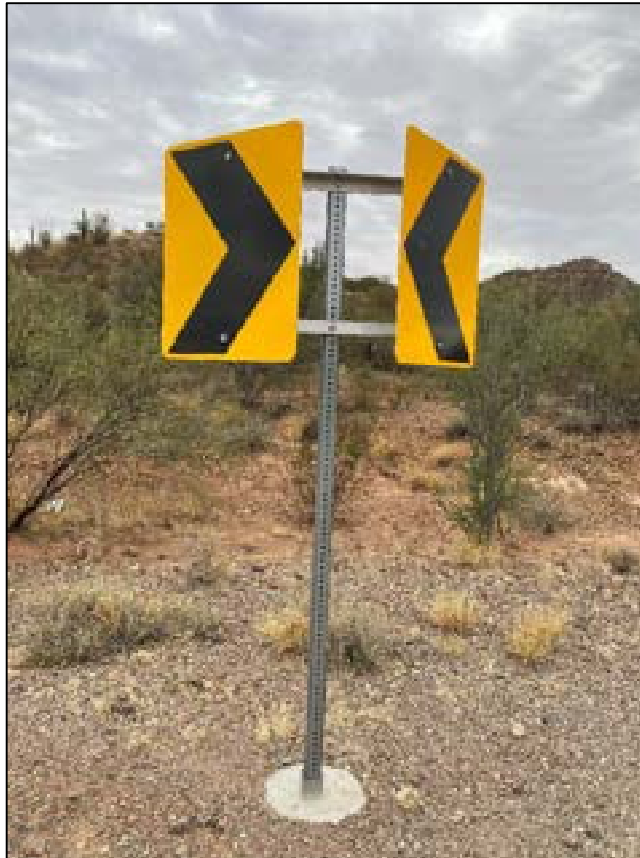
Chevron warning signs

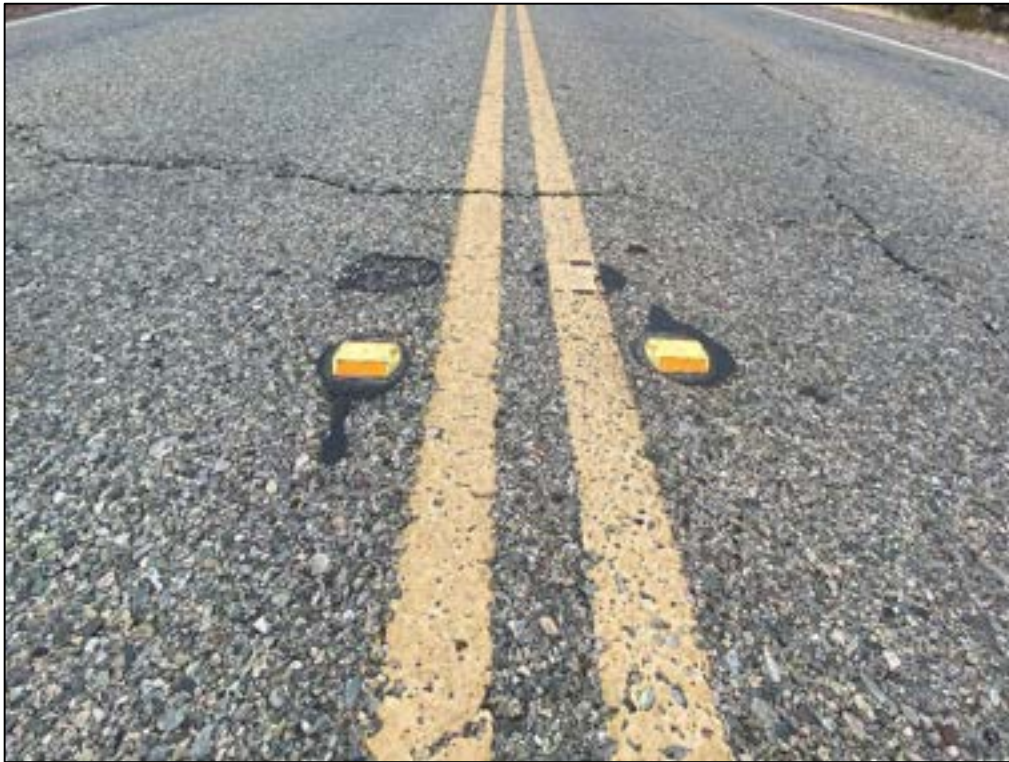
Centerline reflective pavement markers

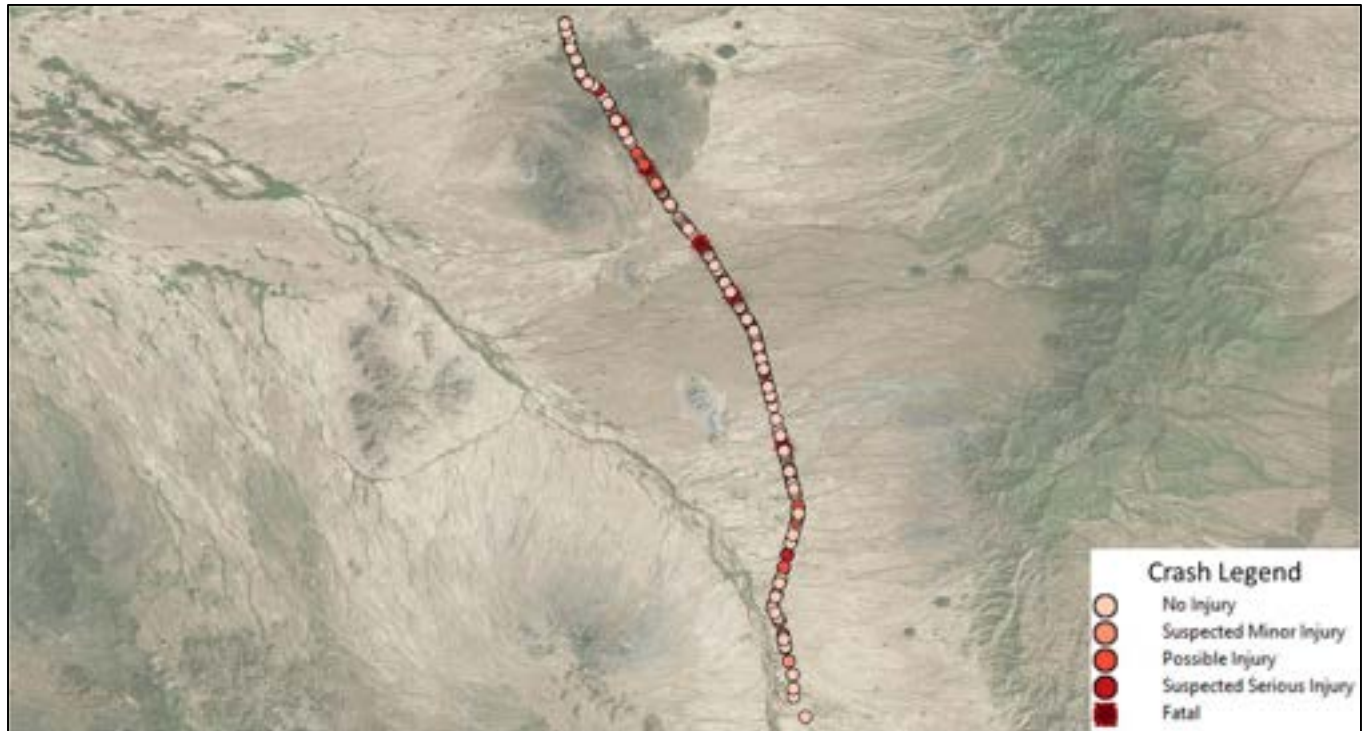
Figure 5: BIA Route 19 crashes between 2011 and 2020 by crash severity

There were five fatal crashes and seven suspected serious injury crashes. The location of crashes by severity are shown in **Figure 5**, and the crash density or heat map is shown in **Figure 6**.

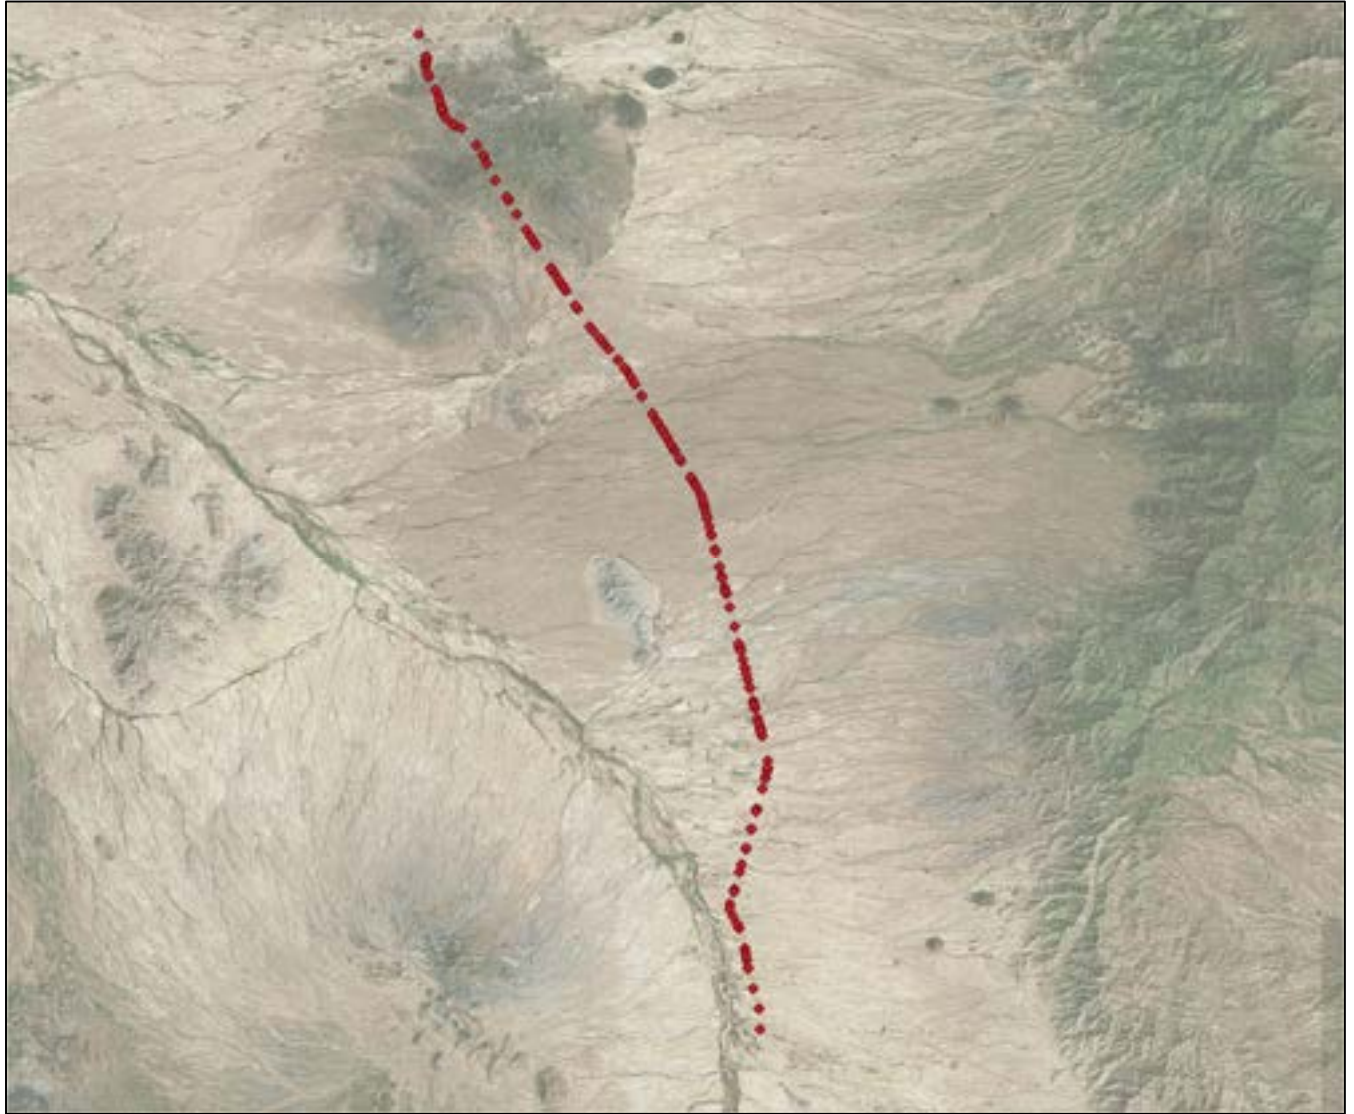
Figure 7: BIA Route 19 2011 to 2020 animal-related crashes

The RSA team observed intermittent no fencing along both sides of the roadway. In the crash data from 2011 to 2020, animal-related crashes appear to be the top crash type, with animal-related crashes throughout the corridor. The locations with animal-related crashes are shown in **Figure 7** below.

It was also observed that cattle were periodically wandering in the roadway. The RSA team observed other cattle congregating on the side of the roadway where vegetation could potentially obstruct their view.

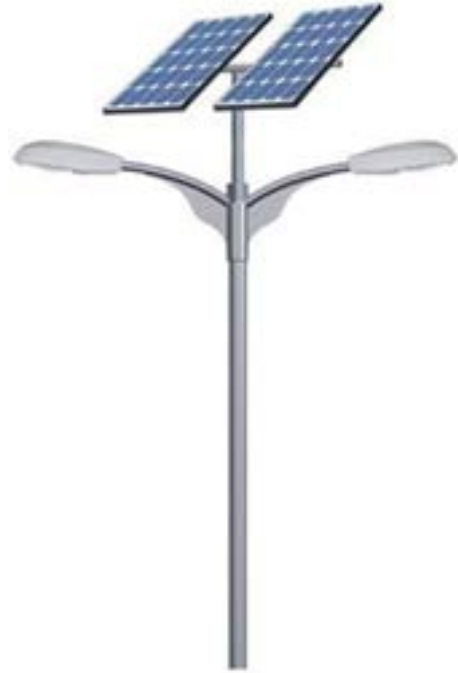
The lighting in the corridor was observed to be absent throughout the team's nighttime review. The observed low lighting conditions appear to allow for the potential of cattle to congregate on the roadway unseen by vehicles until they approach. No driveways or unsignalized intersections were observed to have lighting.

End of the road of Route 19 in low-level lighting conditions and sample solar-powered streetlight
