BIA Rt 21: SR 86 to Papago Farm Road Road Safety Assessment

Prepared for:
The Tohono O'odham Nation

May 2023

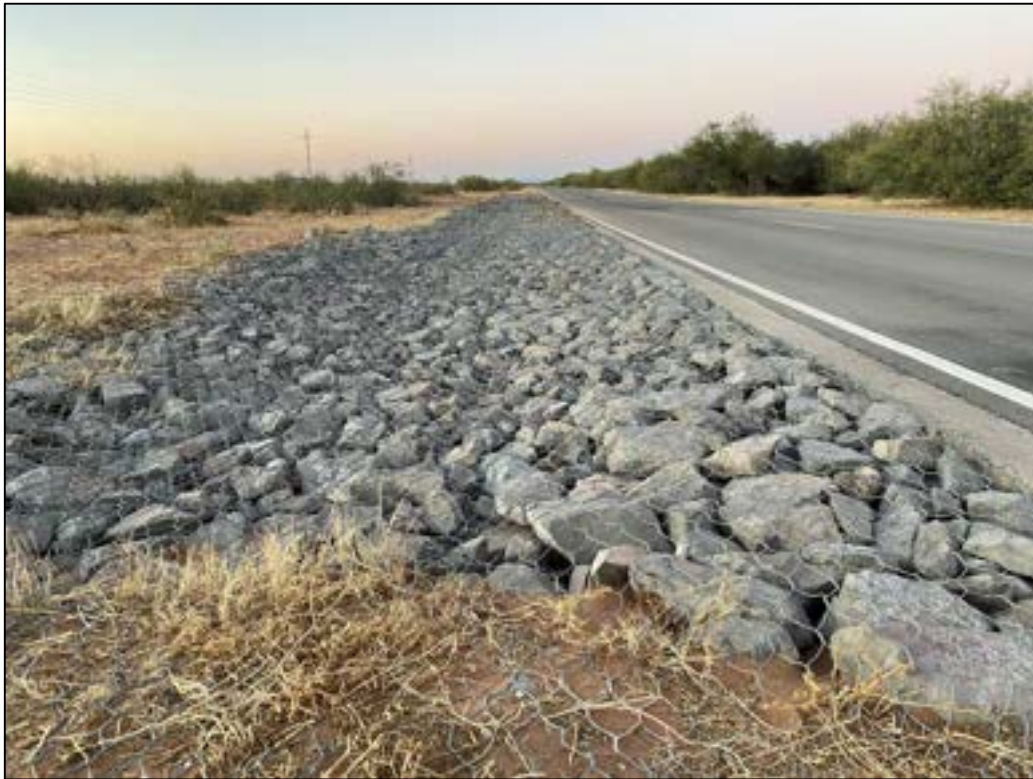
Roadside gabion baskets and refreshed pavement

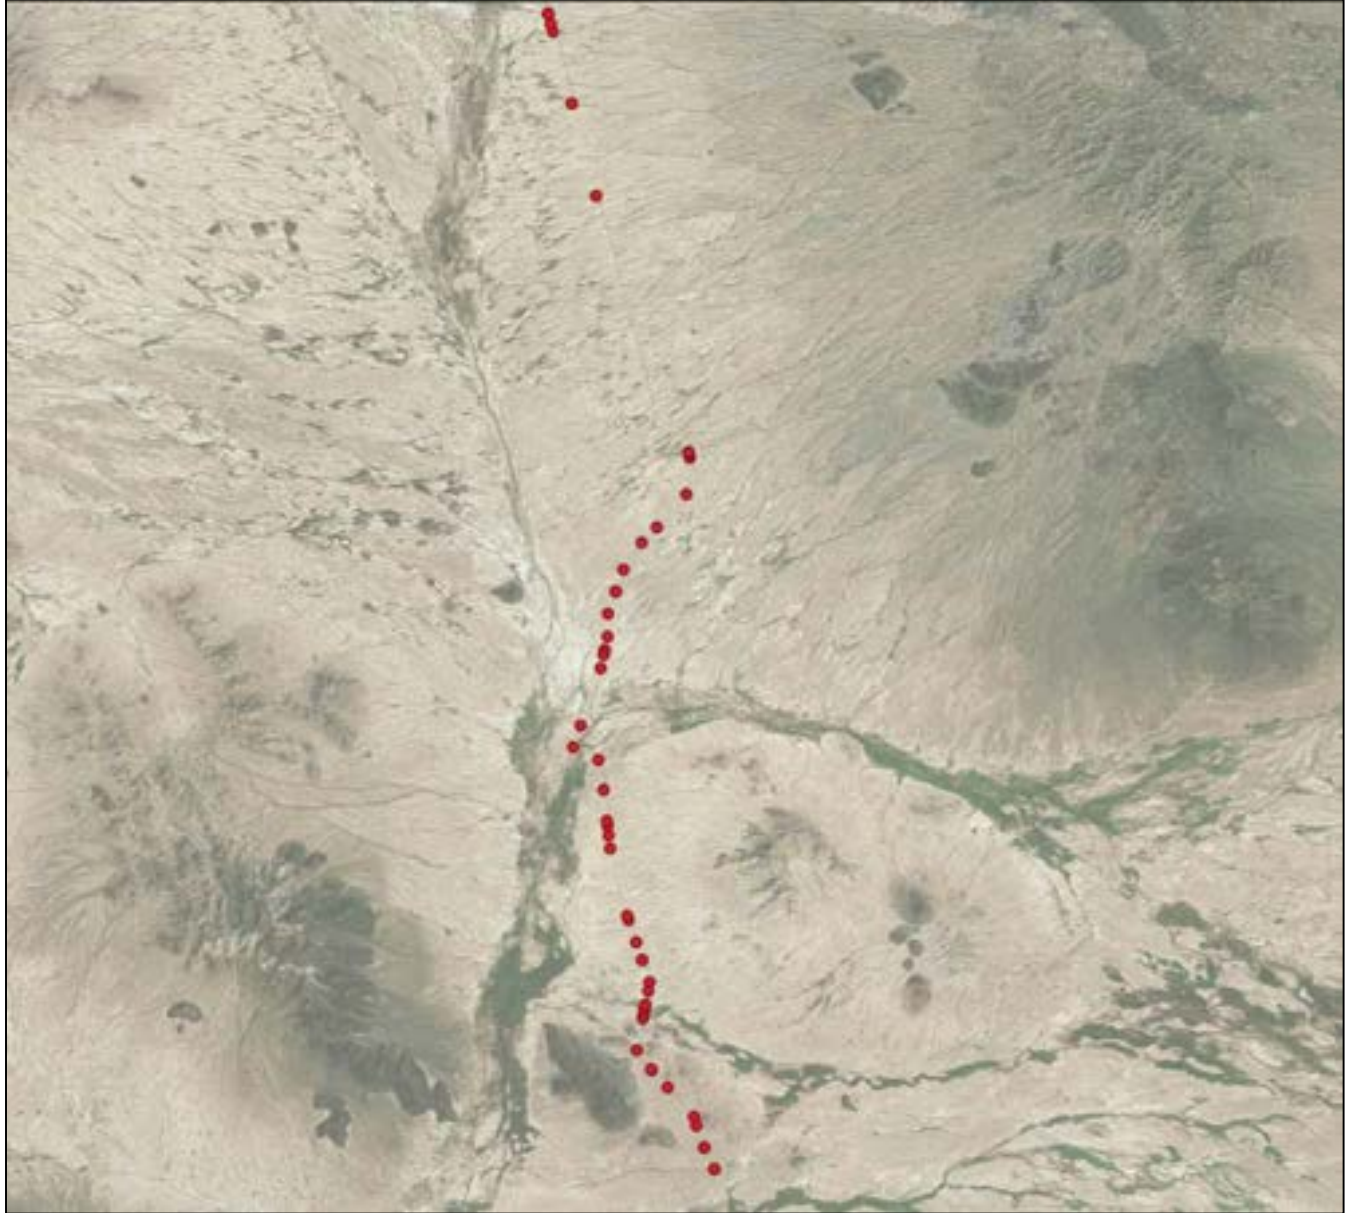
Figure 77: BIA Route 21 2011 to 2020 animal-related crashes

The RSA team observed intermittent no fencing along both sides of the roadway. In the crash data from 2011 to 2020, animal crashes are the top crash type, with animal crashes occurring throughout the corridor. The locations with animal-related crashes are shown in **Figure 77** below.

It was observed that cattle and donkeys were periodically wandering in the roadway. The RSA team was able to observe additional cattle and donkeys congregating on the sides of the roadway where vegetation could potentially obstruct the view of them. It was noted that nighttime conditions would potentially exacerbate the risk of animal crashes occurring.

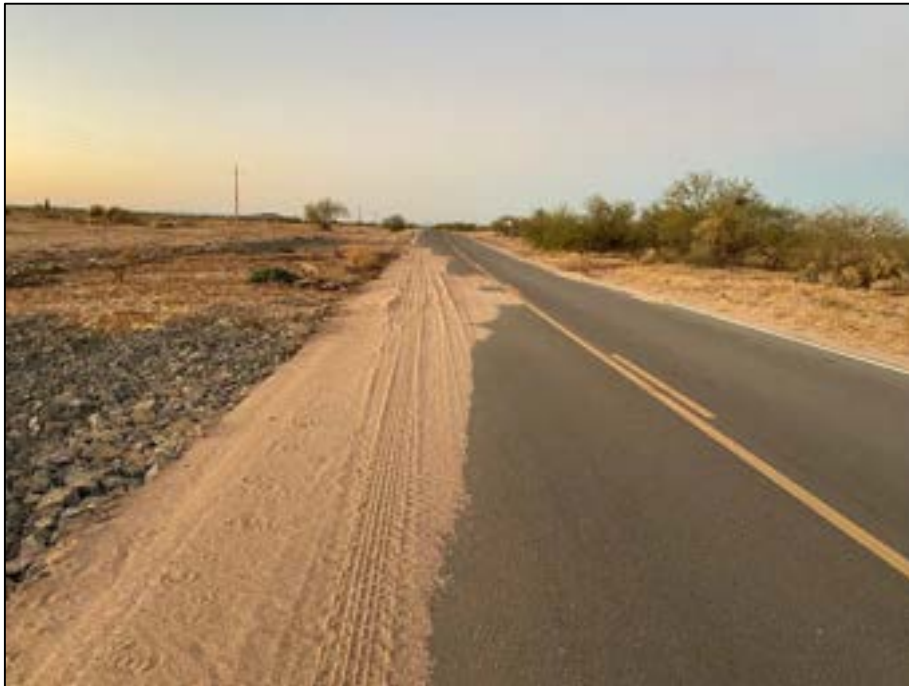
Records indicate the last pavement maintenance that was completed on the corridor was completed in the 1990s. The pavement surface on the route between the SR 86 intersection and mile marker 11.5 appears to have large cracks, superficial cracks, and surface pitting with few or no potholes. Between mile marker 11.5 and the end of the road, the pavement appears to be recently refreshed, with little to no pavement imperfections observed.

Sand on roadway

- Conduct pavement maintenance (i.e., Chip Seal) between SR 86 and mile marker 11.5
- Remove soil from the roadway
- Implement Safety Edge or recoverable sloped shoulder
- Remove shoulder vegetation
- Ensure a 4 ft paved shoulder minimum

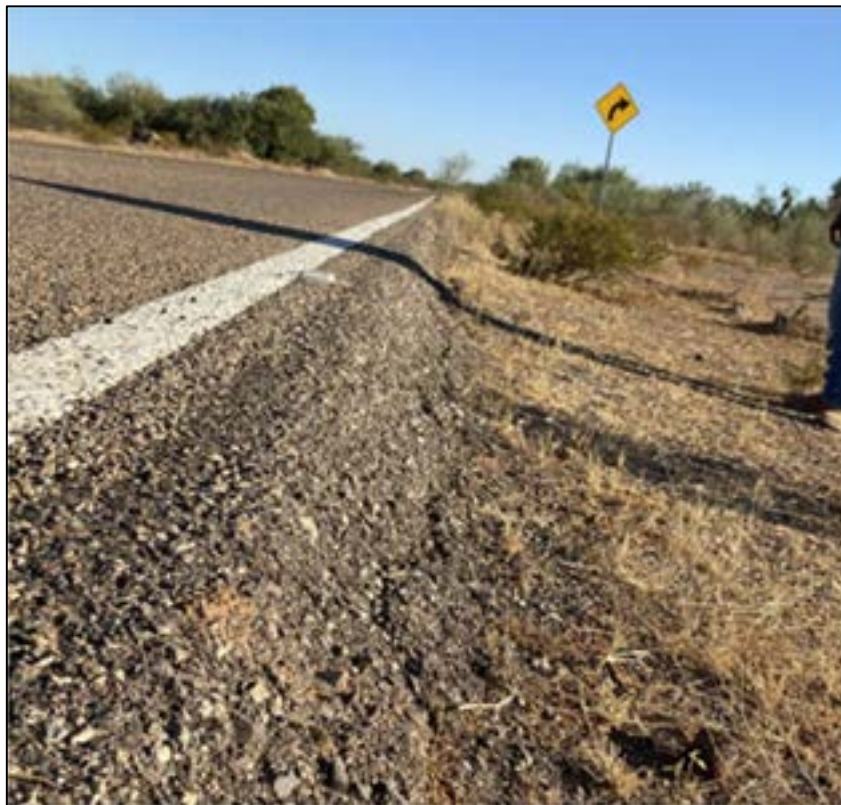
Shoulders throughout the corridor vary from approximately one foot to four feet in width. Edge drop-offs were observed throughout the corridor and specifically at the intersection of SR 86 and Rt 21 and at mile marker 19. It is noted that there are periodic erosion control measures between mile marker 11.5 and the end of the road, including riprap and gabion baskets.

Typical pavement edge drop-off on Route 21

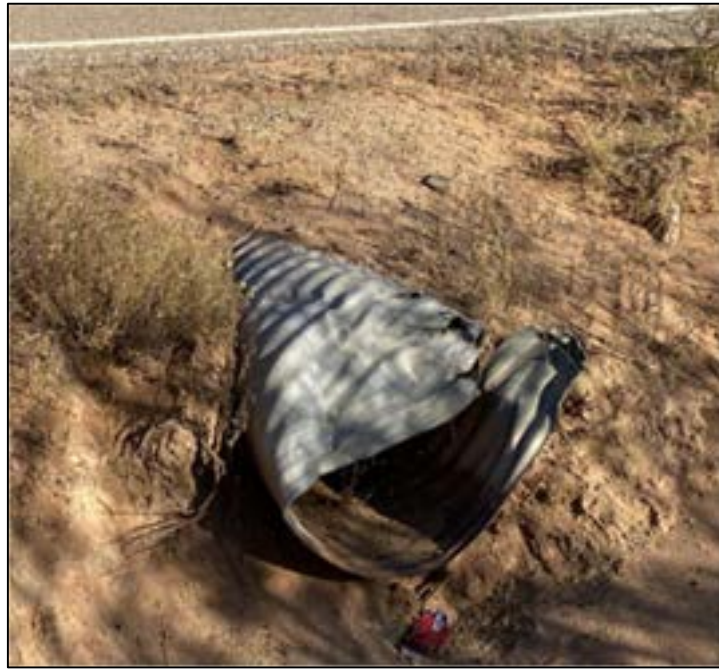
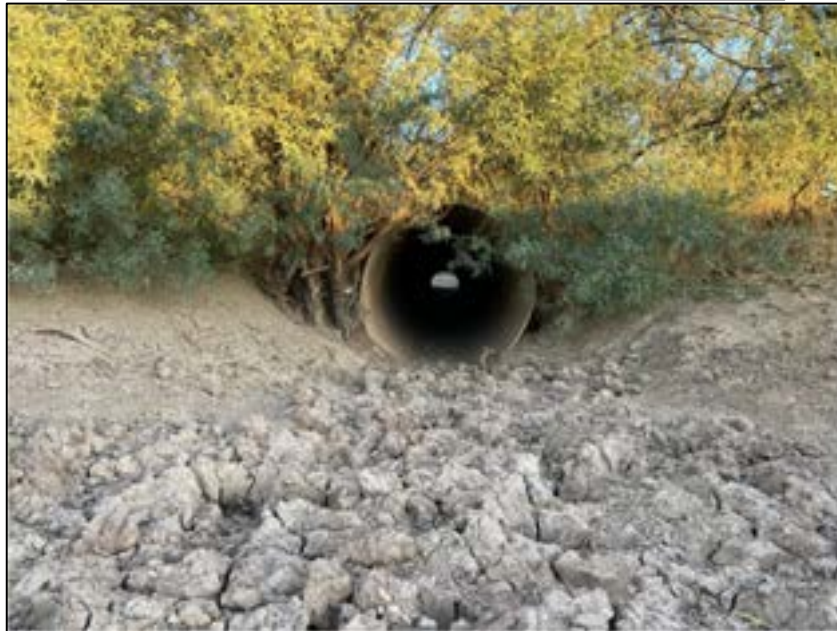
The RSA team observed clogging of existing wash drainage culverts. Culverts at mile markers 19 and 15 appear to be clogged or damaged. In general, the existing culverts on the route appear to be undersized for the apparent volume of drainage that they experience. A five-span box culvert-style bridge at mile marker 12 was observed to be clogged, with three of the spans being completely blocked.

Existing wash drainage culverts under Route 21

- Install culverts at sag curves that experience flooding at mile markers 15 and 19
- Maintenance on damaged and clogging in culverts and under bridges at mile marker 12
- Depth gauges at wash locations

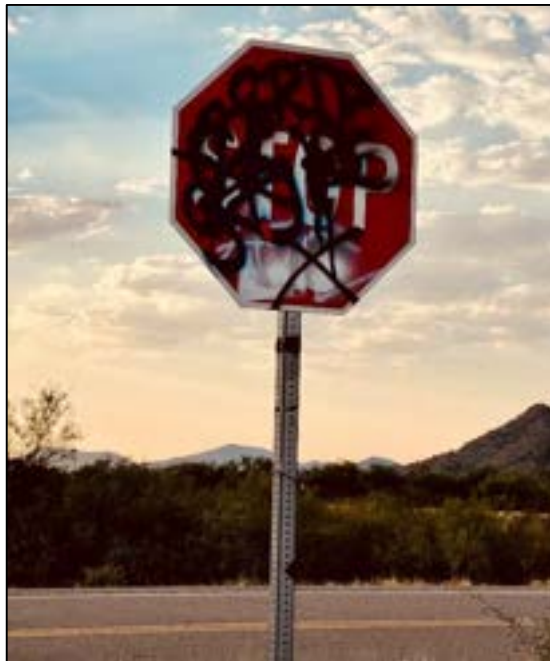
Most signs were visible during the daytime and appeared to have adequate retroreflectivity at night. Signs near mile marker 18 had paint obstructing them. Signs at mile markers 13, 17, and 20 were also obstructed with vegetation.

Roadway signage is obscured with paint.

- Install intersection warning signs at roadway intersections
- Removal of sign graffiti or replacement near mile marker 18
- Removal of signs obstructing vegetation near mile markers 13, 17, and 20
- Install standard community signs
- Add bus stop warning signs at mile marker 18.25 or the new bus stop location
- Relocate bus stops away from the road curve near mile marker 18.25
- Install advanced sag curve warning dip signs
- Install edge of roadway delineators
- Install RPMs from mile marker 11.5 to the end of the road
- Add chevron signs through sharp curves
