BIA Rt 15: Battaglia Dr to SR 86 Road Safety Assessment

Prepared for:
The Tohono O'odham Nation

May 2023

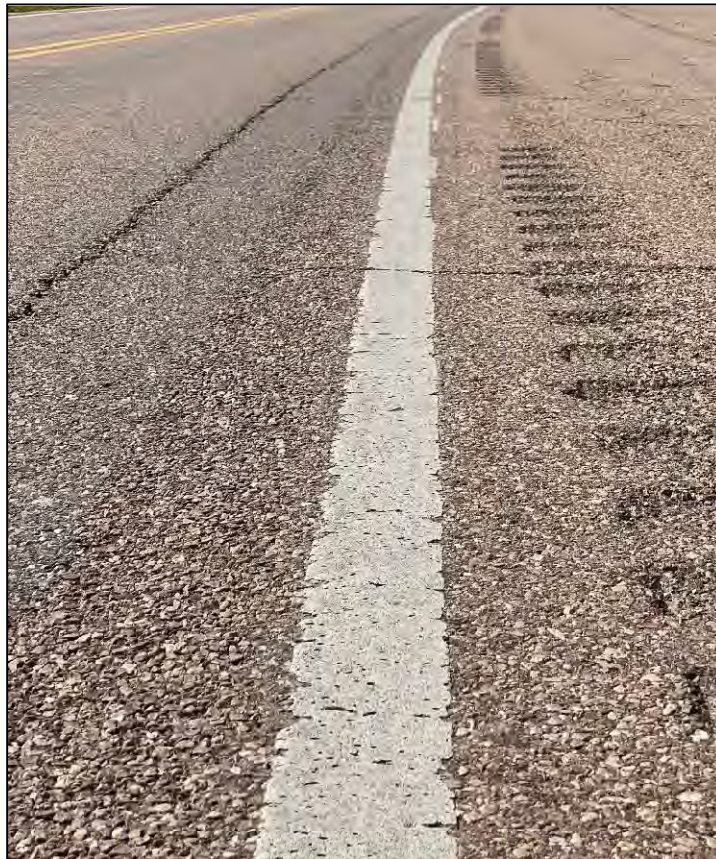
Edge line rumble strips on the route

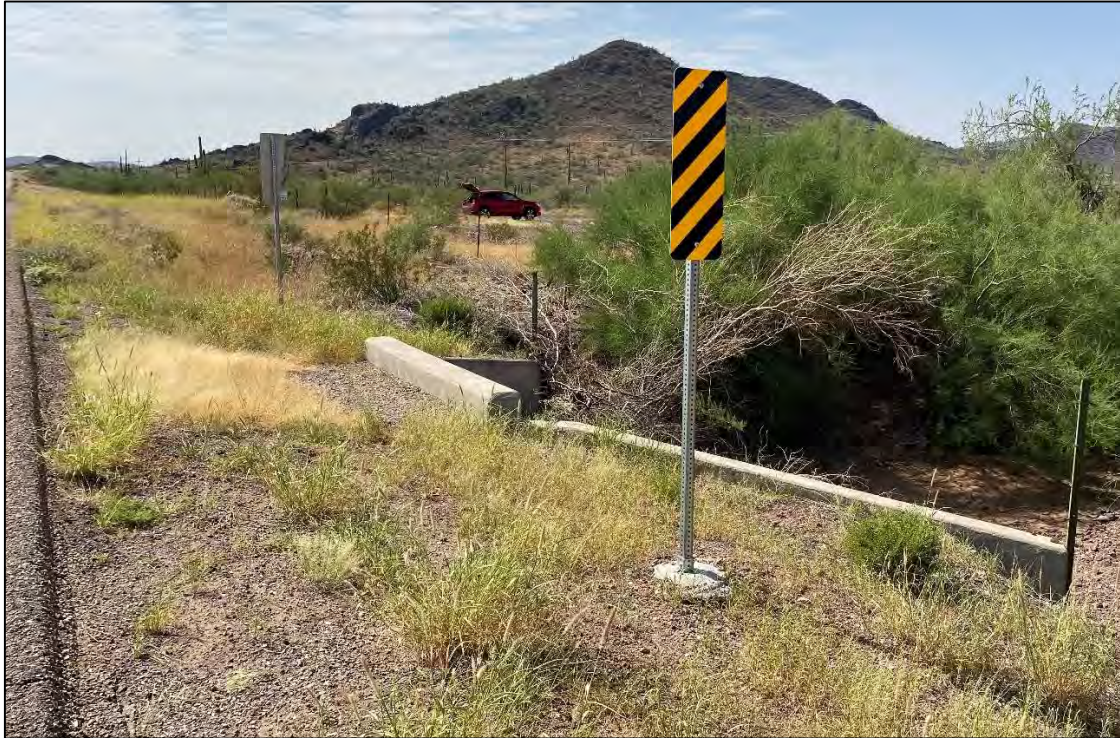
Roadside object marker

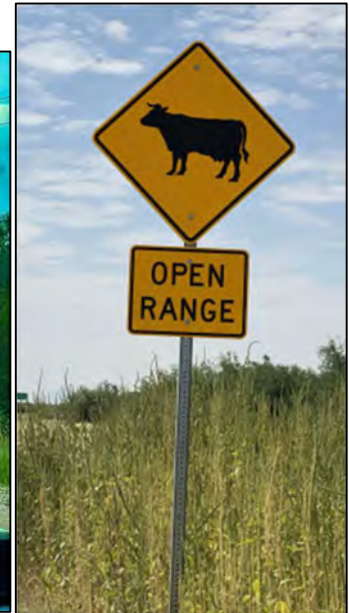
It was observed that cattle were periodically walking in and along the roadway. The RSA team observed other cattle congregating on the side of the roadway where vegetation could potentially obstruct their view.

Cattle in the roadway and warning sign of an open range

- Continuous fencing
- Conduct a systematic inspection on the right-of-way fence, gates, and cattle guards and develop a repair plan
- Replace non-standard cattle guards with standard cattle guards

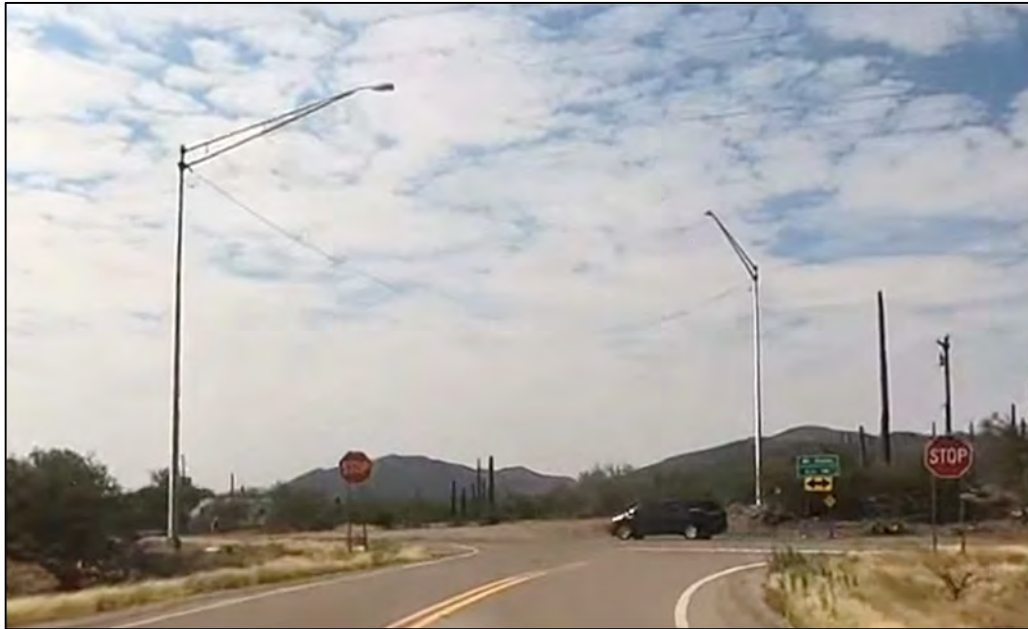
The only street lighting on the corridor is at the SR 86 intersection. Solar street lighting has also been installed within the new Hanam Kek development.

Existing intersection lighting on Route 15 at the State Route 86 intersection.

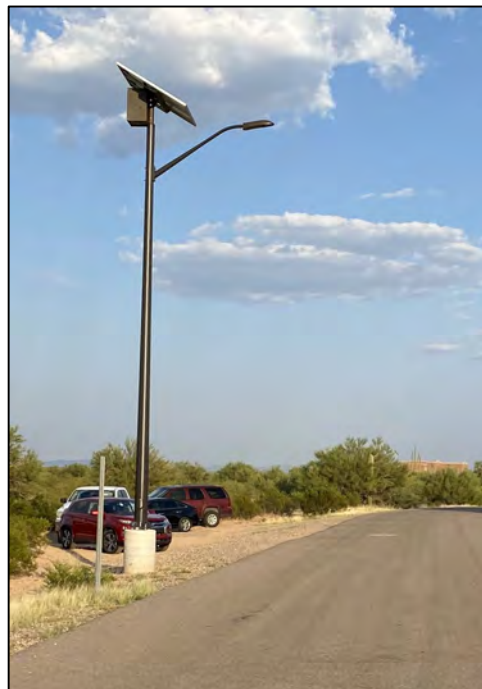
Existing solar-powered intersection lighting at the new development on Route 15

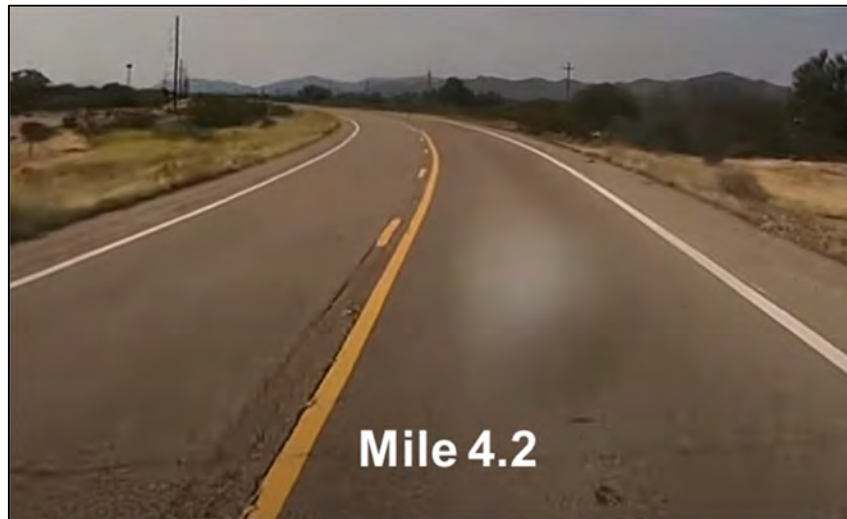
The roadway striping on the route appears to be in good condition and visible day and night. Some intersections do not have warning signs. A passing zone is marked in a horizontal curve near mile marker 4.2. There are some non-standard community signs on the route.

The passing zone is marked in a horizontal curve at milepost 4.2 on Route 15

- Install intersection warning signs.
- Install cattle guard warning signs
- Removal of sign graffiti or replace damaged signs
- Removal of vegetation obstructing signs
- Review passing zones in curves for adequate sight distance
- Install standard community signs
- Install flash flood warning sign

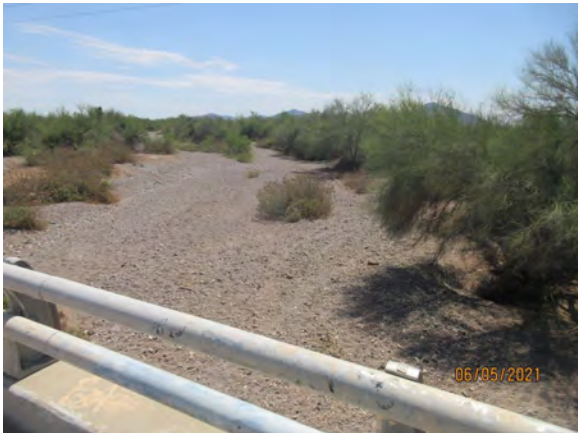
H622_2106_P04 CHANNEL LOOKING EAST (DOWNSTREAM)

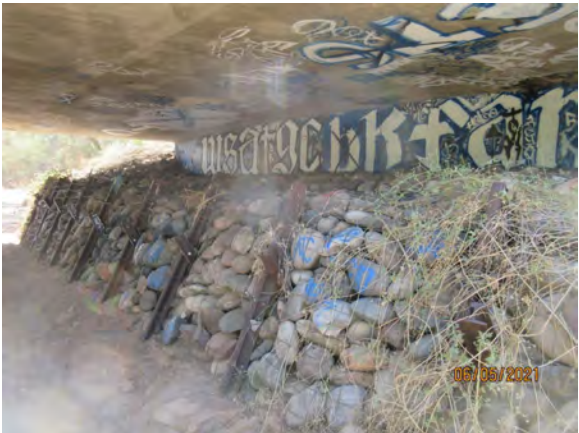
H622_2106_P07 SOUTH ABUTMENT

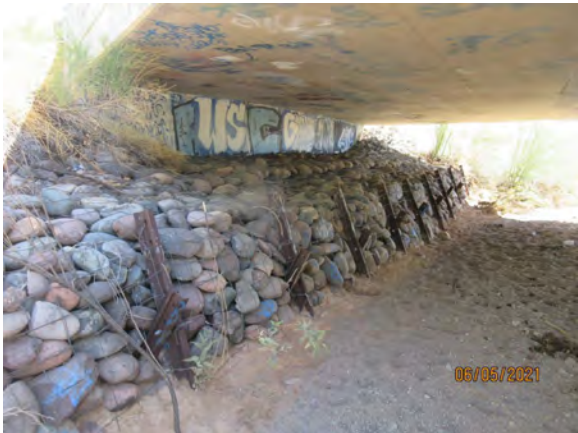
H622_2106_P08 NORTH ABUTMENT
